**CPSC Staff Report on  
Metallurgical Investigations into Corrosion Damage  
in  
Homes Constructed with Problem Drywall**

Rohit Khanna, Fire Protection Engineer

Office of Hazard Identification and Reduction  
U.S. Consumer Product Safety Commission

September 2011

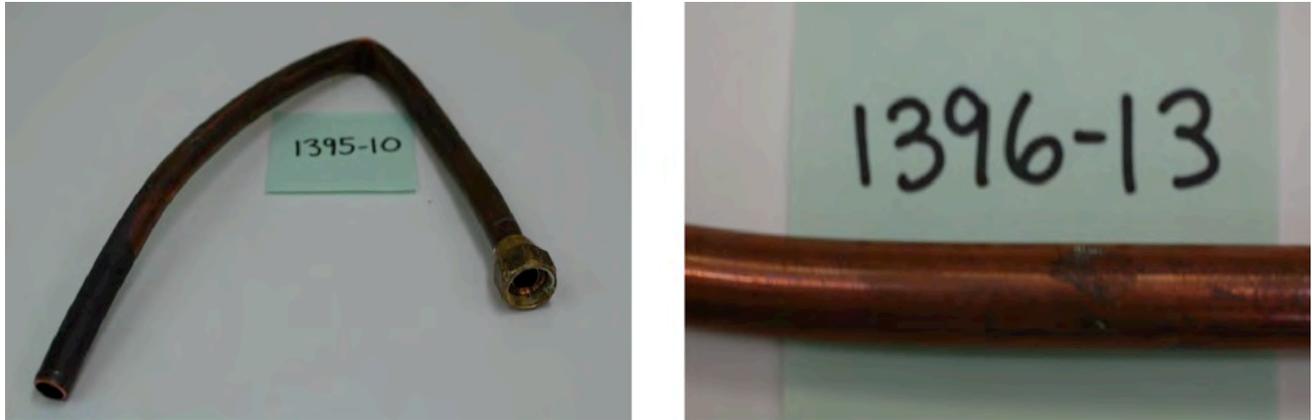
The lengths of copper tubing were discolored to varying degrees. This discoloration, which is illustrated in Figure 1, was found to be due to the presence of a thin, adherent layer of a black substance. This is clearly illustrated in Figure 2, where the sample number has been scribed into the sample exposing fresh bare copper. While this black film adhered to the surface, physical contact would result in the transfer of a small quantity of a fine black powder from the film. In some cases, the discoloration was found to be very uniform, but in other cases it was irregular. The extent of discoloration varied with the thickness of the layer.

Figure 1 – Photographs of two representative samples of Cu fuel gas distribution tubing.

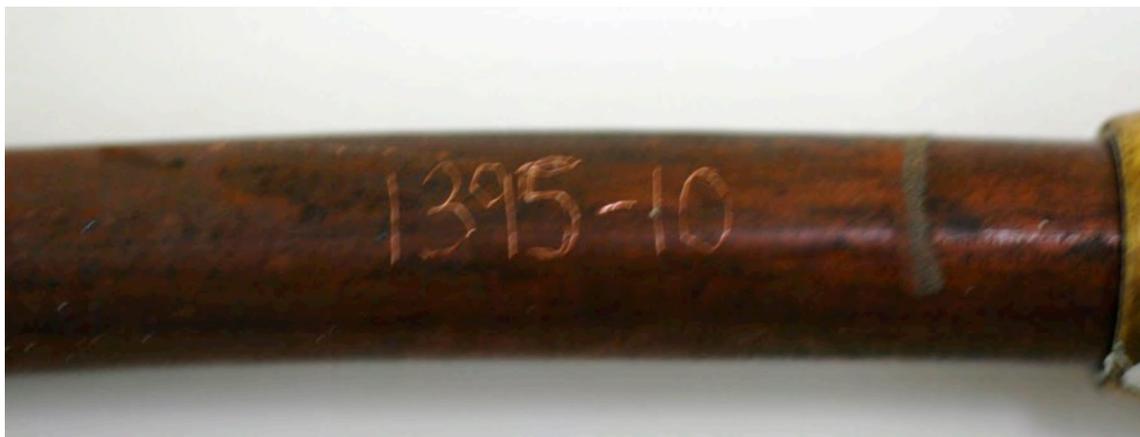
Figure 2 – Scribe marks illustrating the contrast between the color of bare copper and a sample of copper natural gas line tubing.

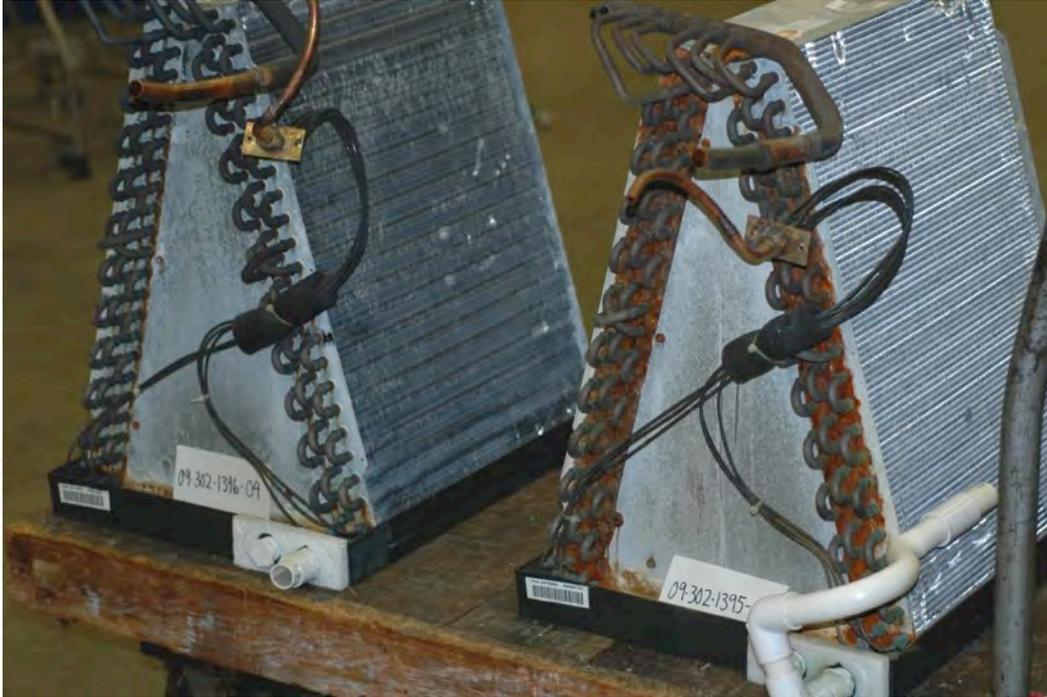
The air conditioner evaporator coils were also examined, Figure 3. From the two coils in this figure, all exposed copper surfaces appear to have turned dark. These coils are constructed out of parallel lines of copper tubing placed through thin sheets of aluminum (Al) that serve as the heat transfer fins. The copper tubing is linked by soldered U-bends to the ends of adjacent lengths of copper tubing. The end plates that hold this assembly in place are made out of galvanized steel. Copper manifolds and valves complete the assembly. Figure 4 is a close-up of the end plates and the U-bend region. In this figure, brown and orange corrosion products can be seen on the galvanized end plates, while black and green corrosion products can be seen on the copper tubing. The normal patina that forms on copper in the cyclically wet and dry environment of an air conditioner evaporator coil would be expected to contain copper (I) or copper (II) ions in oxides (black to brownish-red), carbonates (green to blue), sulfates (bright blue), and chlorides (greenish white to blue-green).<sup>1,2</sup> Again, the black color was found to be due to the presence of a thin layer of black powder.

Figure 3 – Photograph of the two air conditioner evaporator coils showing the black discoloration of the copper U-bends and corrosion of the end plate.

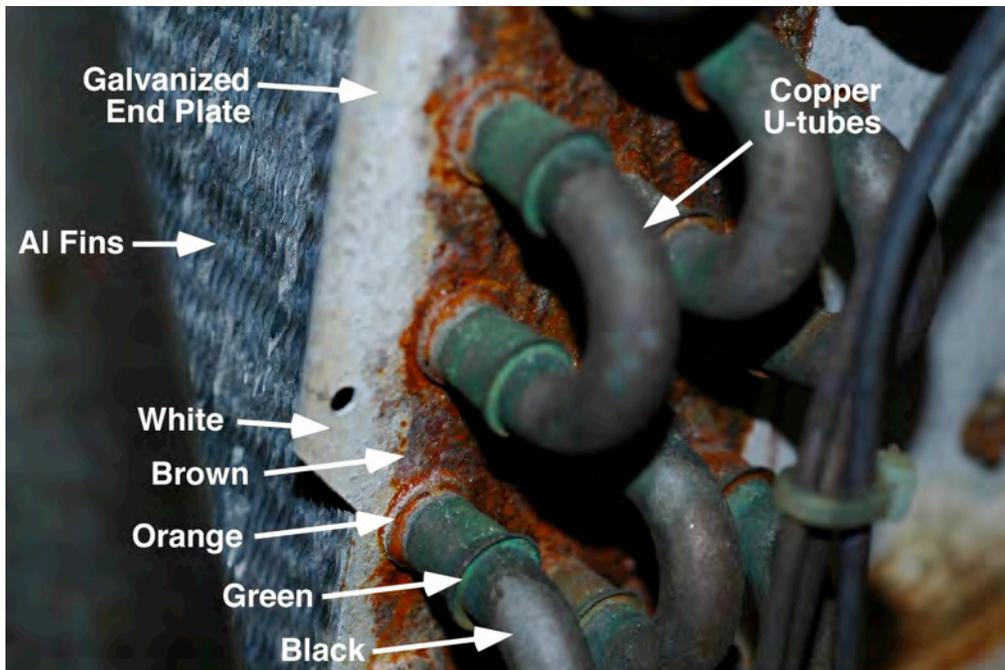
Figure 4 – Close-up photograph of the U-bends and end plate of an air conditioner evaporator coil showing that there appears to be five colors associated with the corrosion products: white, brown, orange, green, and black.

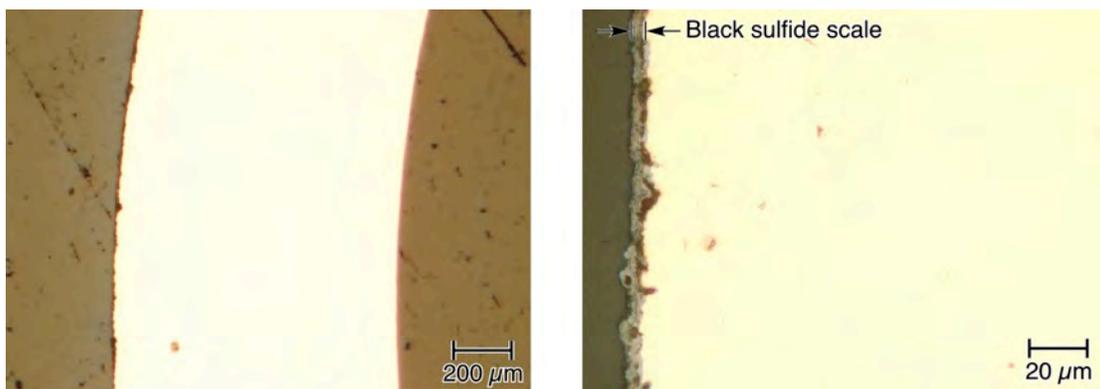
The thickness of the black corrosion product on a fuel gas supply tube was measured using optical microscopy of samples prepared in cross section. For this analysis, samples of natural gas supply lines were cut, mounted in epoxy, and polished, using standard metallurgical practice, exercising care to maintain the edge of the sample with the corrosion products in place. Figure 9 shows optical micrographs of this sample, where the corrosion product layer varied from  $(5 \text{ to } 10 \pm 0.5) \mu\text{m}$  thick.

Figure 9 – Optical micrographs of the wall of a copper natural gas supply line and the corrosion product layer at two magnifications.

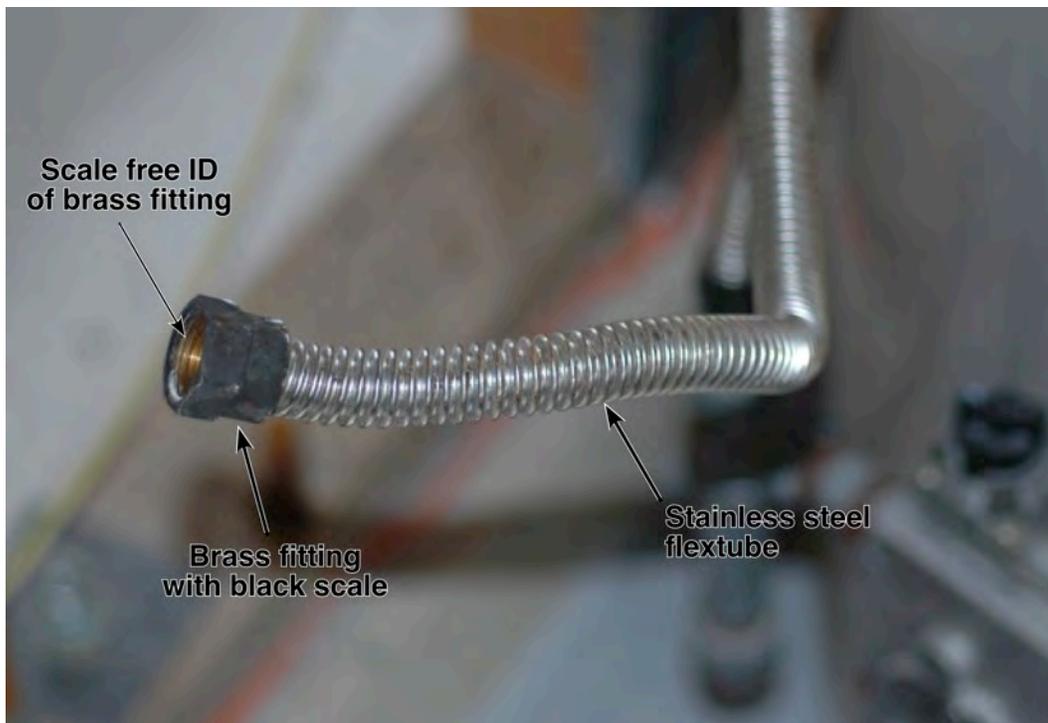
Figure 11 – Stainless steel fuel gas supply tube for the water heater. Note the contrast in the color between the inside and the outside of the brass fitting on the end.

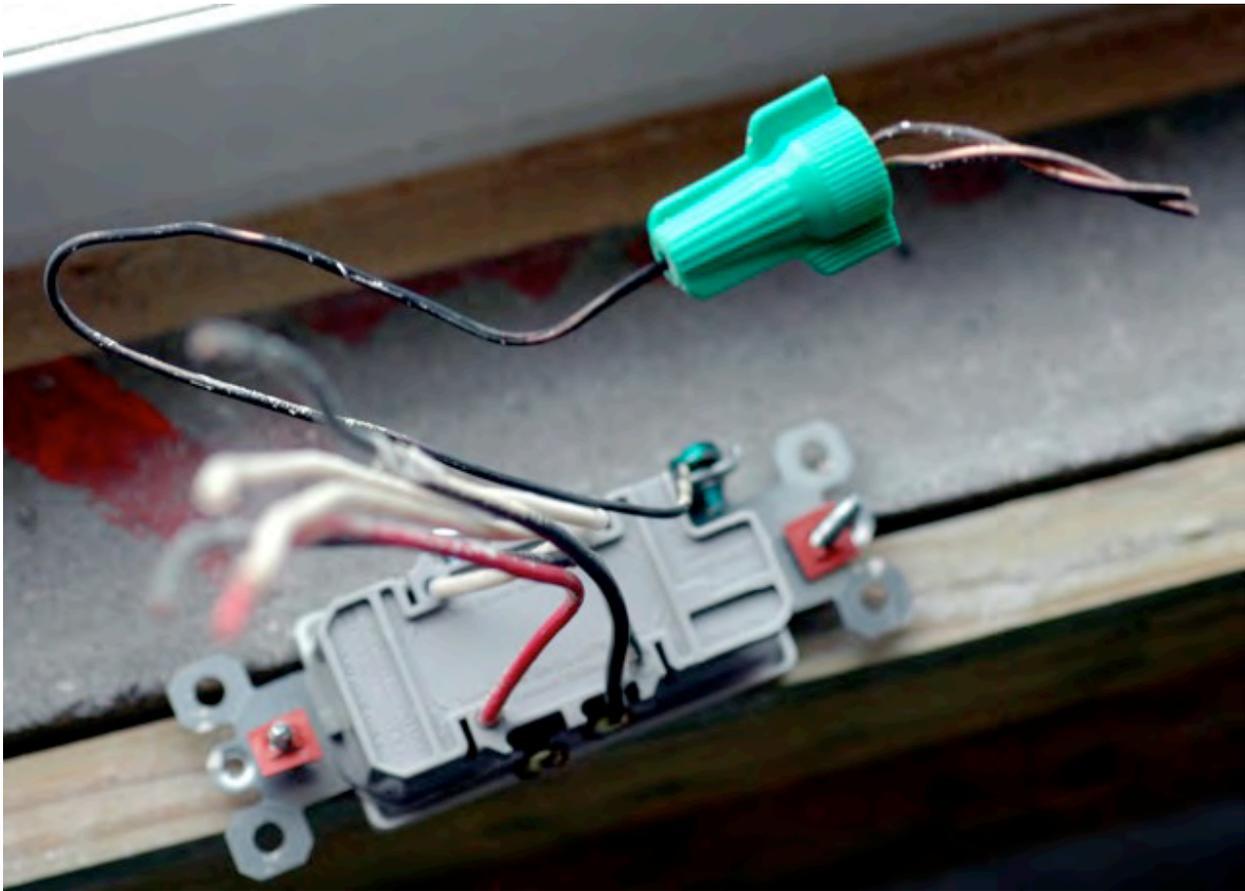
Figure 12 – Electrical wall receptacle in a home with problem drywall showing the characteristic black deposits on the bare copper ground wire.

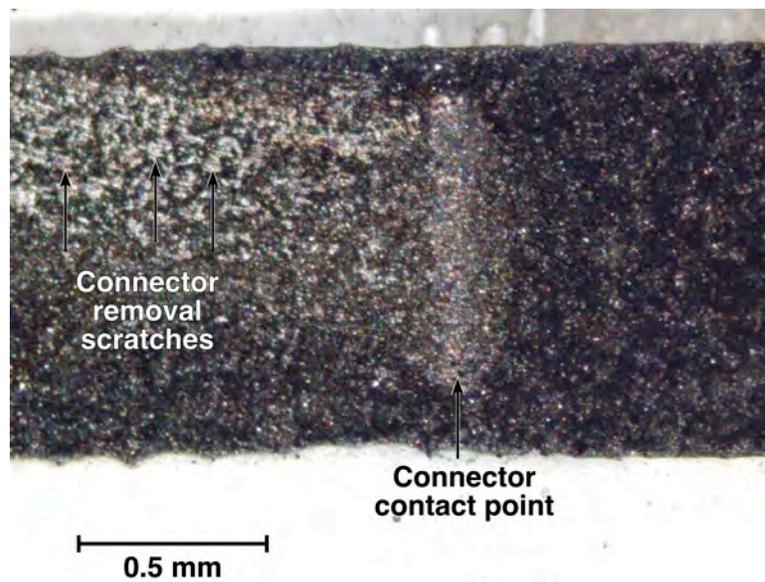
Figure 19 – Black deposits on silver connector for flat flexible cable, connector contact area, and scratches from unplugging the cable.

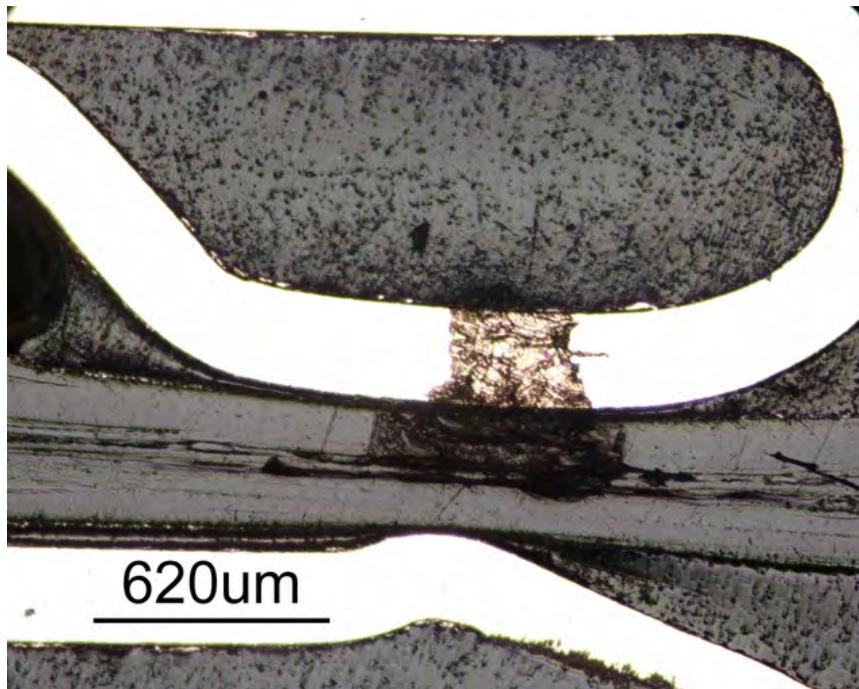
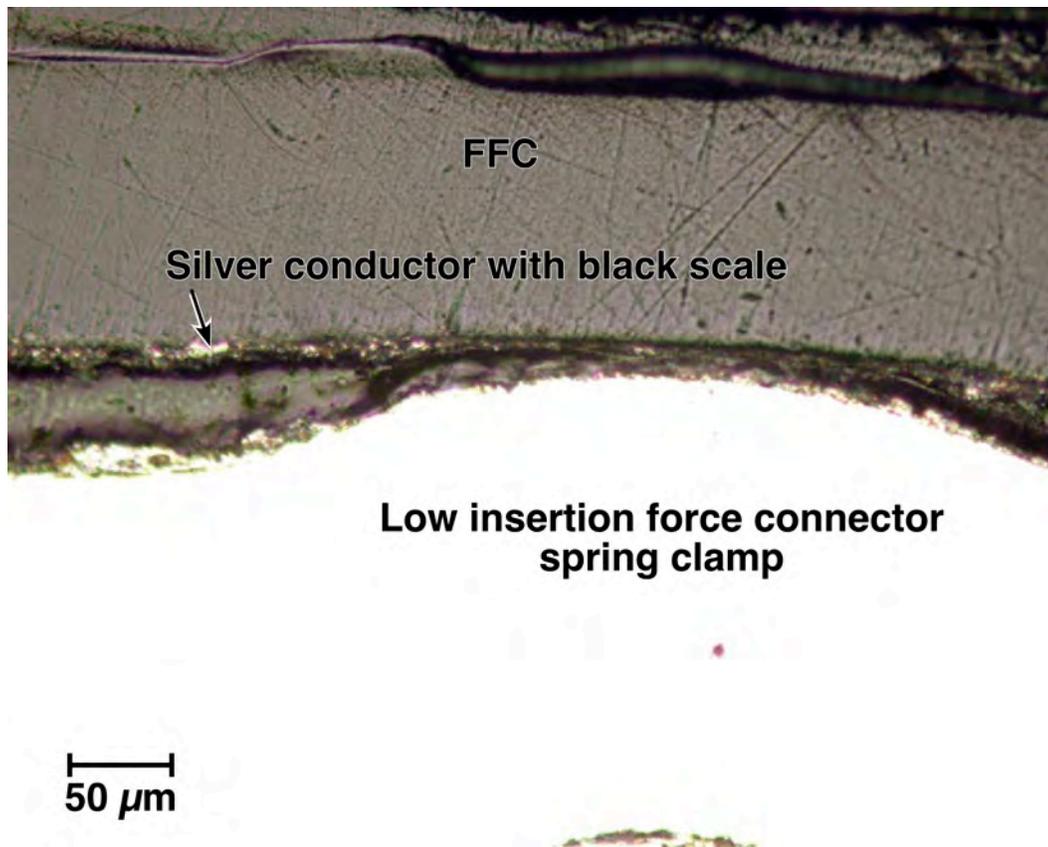
Figure 21(a) – Optical micrograph of the contact area of the flat, flexible cable plug in between the spring contacts of the female receptacle in cross section.

Figure 21(b) – Higher magnification view of flat, flexible cable contact area.

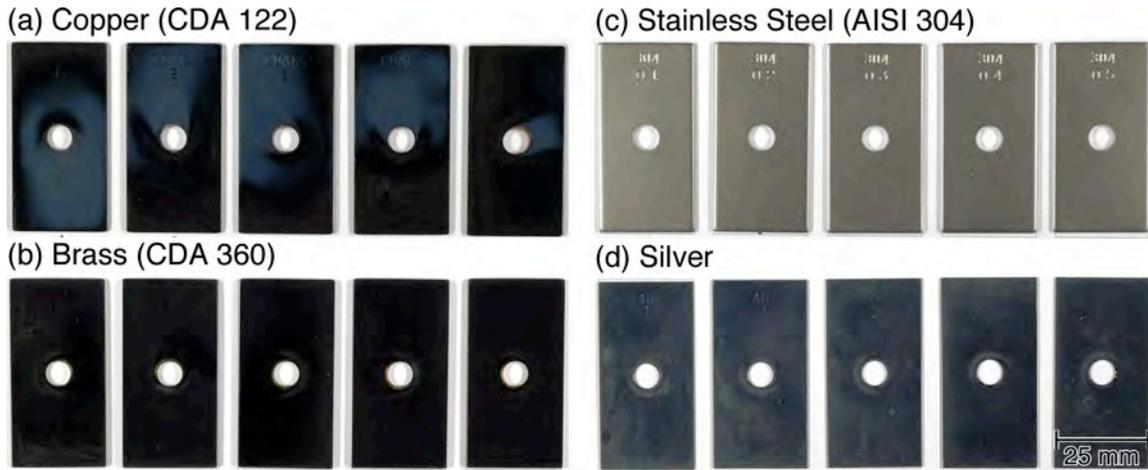
(2) Optical Examination Results. Figure 23 shows photographs of the five flat coupon samples of each alloy after exposure to the accelerated test environment at SNL. Figure 24 shows a photograph of a representative sample of each alloy, after exposure, next to a sample that was not exposed to the accelerated test environment. By comparing these photographs, it can be seen that the alloys that contain copper formed very dark deposits that appear to be thick due to the dark opaque color of these deposits. The silver samples are also significantly altered

by this exposure, although the change seems to be more of a case of loss of luster rather than the development of a corrosion product. No evidence of general or localized attack was observed on any of the stainless steel coupons. Similar deposits were found on the U-bend coupons, but no evidence of any form of localized corrosion, pitting, or stress corrosion cracking was found on any of the samples.

Figure 23 – Flat coupons after exposure to the simulated Class IV accelerated corrosion environment at SNL.

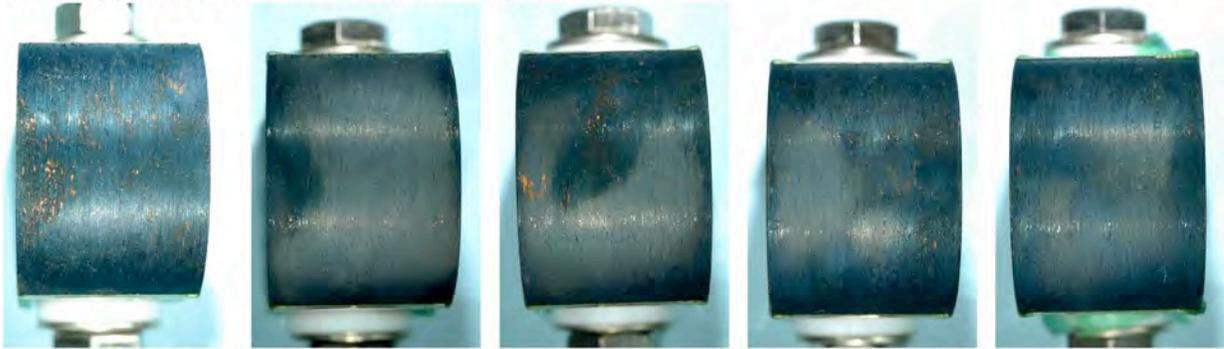
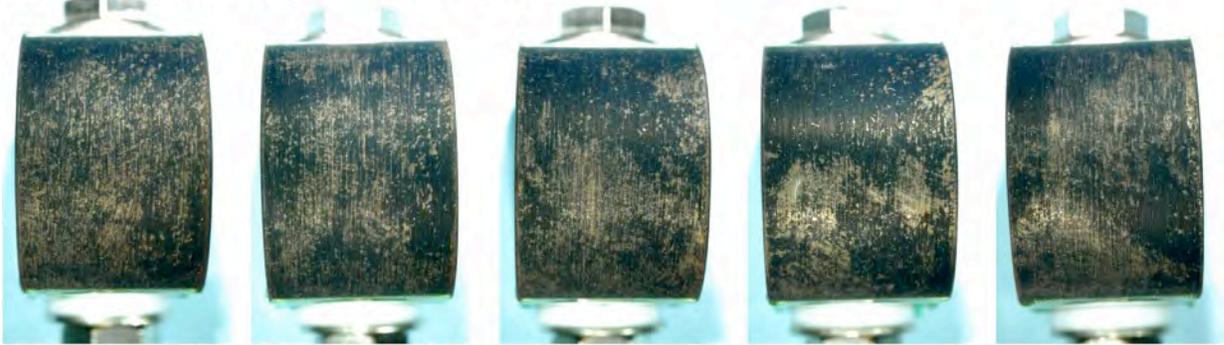
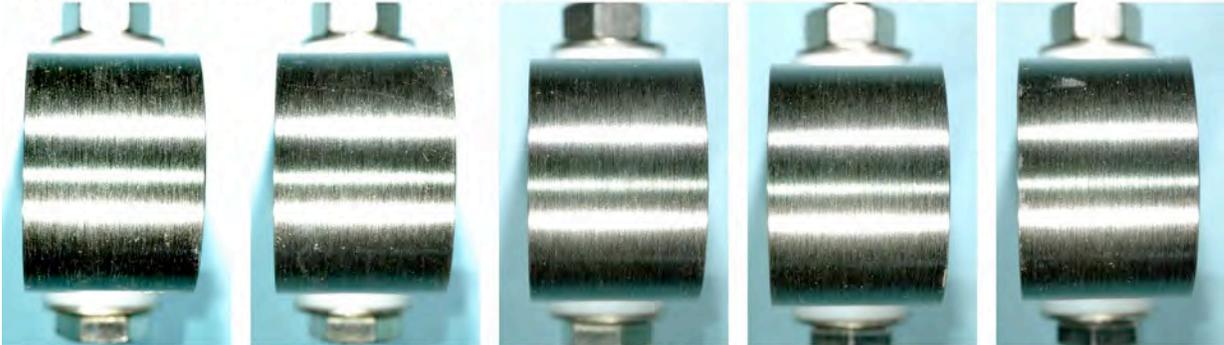
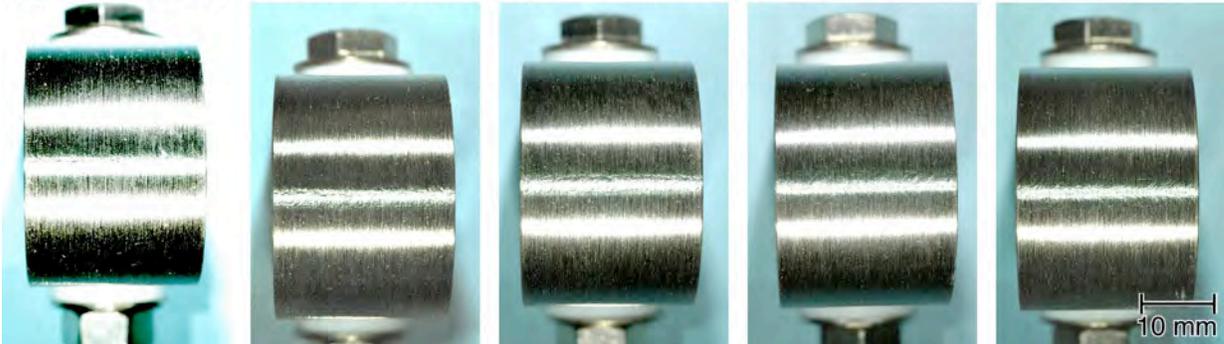
The U-bend samples were examined to determine if there was any evidence of stress corrosion cracking, pitting, or crevice corrosion. These samples were examined by eye, macroscopically, and microscopically with a metallurgical microscope. No evidence of any of these forms of attack was found on any of these samples. Figure 26 and 27 are macro photographs of the apex of the bend section of all 20 of the U-bend samples exposed to the accelerated testing environment at SNL. Figure 26 shows the stressed face across the entire width of the bend while Figure 27 shows the edge and corner of the bend in each sample. In these figures, the thin layer of uniform corrosion product can be seen on the copper and brass samples, while there is no visual evidence of any attack on the stainless steel or the welded stainless steel samples.

Figure 26 – Macro photographs of the bend apex in all 20 of the U-bend samples exposed to the accelerated testing environment at SNL.

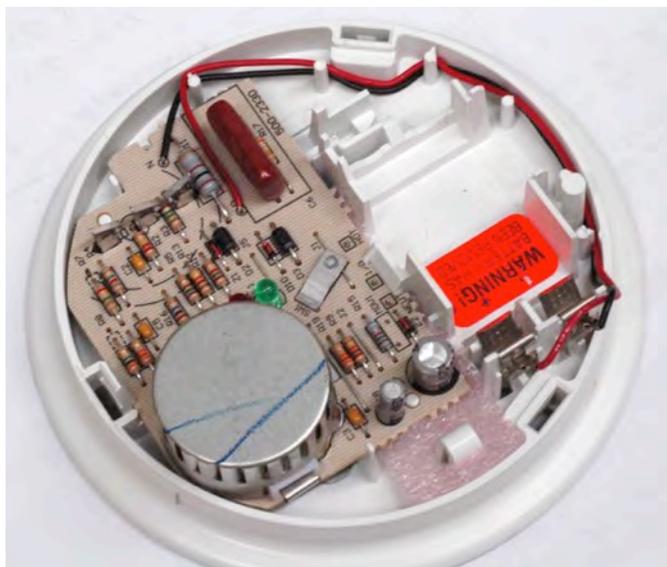
(2) Results of Metallurgical Examinations: The smoke alarm examined was one that failed to produce a strong and steady alarm. Figure 28 is a photograph of this unit with the cover removed. In this figure, the circuit board, with the cell containing the electrodes and the Americium source and connections for the 9-volt battery are immediately obvious. Less obvious are the connections to the piezoelectric bending disc used for the alarm-sounding device. These connections are of the lever spring-type, and they are located on the upper left side of the circuit board in the figure. The piezoelectric alarm-sounding device is attached to the cover and makes electrical contact with these connections by pressing against them when the cover is put into place. Figure 29 is a photograph of two piezoelectric bending discs used for the alarm-sounding device in smoke alarms. The one on the left is from the alarm that failed to present a normal signal when it triggered the alarm, and the one on the right is from an alarm of the same type that had been used for smoke testing, but had not been exposed to the accelerated corrosion environment at SNL. The difference in the appearance between these piezoelectric discs is remarkable, and the one of the left appears to be covered with a black corrosion product that has spalled off, at several locations, at the point of contact with the spring connections, probably due to repeated disassembly and reassembly of the unit. To determine the composition of this black film, this sample was placed into the X-ray diffractometer and examined in the same manner as the corrosion coupons above. This analysis, Figure 30, found peaks for silver metal and silver sulfide ( $\text{Ag}_2\text{S}$ ). The silver sulfide phase was identified as the same phase found on the corrosion coupons listed in Table II (acanthite). Therefore, it is concluded that, as in the microwave connection, the growth and creep of  $\text{Ag}_2\text{S}$  into the interface between the lever-type spring connections and the silver-coated piezoelectric of the alarm sounding device is responsible for the failure of this unit to make a normal alarm sound.

Figure 28– Open smoke detector alarm after exposure to the accelerated corrosion-testing environment at SNL.

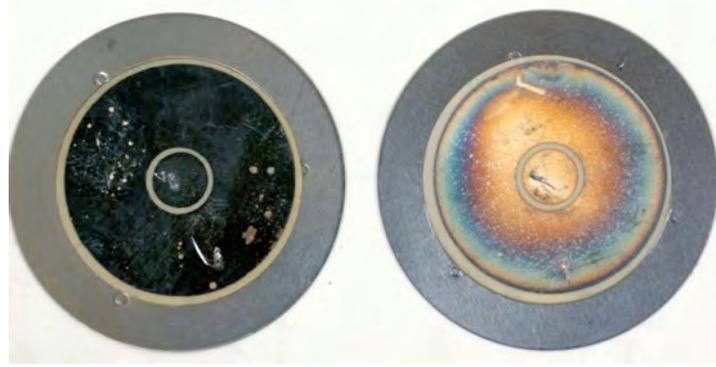
Figure 29 – Comparison of the piezoelectric alarm tone-producing disks from a smoke detector after exposure to the accelerated corrosion-testing environment at Sandia National Laboratory (on left) to one from a detector not exposed to this environment (on right). These photographs were taken after smoke response testing where the one on the left failed to produce a normal tone while the one on the right functioned normally.

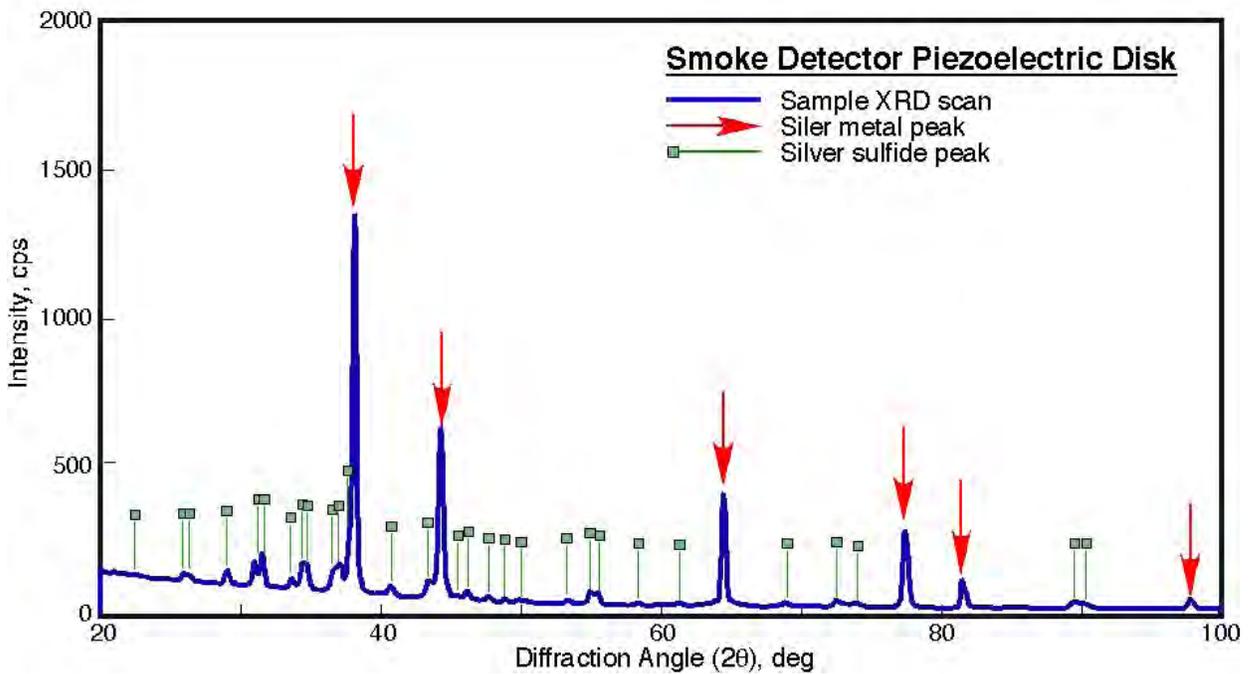
NIST found silver sulfide ( $\text{Ag}_2\text{S}$ ) deposits in the alarm buzzer contacts of the one smoke alarm that failed to produce a steady alarm during the NIST functional tests; these tests occurred after the alarm had undergone accelerated aging at SNL. NIST concluded that the growth and creep of  $\text{Ag}_2\text{S}$  into the interface between the spring connections and the silver-coated piezoelectric disk of the sounding device was the cause of the failure of the smoke alarm to produce a steady alarm.

Figure 30 – X-ray powder diffraction scan showing peaks for silver and silver sulfide obtained from the surface of the piezoelectric buzzer disc shown on the left in Figure 29.

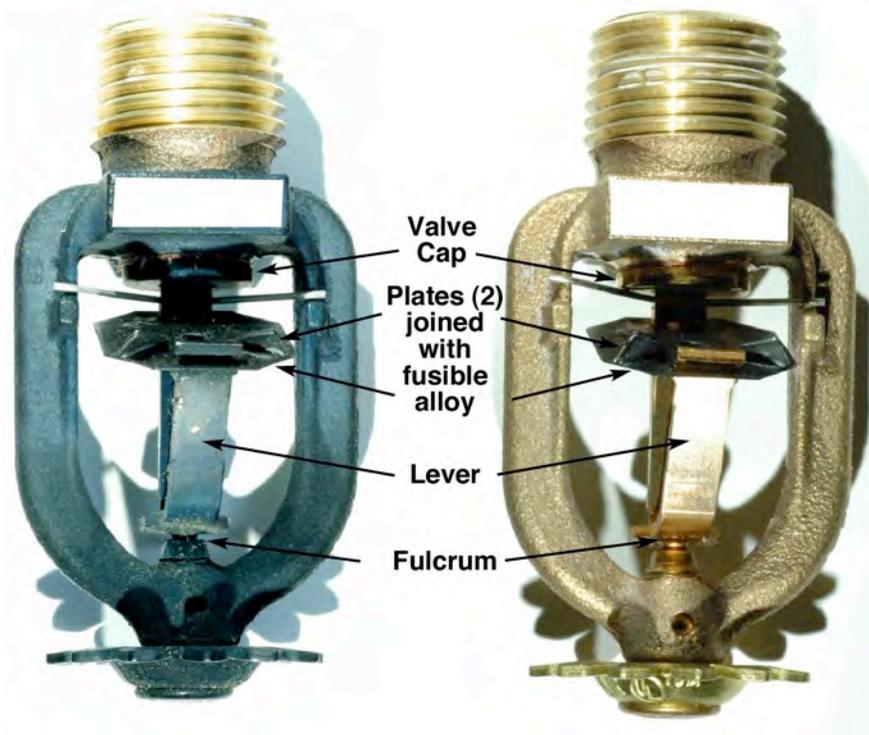
Because corrosion could alter the contact of the pivot and lever mechanism, the force applied to the fusible link by the lever of the unit that failed to activate was measured by suspending weights from the lever and determining the mass that freed the fusible plate from the lever. The force the lever placed on the fusible link of the unit that failed to activate was estimated at  $3.03 \text{ kg} \pm 0.05 \text{ kg}$  and this compares to  $4.84 \text{ kg} \pm 0.06 \text{ kg}$  for a similar unexposed unit. While this is a large enough difference for one to detect by hand, 3 kg of force should still be enough force to separate the plates if the low melting point alloy between the plates melted and the plates were free to move.

Figure 31 – A comparison between a lever-type, fusible-link fire sprinkler head after exposure to the accelerated corrosion test environment at SNL (left) and another one from the same batch that has not been exposed to this environment.

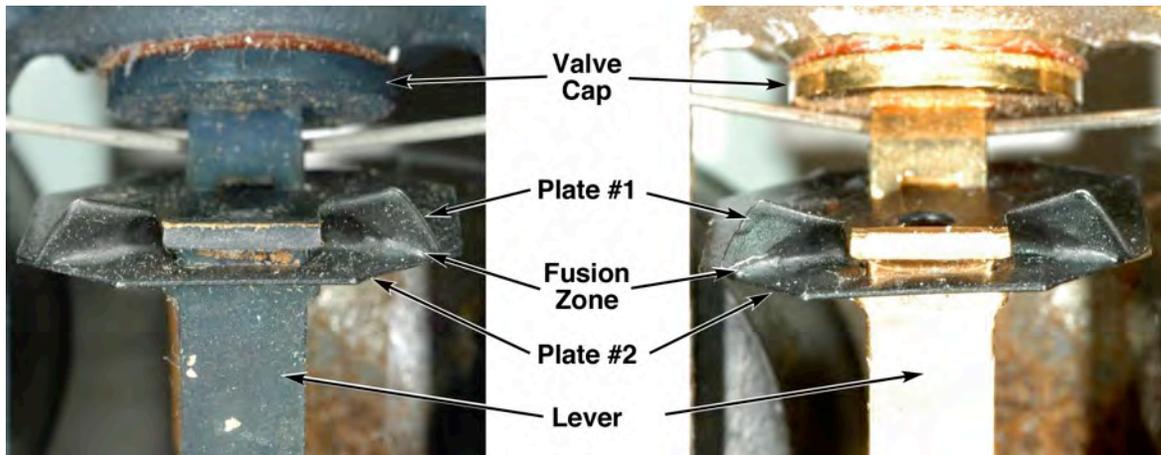
Figure 32 – Close-up of the fusible link (arrowhead) of the units shown in Figure 31, demonstrating the gap between the two plates of the link where they are fused together. It should be noted that the black coating is on the fusible link of both the unexposed and exposed units.
