CPSC Staff Statement on the
Southwest Research Institute Report,
“Internal Cabinet Temperature Evaluation of Three Models of Commercially Available Resistive
Element Clothes Dryers”
July 2015

INTERNAL CABINET TEMPERATURE EVALUATION OF THREE MODELS OF COMMERCIALY AVAILABLE RESISTIVE ELEMENT CLOTHES DRYERS

FINAL REPORT Consisting of 59 Pages

SwRI® Project No.: 01.20741.01.001
Test Dates: December 10–12, 2014, and January 19–26, 2015
Report Date: May 1, 2015

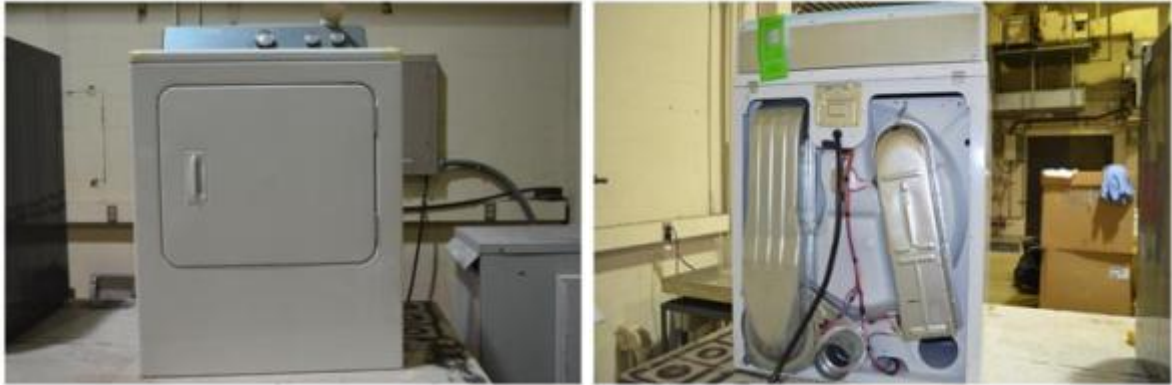
Figure 1. Dryer 1 – Front (Left); Back with Panel Removed (Right).

Three commercially available, resistive-element electric clothes dryers were selected by SwRI for this test series. A single dryer was selected each from a low, medium, and high price-tier to represent the range of options currently on the market. Figures 1 – 3 show the front and back of each dryer (back panels removed for pre-test characterization and instrumentation). The dryers were elevated for initial inspections and instrumentation. During operation, the dryers were placed on the ground and connected to a standard exhaust duct for both unmodified and insulated testing.

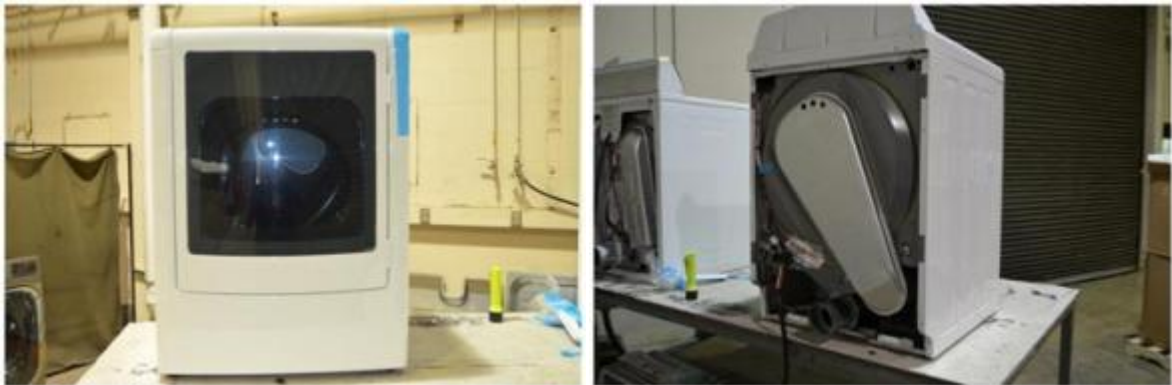
Figure 2. Dryer 2 – Front (Left); Back with Panel Removed (Right).

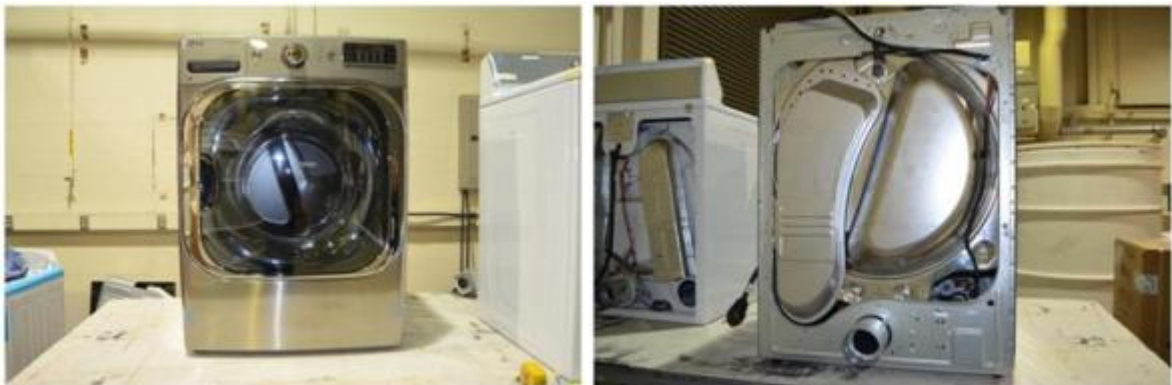
Figure 3. Dryer 3 – Front (Left); Back with Panel Removed (Right).

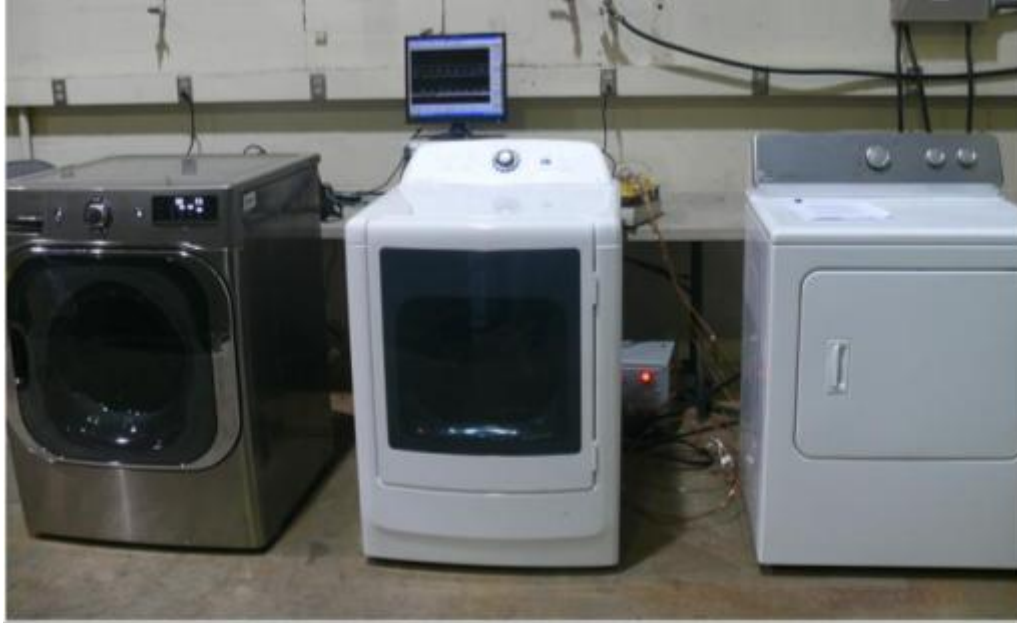
A 4-in. diameter, 10-ft long duct was attached to the restrictor to vent the dryer exhaust outside of the test building. No weather hood was connected to the end of the exhaust duct. Figure 6 shows the dryers set up side-by-side in the test facility.

Figure 6. Overall Dryers Setup (Dryers 3, 2, 1, Left to Right).

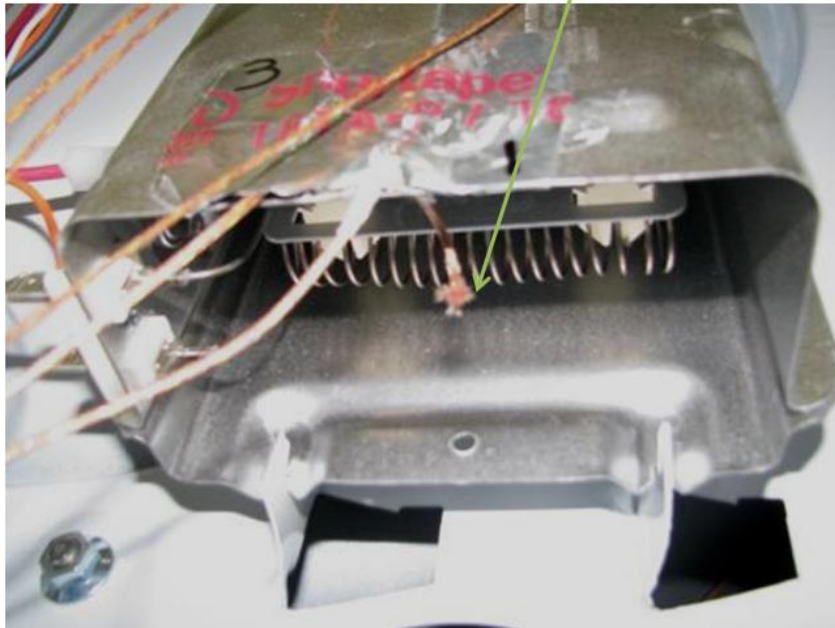
TC 1
Air temp at the intake into the heating element. TC was placed thru a drilled hole and 1 in. away from the heating element.

Figure A-2. Dryer 1: Location of TC 1.

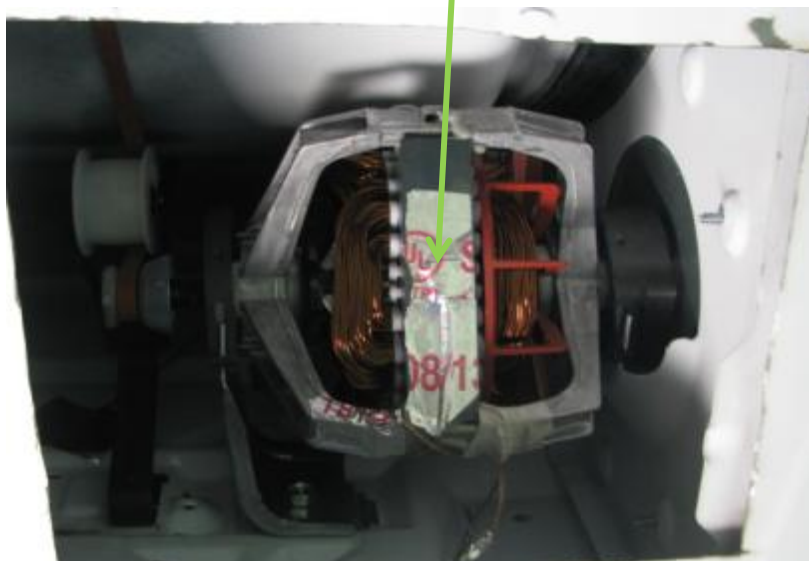
TC 8
Motor temp (located
behind the blower).

Figure A-5. Dryer 1: Location of TC 8

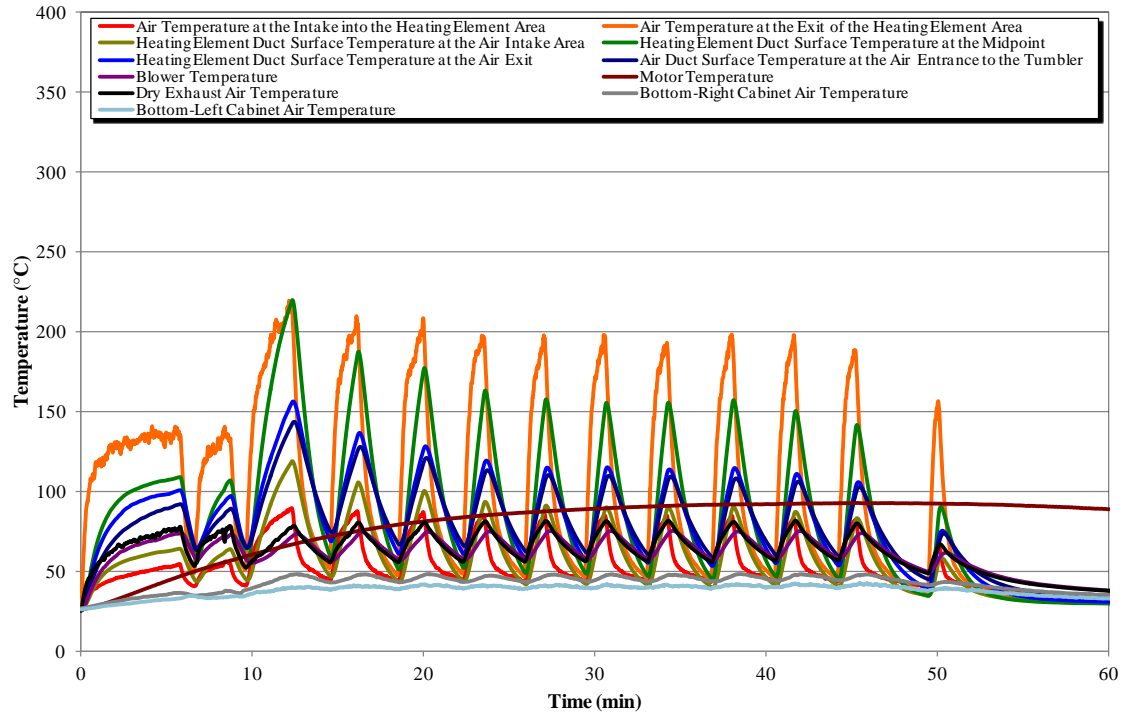
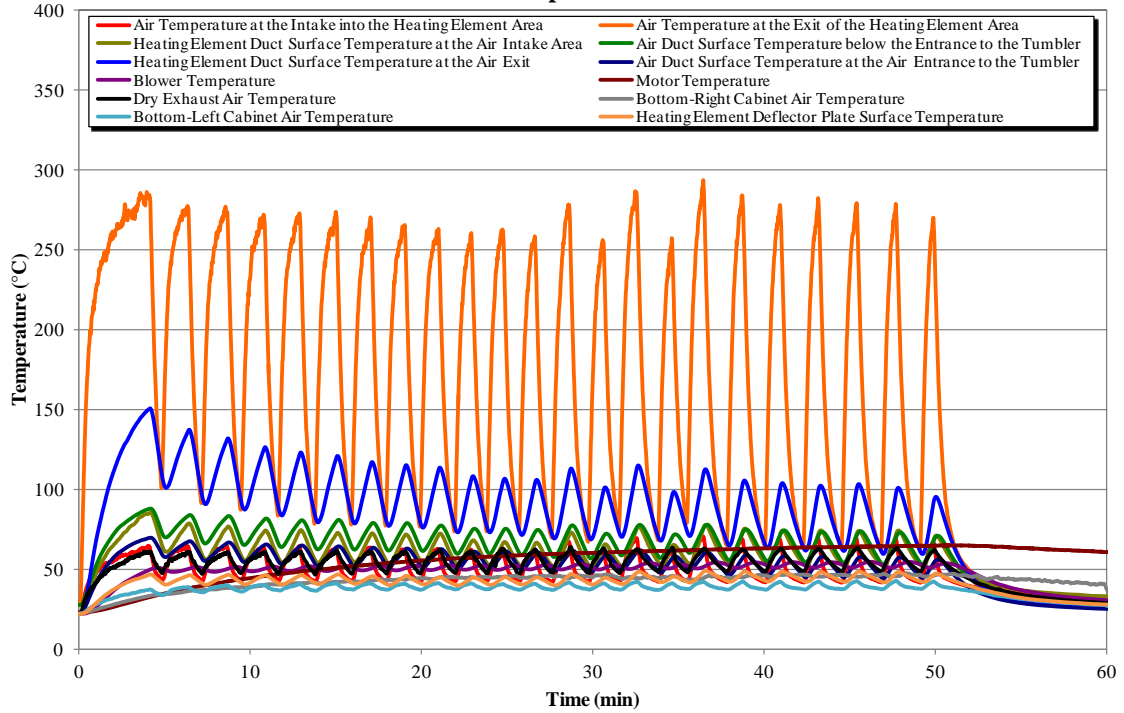
Testing of the new dryers was completed on December 10–12, 2014. These tests were conducted without modification of the dryers in order to establish a baseline under normal drying conditions. Table 2 provides the test results. Graphical temperature data can be found in Appendix B.

Figure B-1. Unmodified Run 1, Dryer 1 – Temperatures.
