CPSC Meeting Log: Polaris

CPSC Attendees	Commissioner Mary Boyle Eva Caldera
Date of Meeting	October 30, 2024
Date of Log Creation	November 1, 2024
Log Creator	Jacob Murray

**Notice of Proposed Rulemaking on Safety
Standard for Debris Penetration Hazards
Docket No. CPSC-2021-0014**

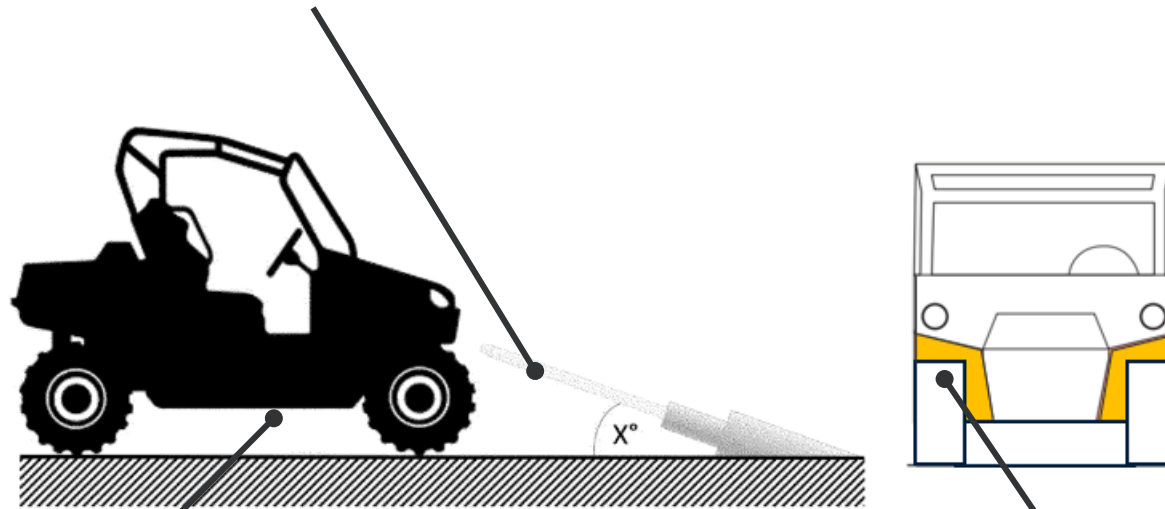
Figure 7— Illustration of Debris Penetrator Test Dowel Orientation

Dowel Impactor

Large variation in strength results in poor repeatability
Manufactured dowel strength inconsistent with natural stick strength

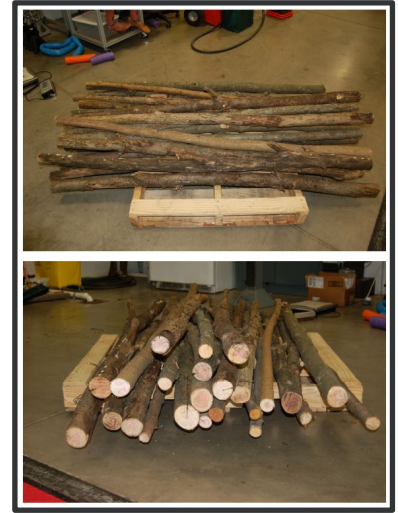
Manufactured dowel 2x as strong as natural sticks

Variation as much as 2x

Not Tied To Natural Stick Strength

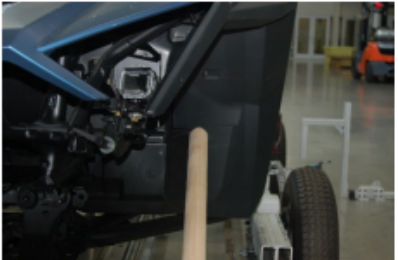
Pre-Impact Stick Alignment

Primary Impact Location: Stick aligned to impact where overlapping sections of the OEM components meet at a point. (Same Impact Point as Run #2). No C-Brace was used, and movement of the stick holder base was restrained.

11 3/4" Above Bottom of Floorboard
18 1/2" Left of Vehicle Centerline

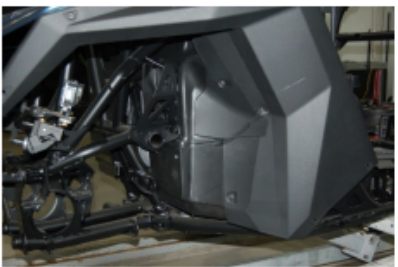
Post-Impact – Side View

The stick tip slid upward and outward, until the tip of the stick became constrained by a frame member under the plastic. The stick made a 1" diameter dent in the plastic as it pushed against the frame member. This dent can be seen in the photo to the right. There was significant stick force, with significant vehicle lifting and yawing. The front wheels of the cart lifted off the floor during impact and the cart yawed 9° counterclockwise.
