## CPSC Staff Statement<sup>1</sup> on Contractor eBike Battery Test Report

## **Consumer Product Safety Commission Lithium-ion Safety Performance**

June 19, 2024

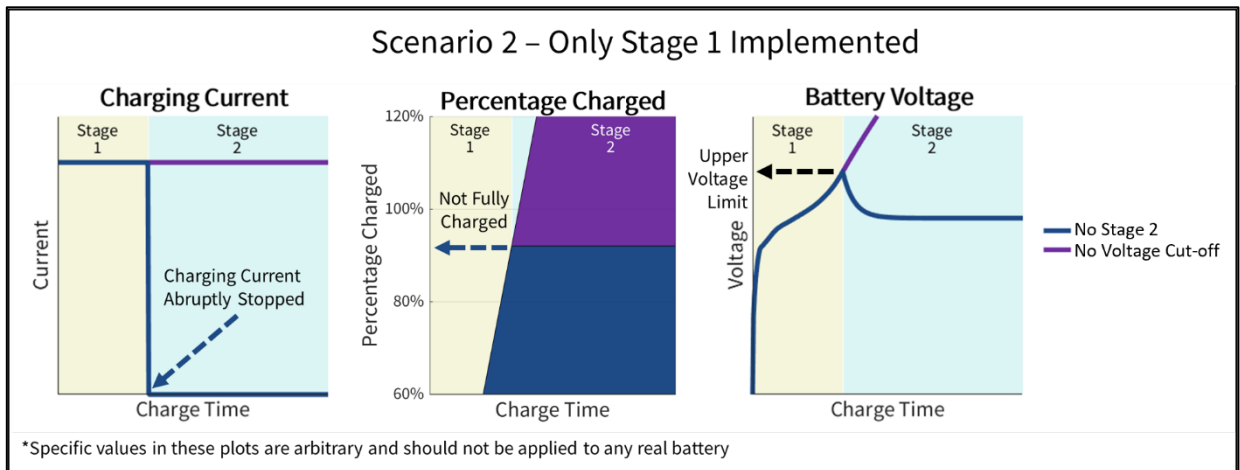
Scenario 2 (Figure 3) depicts the simplest charging protocol, where the battery is only charged using a constant current until it reaches the Upper Voltage Limit. A battery charged under this scenario will result in an incomplete charge.

Figure 3. Schematic of a CC charging profile with an Upper Voltage Limit.

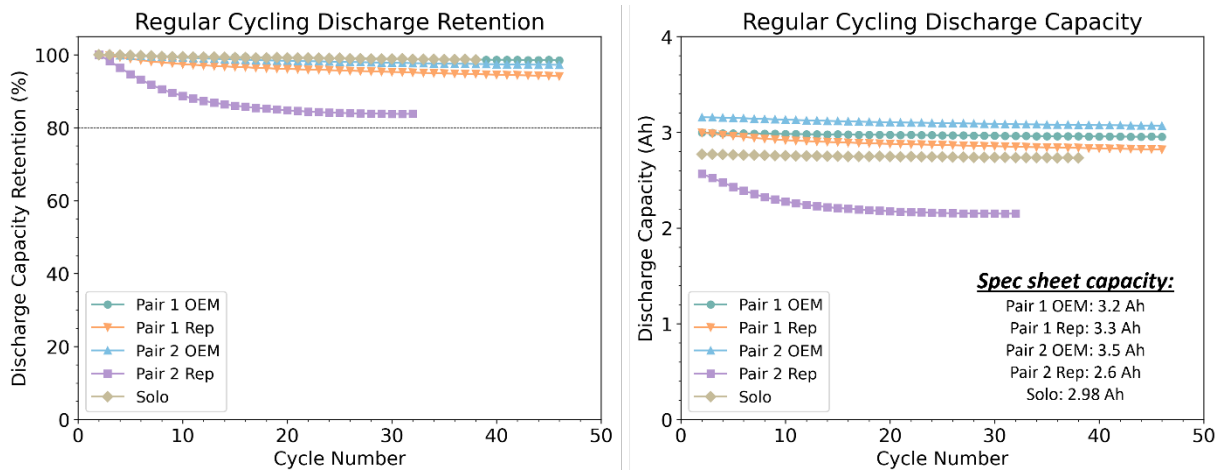
Figure 23 shows the discharge capacity as a function of cycle count. The cycling study demonstrated a capacity retention of at least 94% for all cells, except for Pair 2 Rep – Pack cells which exhibited a retention of 84% after 30 cycles.

Figure 20. Cell cycling for one cell in each module.

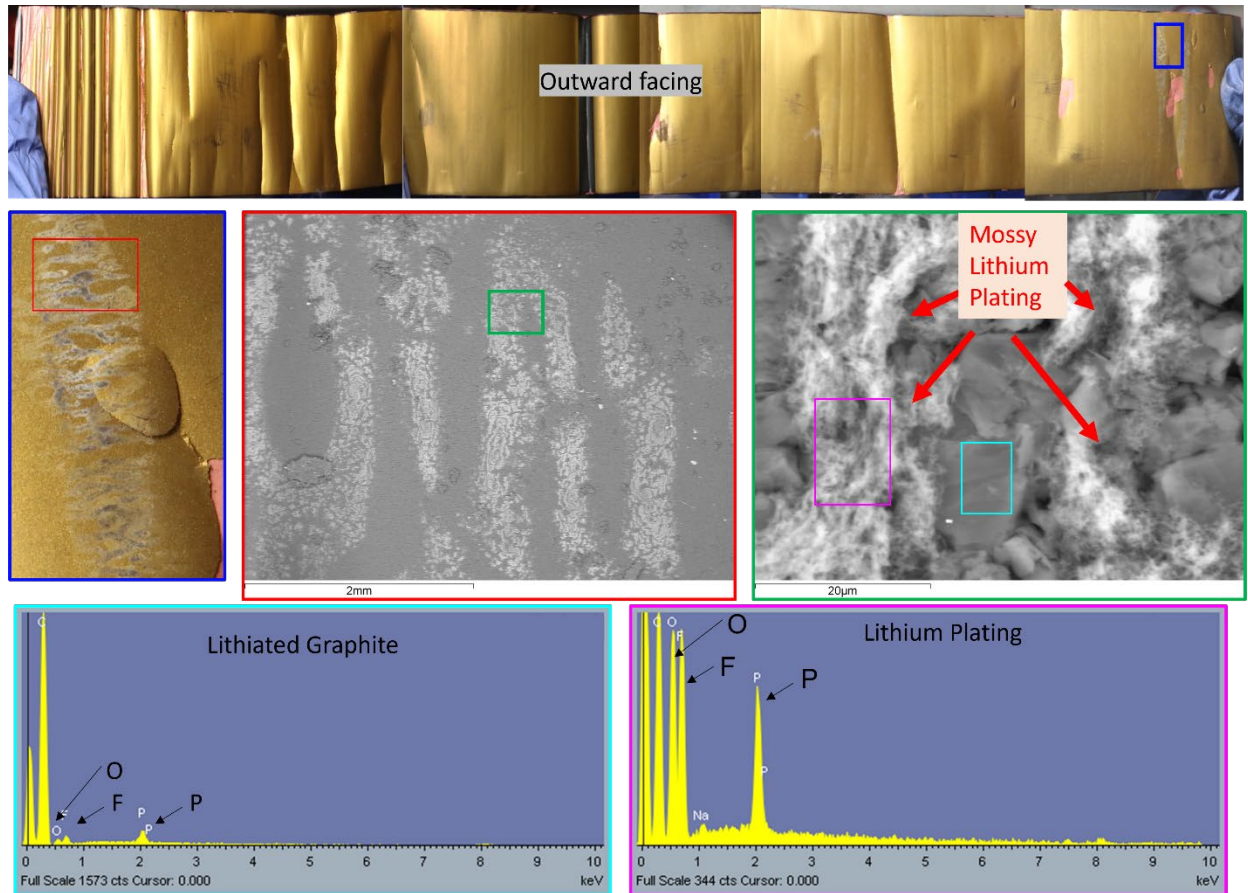
Exponent has identified the lithium plating in the post-cycle disassembly of the Solo – Pack cell to be a potential safety risk<sup>25</sup>.

Figure 22. Evidence of lithium plating on 100% disassembled Solo – Pack cells post cycling.

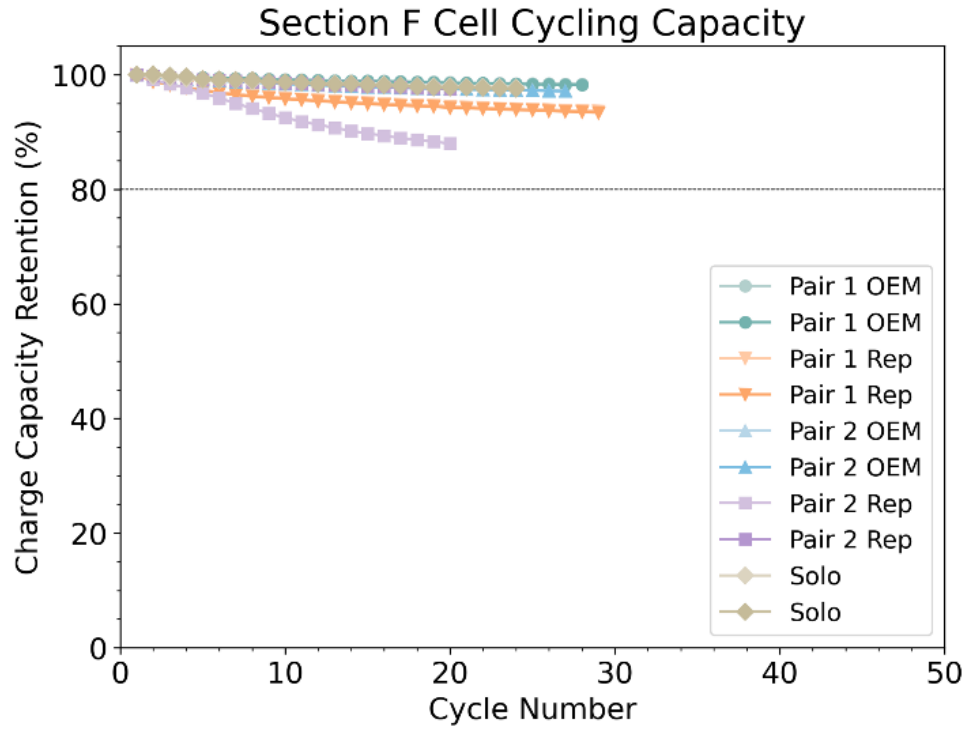
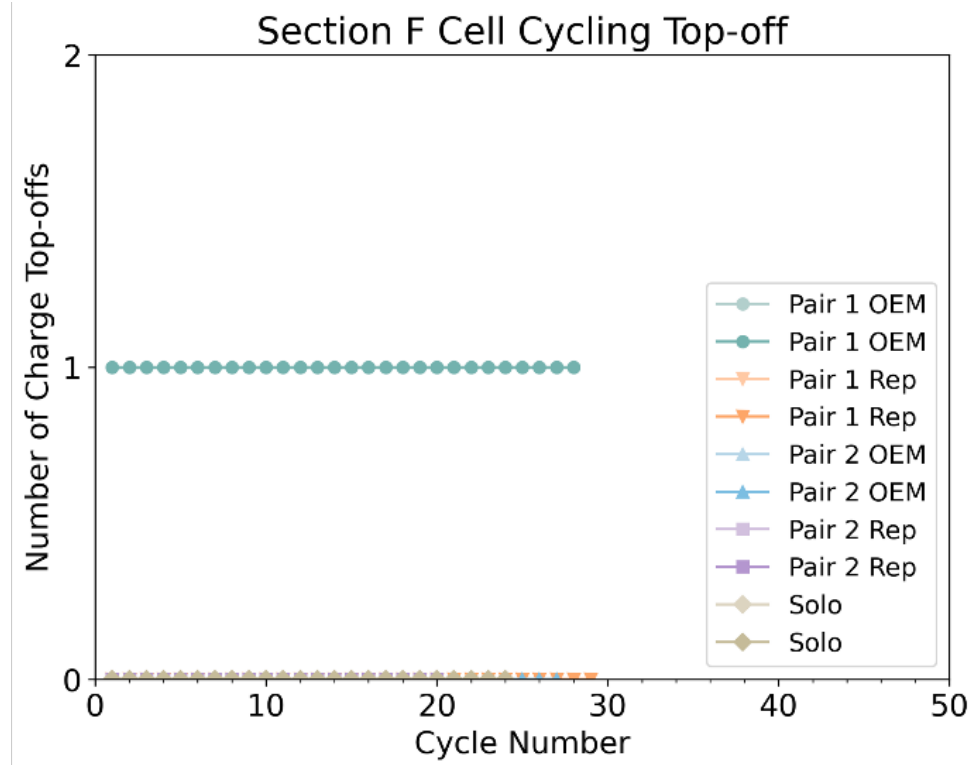
Based on the results of this testing, the cells neither lost excess charge capacity, nor showed obvious signs of degradation that would create an elevated safety risk compared to cells cycled under nominal conditions. However, this result is only valid for the number of cycles used in this test. Repeated cycling under this scenario may lead to cell degradation and potential safety risks, but the required long-term testing was outside of the scope of this project.

Figure 23. Section F.2.2 cell cycling capacity retention (top) and number of top-offs per cycle (bottom).

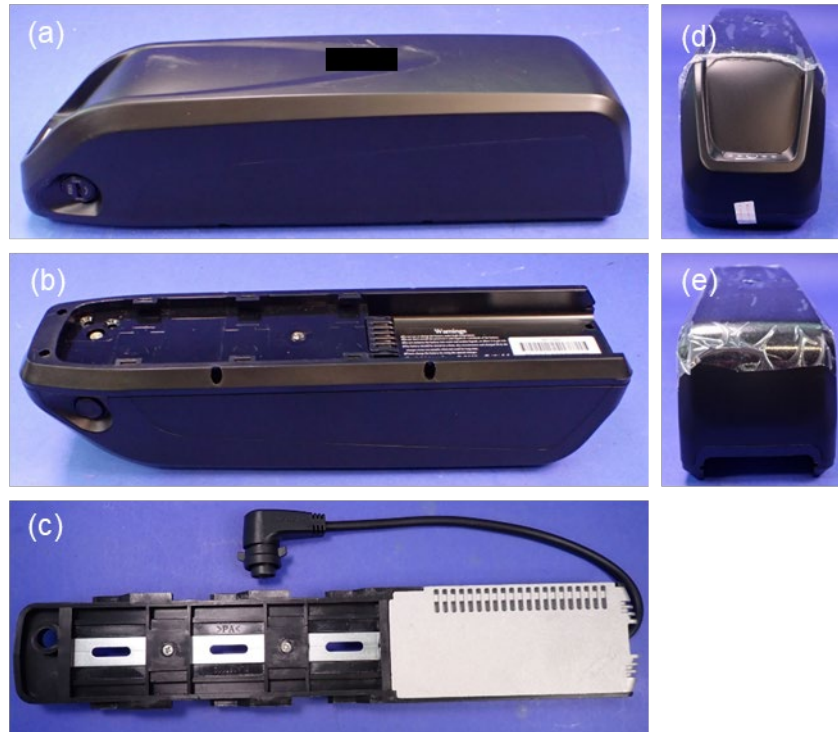
Figure A - 5 Pair 2 OEM – Pack as received; (a) and (b) outer enclosure; (c) adapter between stack and load; (d) and (e) end caps with indicators.

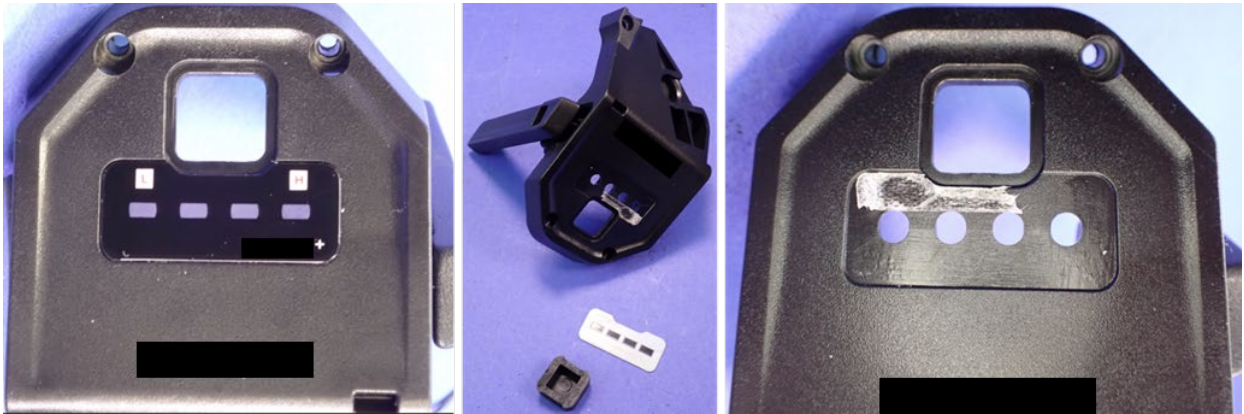
Figure B - 4. SOC indicator had openings that were covered only with a plastic sheet held in place with an adhesive. No gasket or seals were observed around this indicator making it prone to ingress.

<b>Construction</b>	No gaskets or sealing mechanism on pack enclosure and screws.
	Potting material present around the pack terminals at the connector; Positive and negative terminals have heat shrinks on the cables.
	SOC indicator has openings that are covered only with a plastic sheet held in place with an adhesive. No gasket or seals observed around this indicator making it prone to ingress. <sup>10</sup>
<b>PCBs</b>	No conformal coating on PCBs.
	No temperature sensor on the PCB.
	Evidence of solder splatter, contaminants, and flux observed on all PCBs. <sup>11</sup>
<b>Cable Management</b>	Cables and sense wires not properly insulated from the cell stack.
	Main positive and negative terminals potted near the connector.
<b>Cell Stack</b>	Sense wires connections covered with insulation paper and Kapton tape.
	Signs of overheating observed on some tab welds on cell cans. <sup>12</sup>
	PCB insulated from the cell stack.

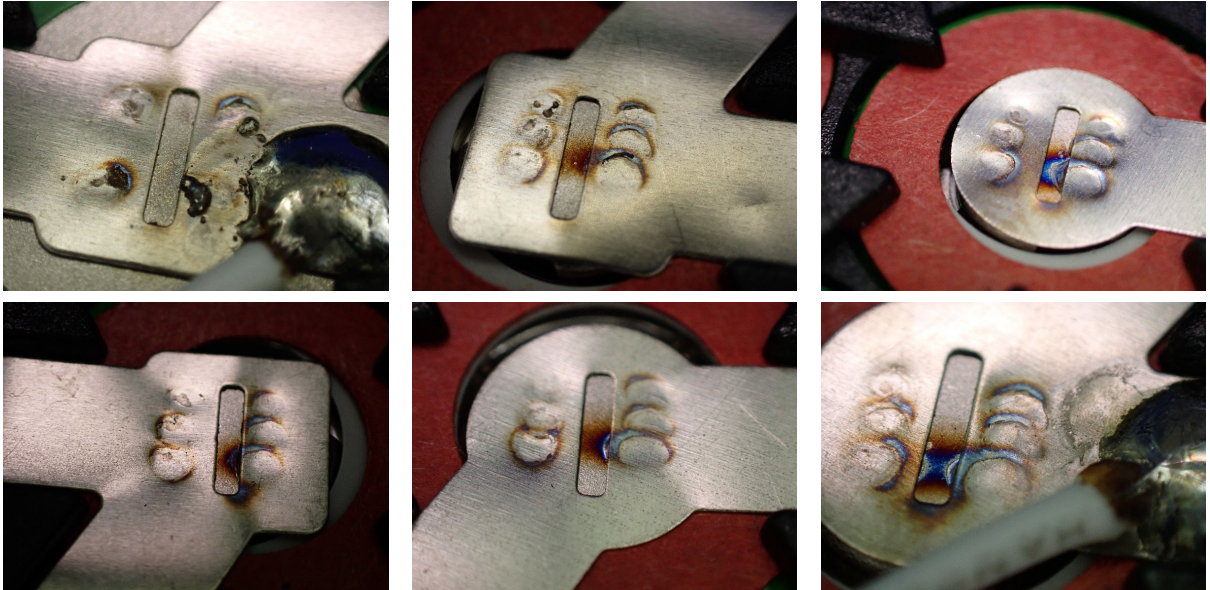
Figure B - 7. Signs of overheating observed on some tab welds on cell cans.

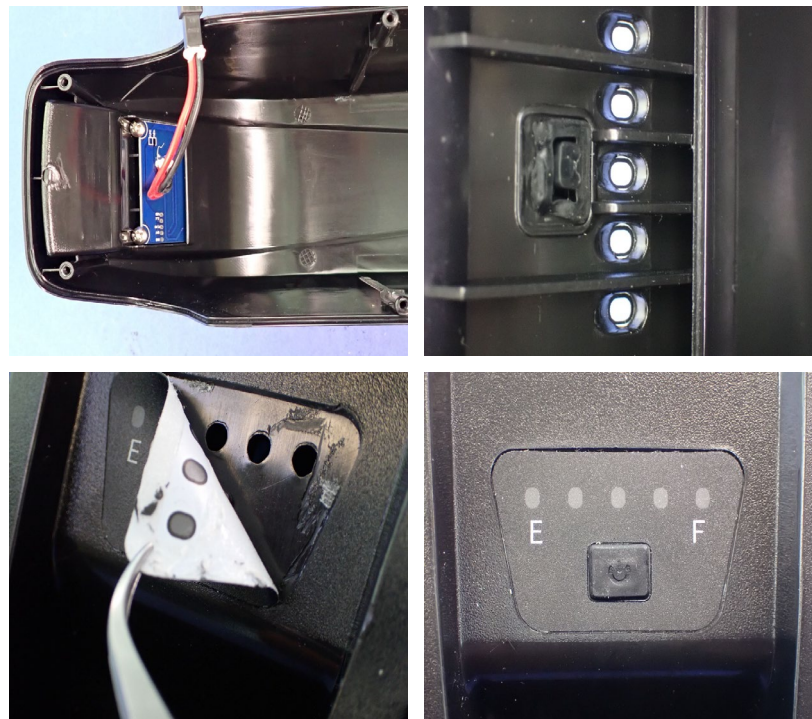
Figure B - 10. SOC indicator had openings that were covered only with a plastic sheet held in place with an adhesive. No gasket or seals were observed around this indicator making it prone to ingress.

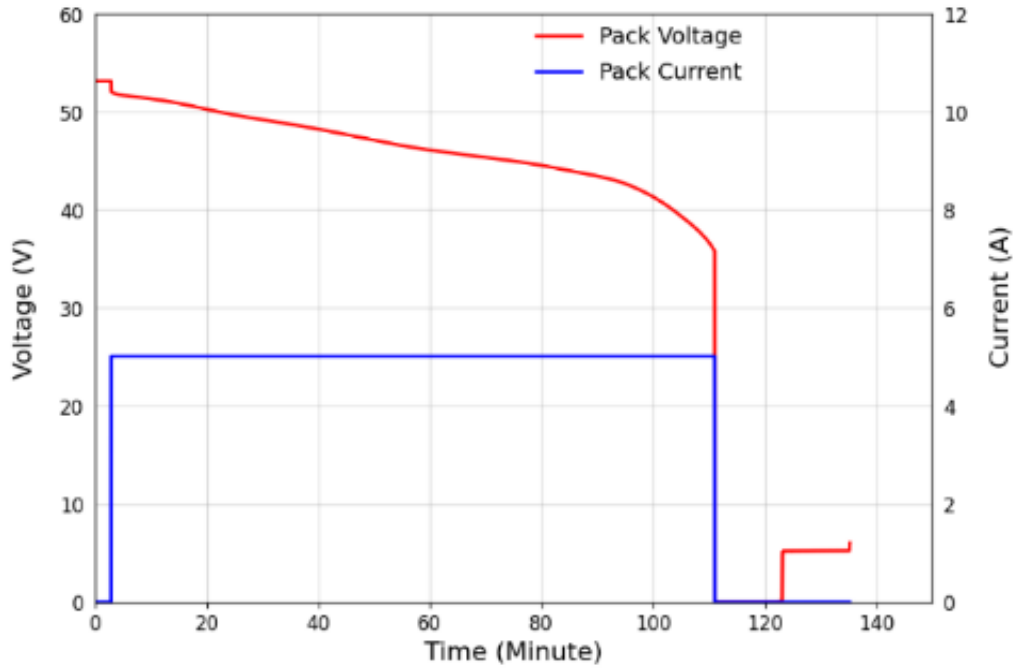
Figure B - 20. Discharging of Pair 2 OEM – Pack.

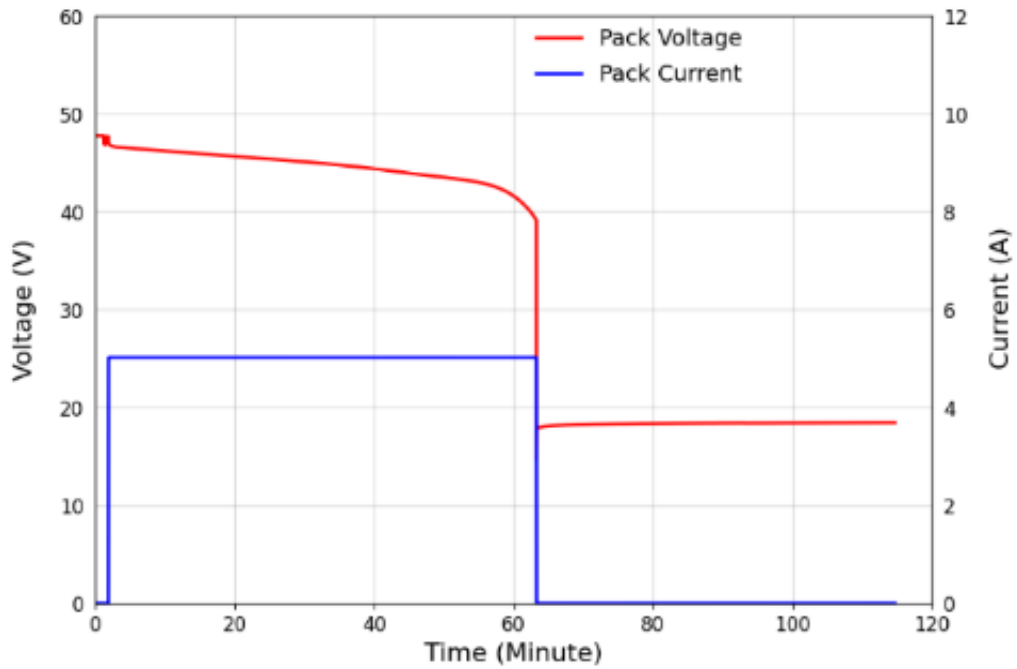
Figure B - 21. Discharging of Pair 2 Rep – Pack.

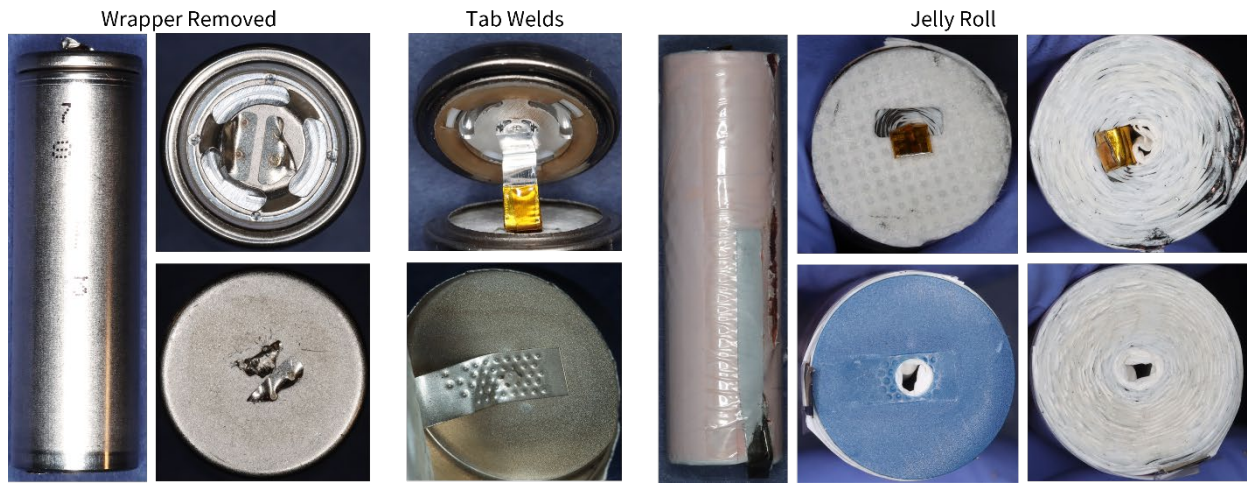
Figure B - 38. Pair 1 OEM disassembly and cell construction overview.

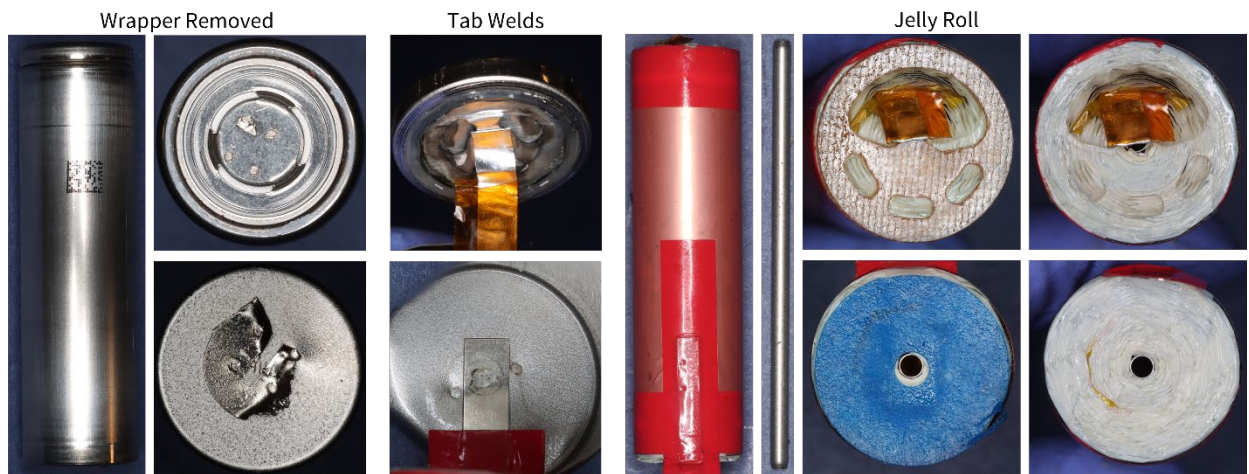
Figure B - 40. Pair 1 Rep – Pack disassembly and cell construction overview.

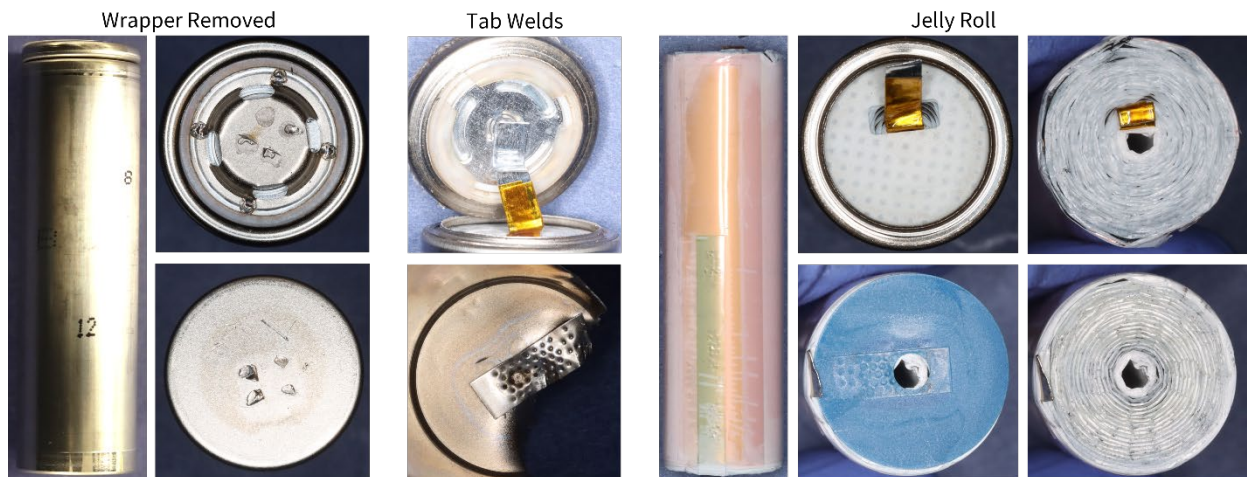
Figure B - 42. Pair 2 OEM – Pack disassembly and cell construction overview.

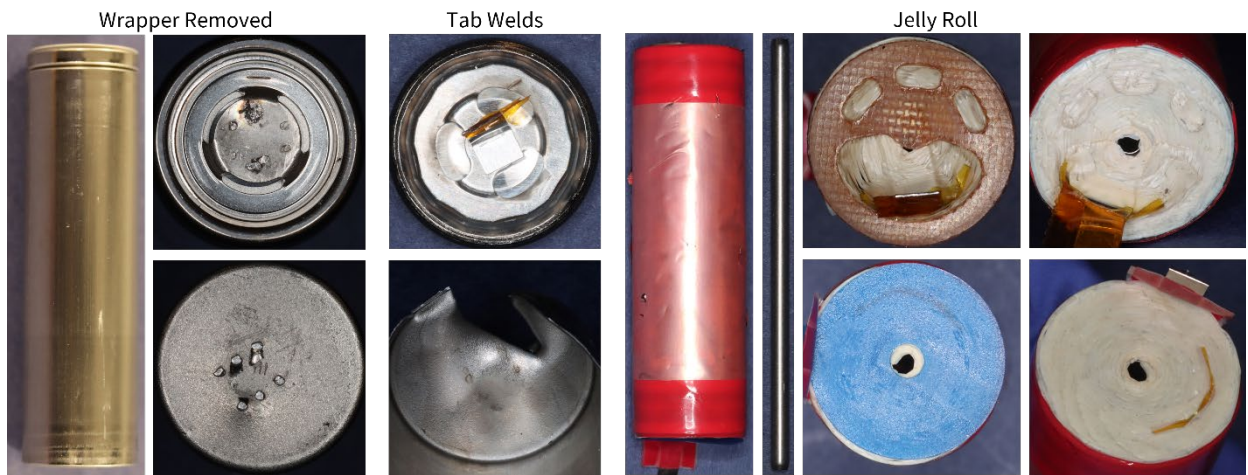
Figure B - 46. Solo – Pack disassembly and cell construction overview.

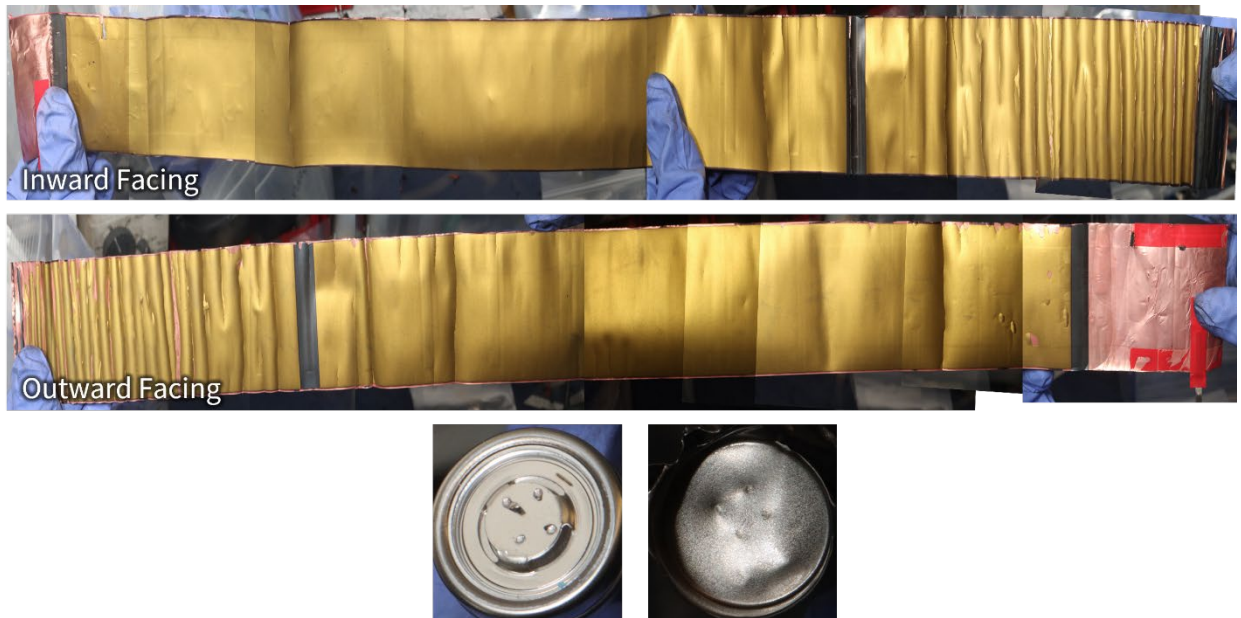
Figure B - 49. Pair 1 Rep – Pack disassembly at 100% SOC; negative electrodes are shown.

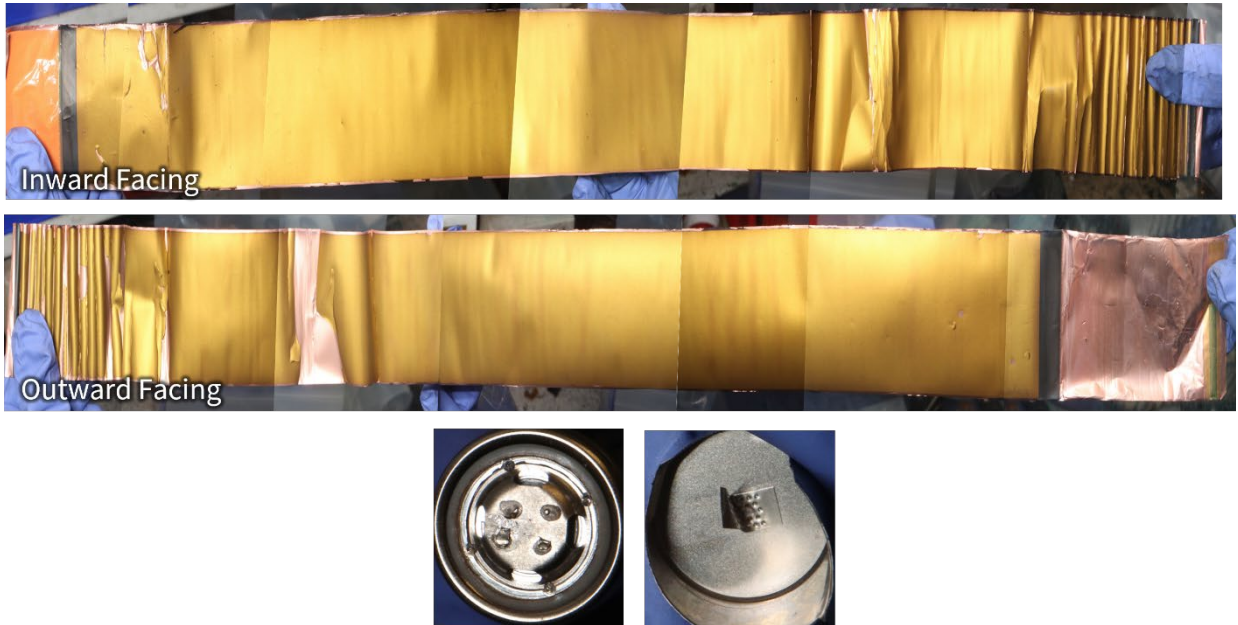
Figure B - 50. Pair 2 OEM – Pack disassembly at 100% SOC; Negative electrodes are shown.

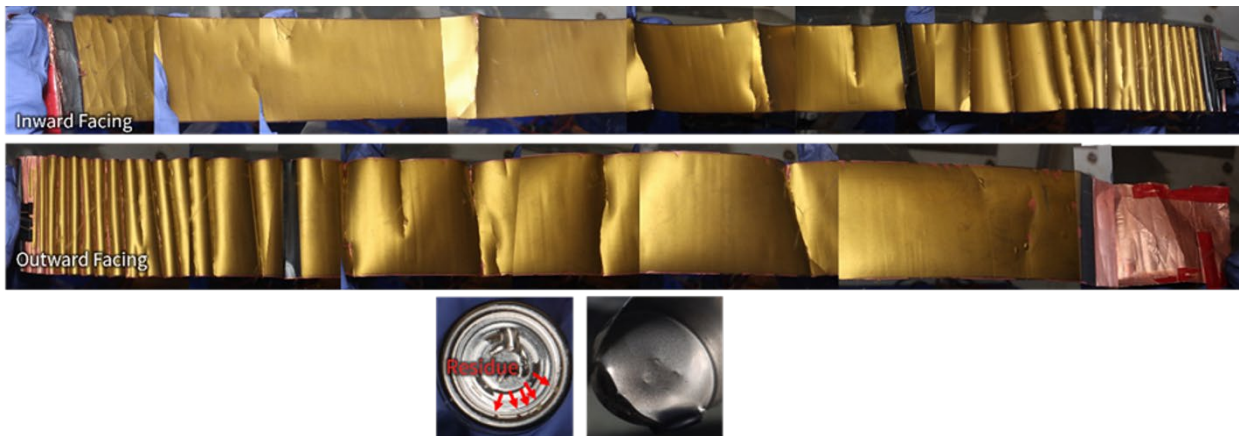
Figure F - 7. Pair 1 Rep – Pack disassembly at 100% SOC; negative electrodes are shown. A brown residue was observed on the edge of the outer can where the crimping occurs.
