U.S. CONSUMER PRODUCT SAFETY COMMISSION  
4330 EAST WEST HIGHWAY  
BETHESDA, MD 20814

March 24, 2015

131022HCC1048

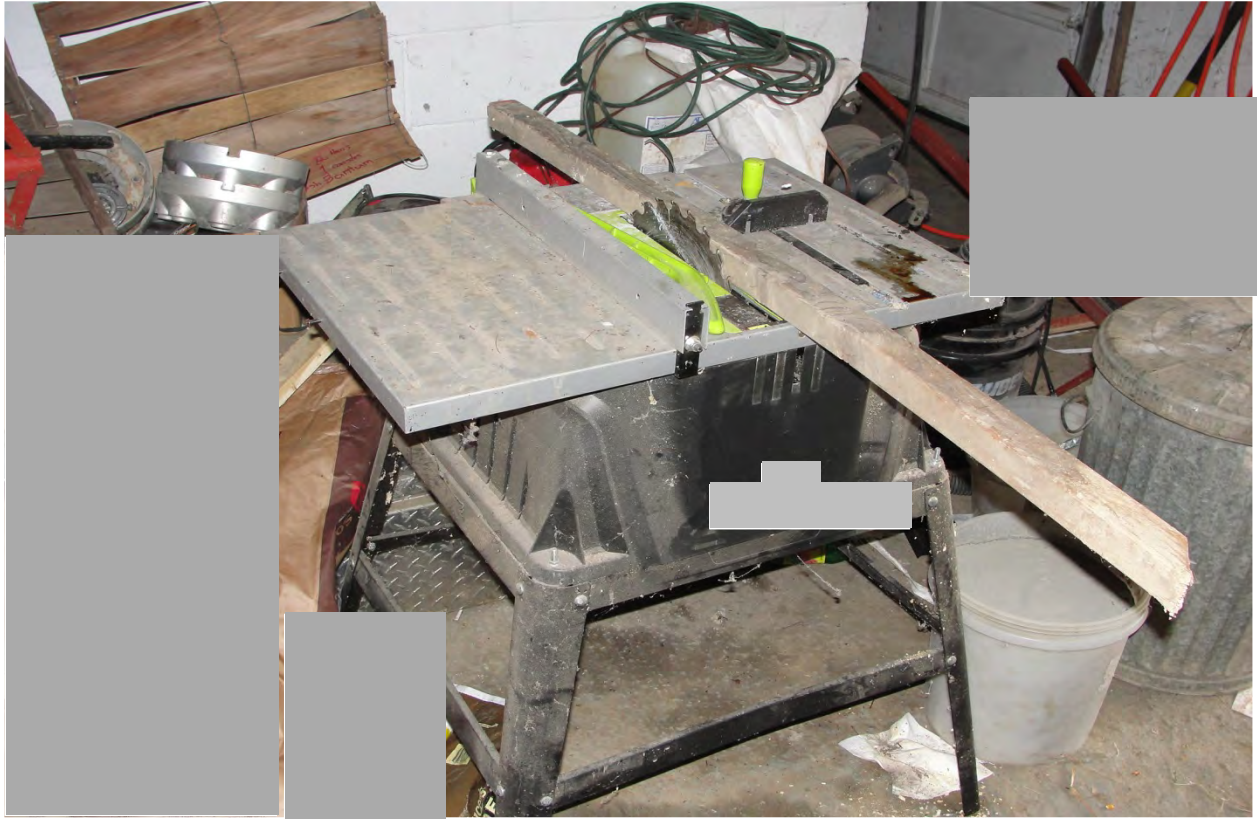
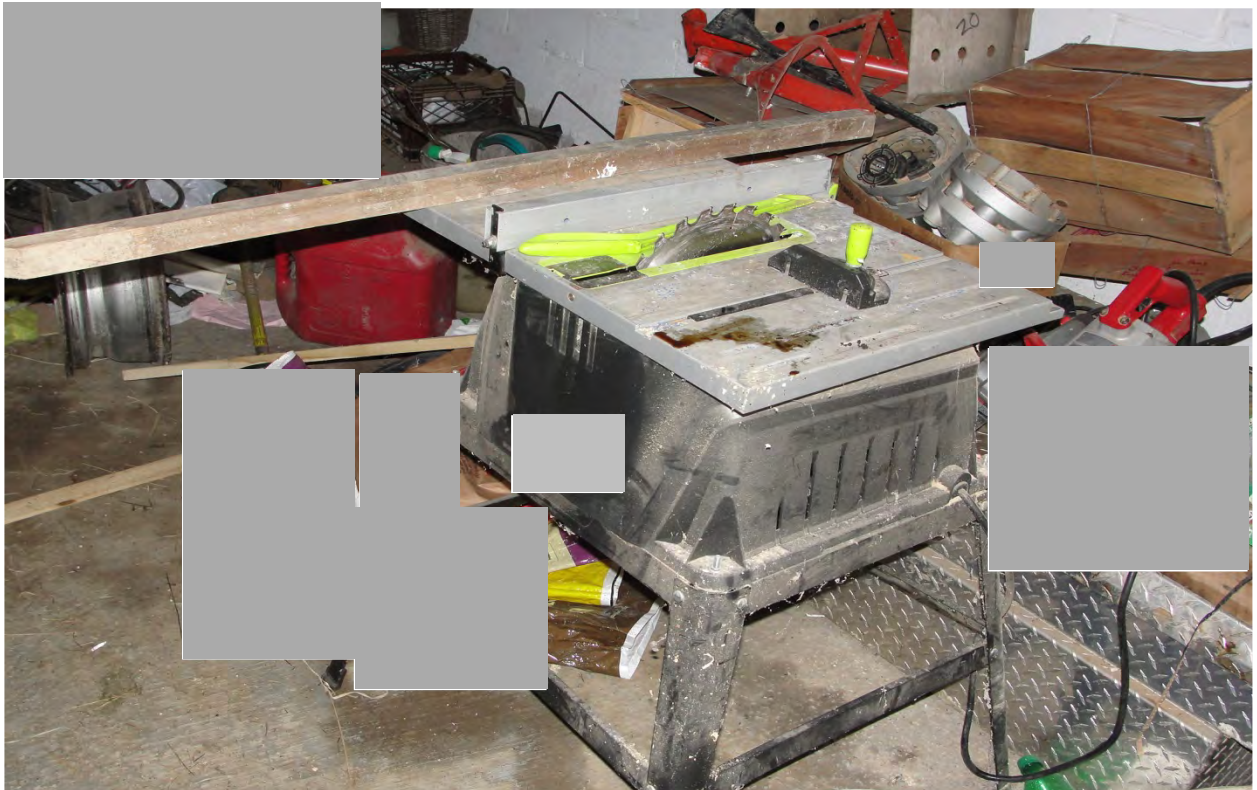
131022HCC1048 Photographs #1 & #2 depict overview of table saw.

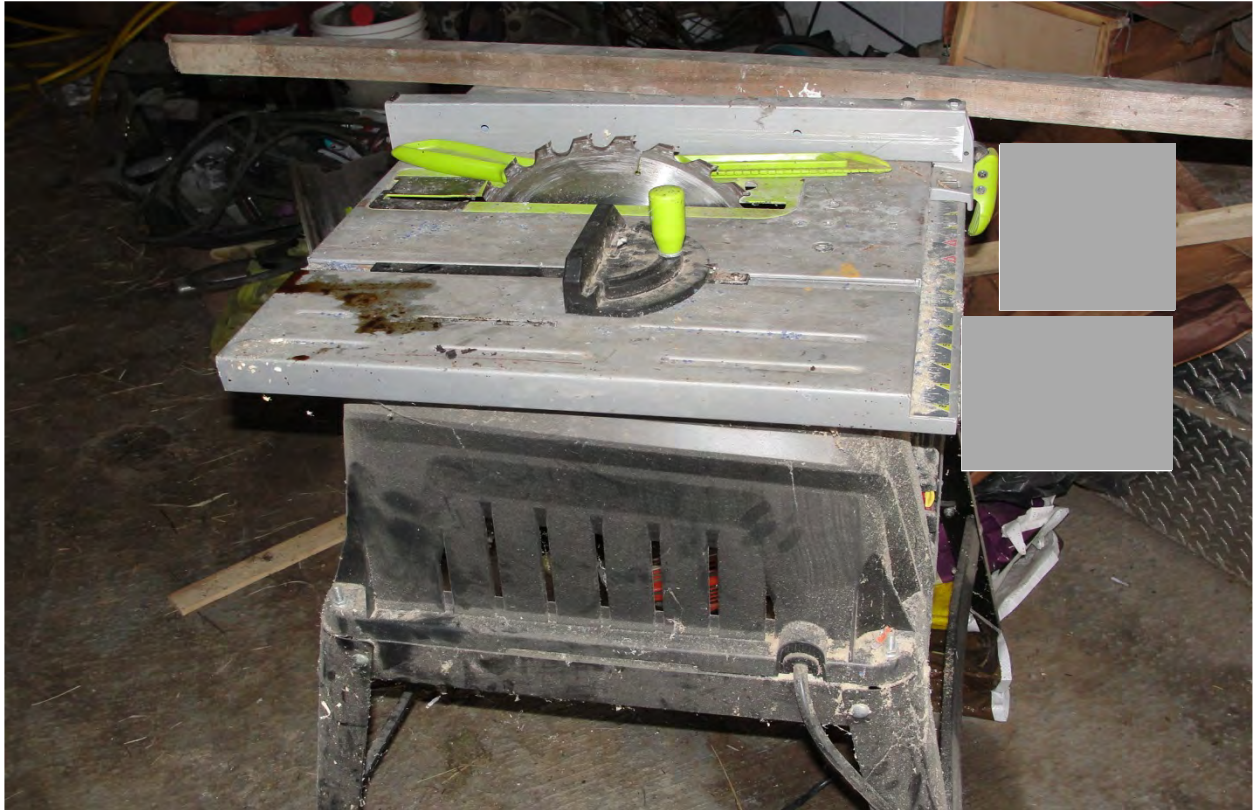
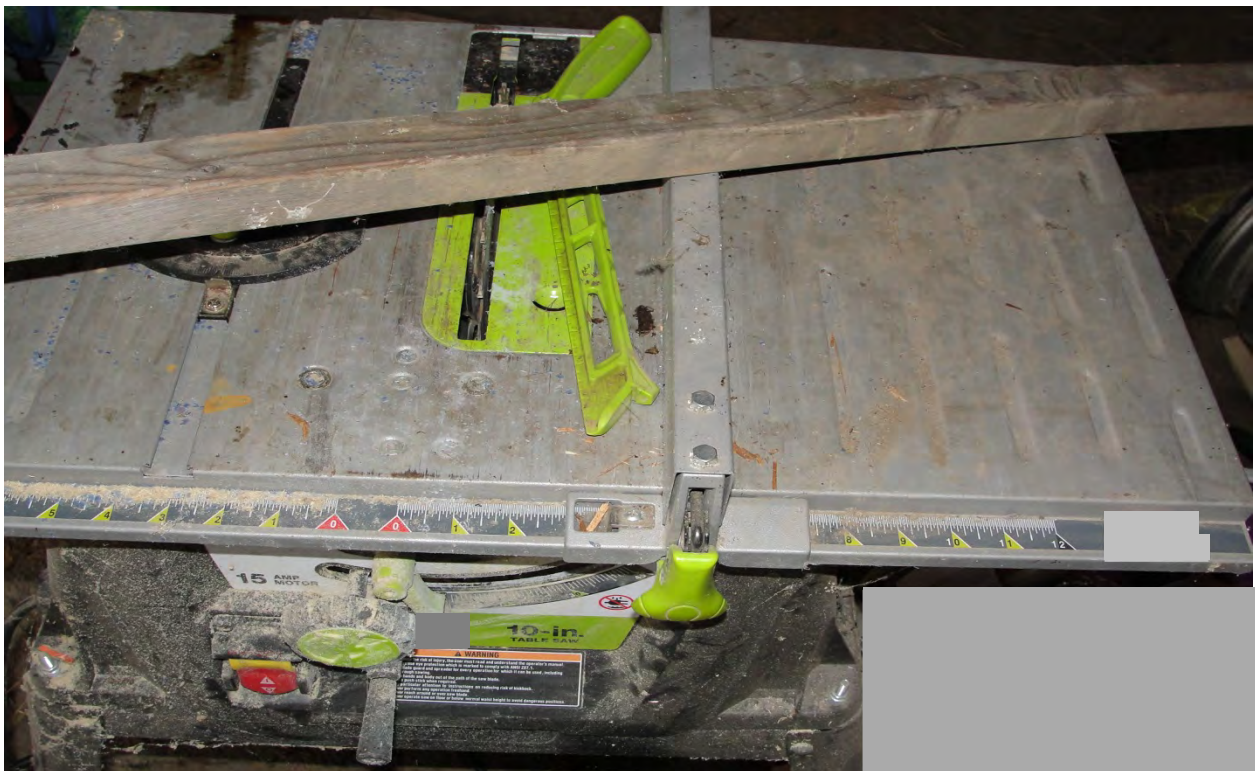
131022HCC1048 Photographs #3 & #4 # depict overview of table saw.

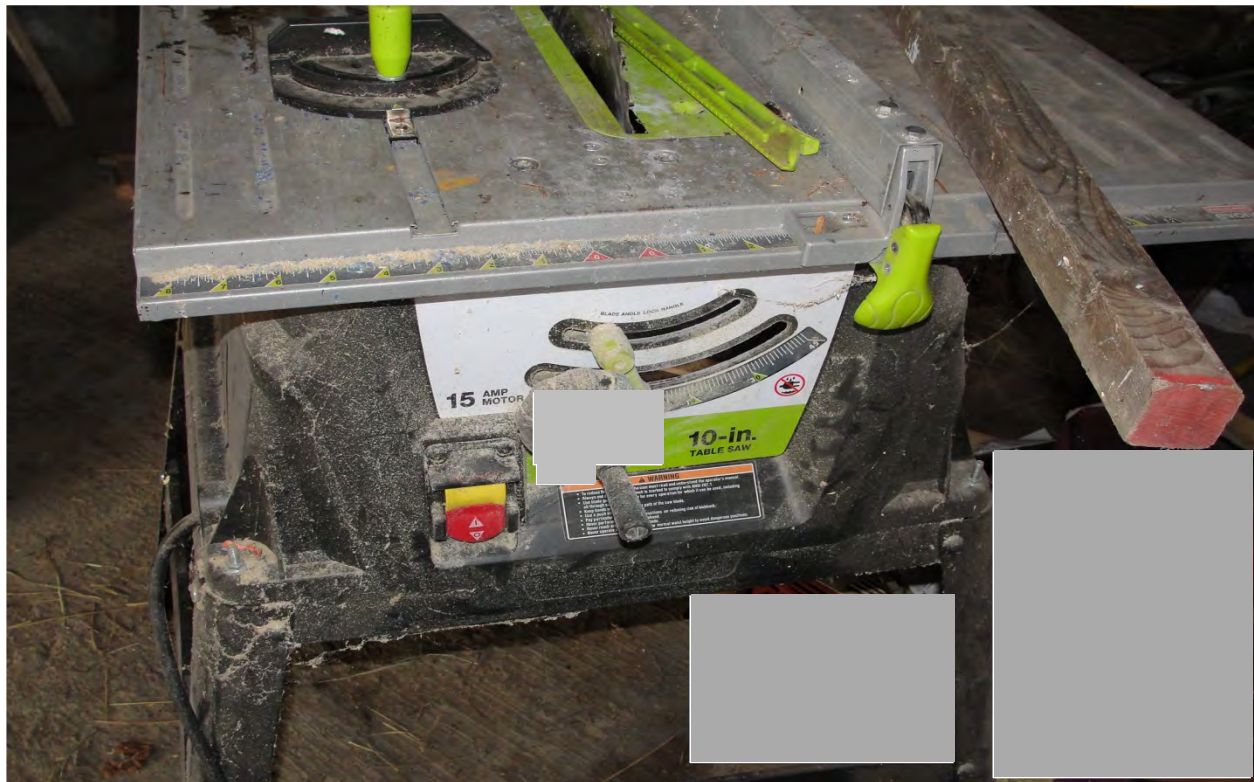
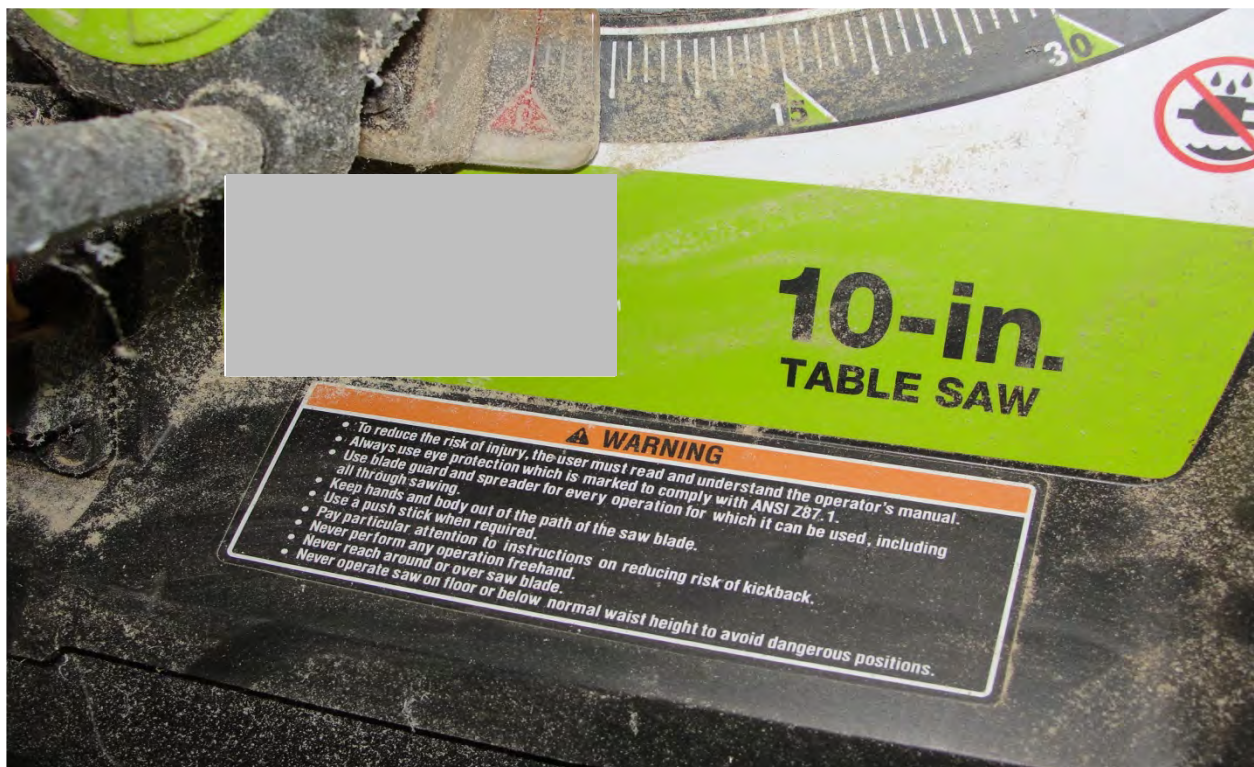
131022HCC1048 Photographs #5 & #6 depict overview of table saw & labeling.

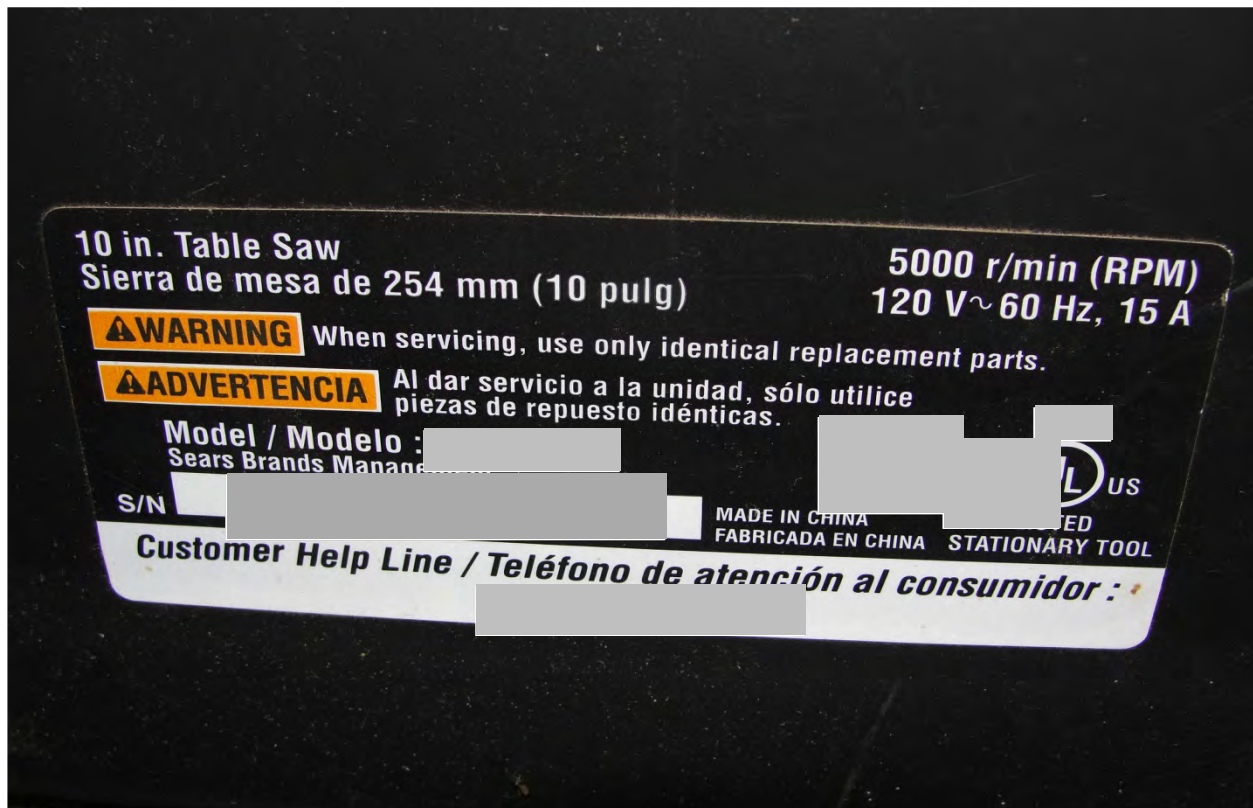
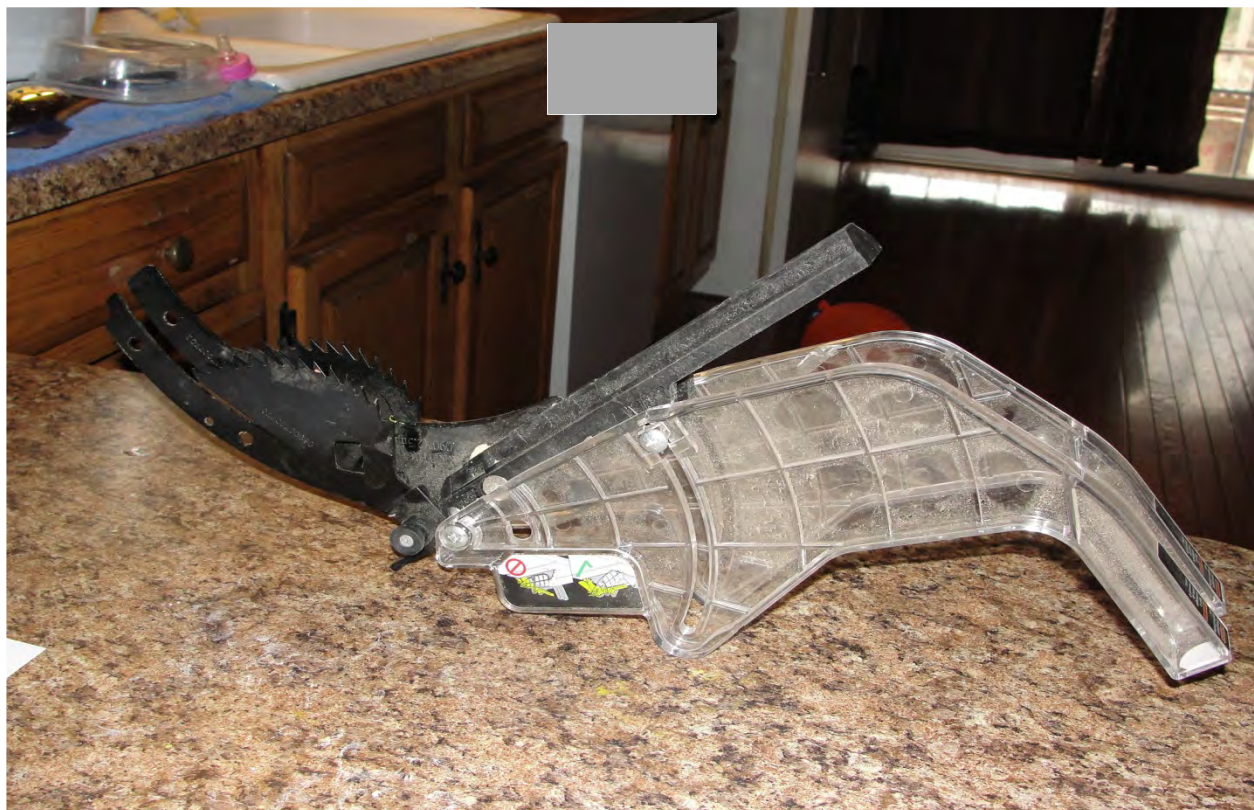
131022HCC1048 Photographs #7 & # 8 depict overview of table saw labeling & blade guard.

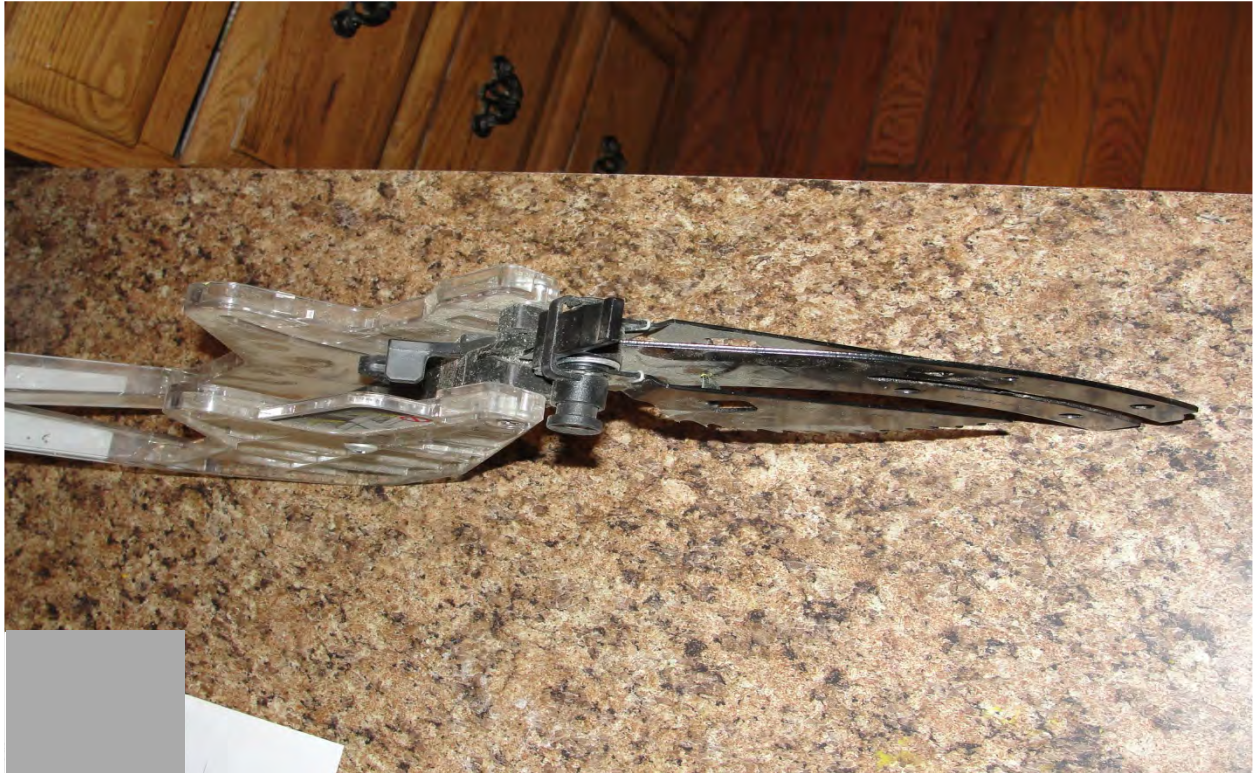
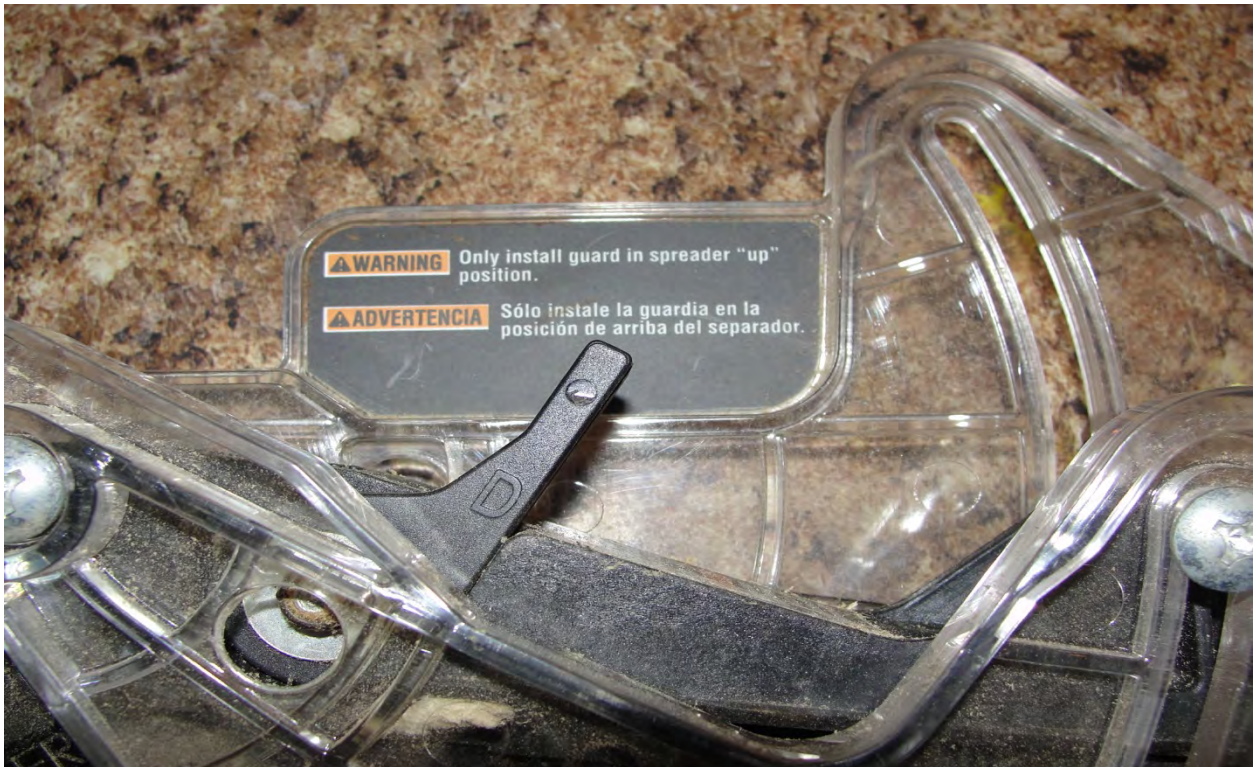
131022HCC1048 Photographs #9 & # 10 depict overview of table saw blade guard.

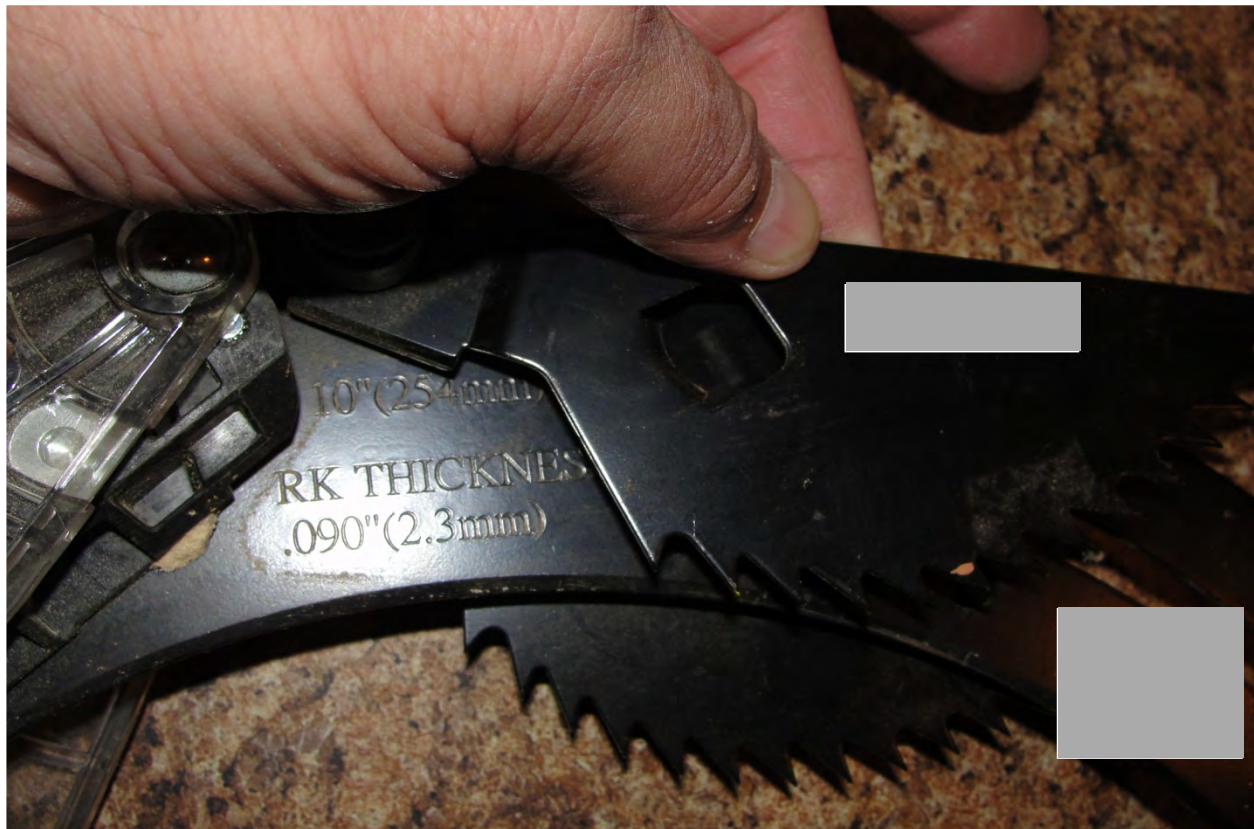
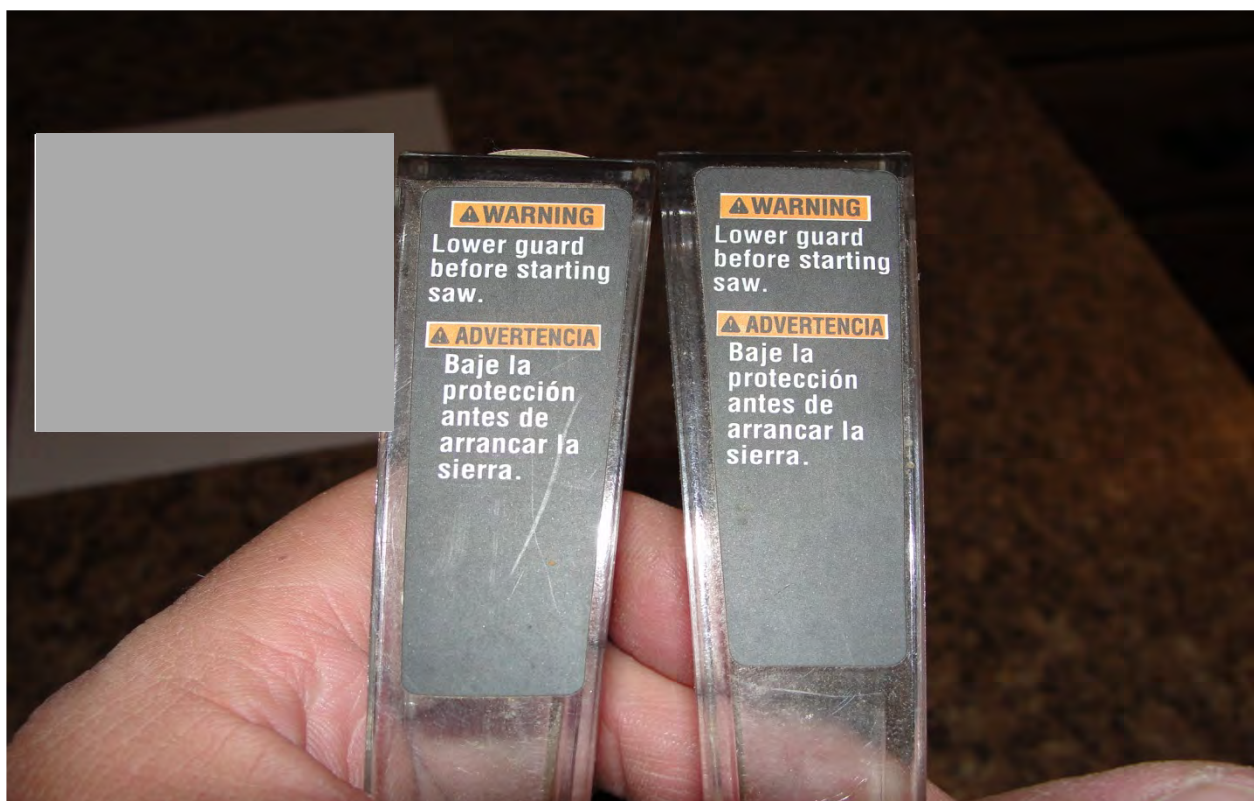
131022HCC1048 Photographs #11 & # 12 depict overview of table saw blade guard.

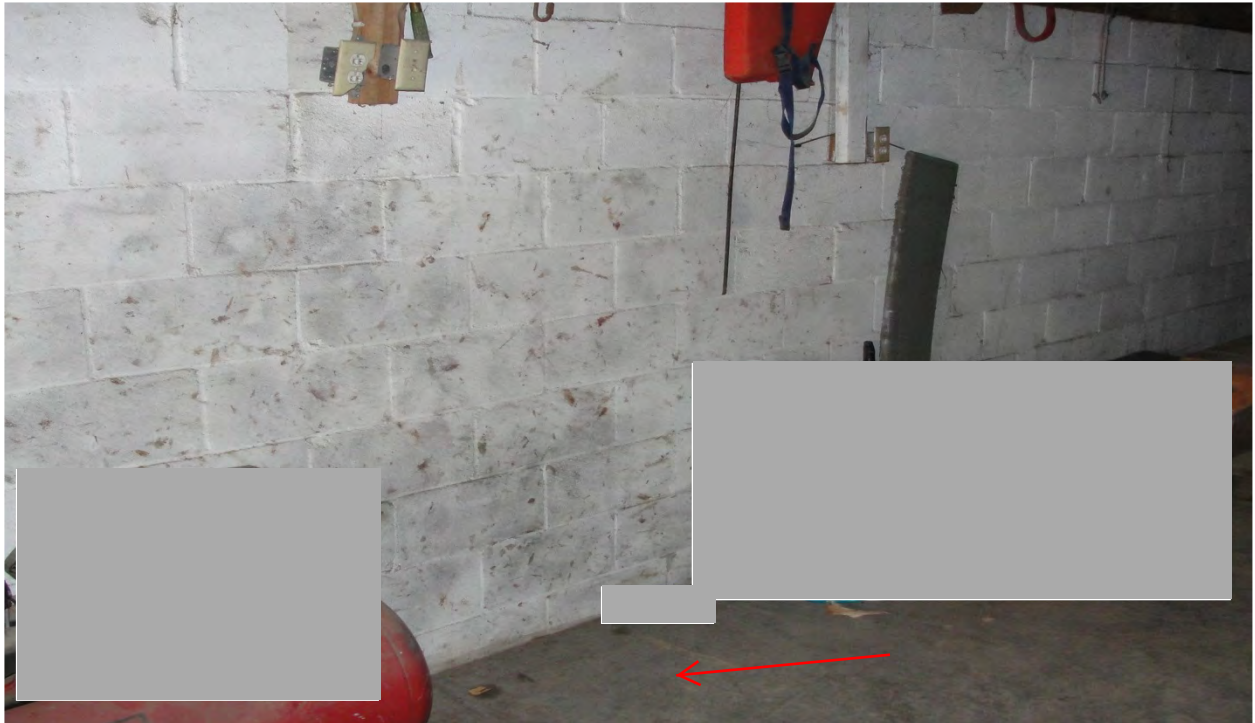
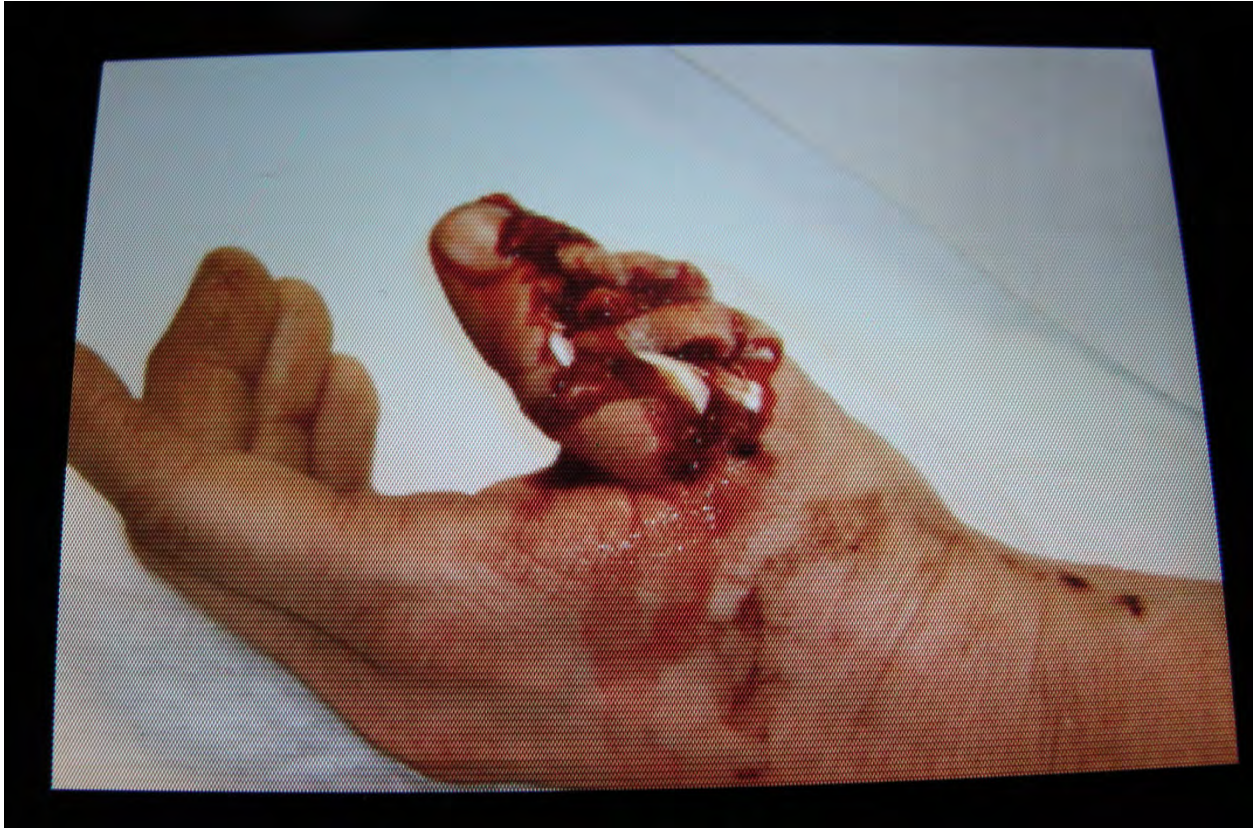
131022HCC1048 Photographs #13 & # 14 depict overview of location of table saw time of incident & injury to thumb at time of incident

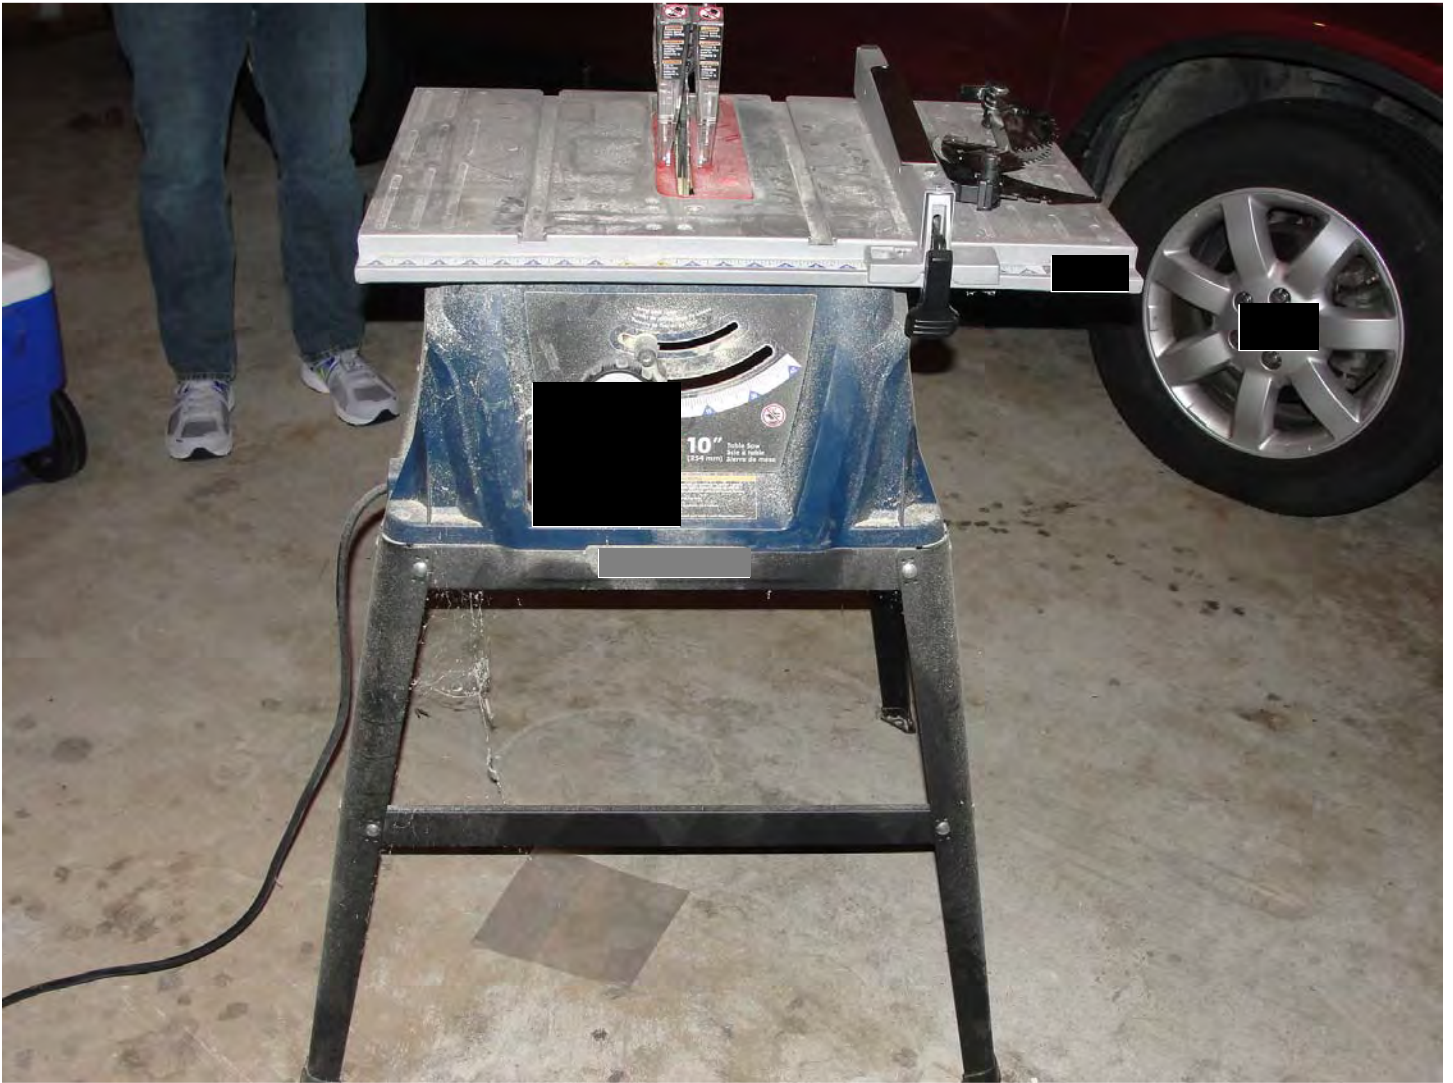
Photo 1: Overview of incident table saw with exemplar modular blade guard installed

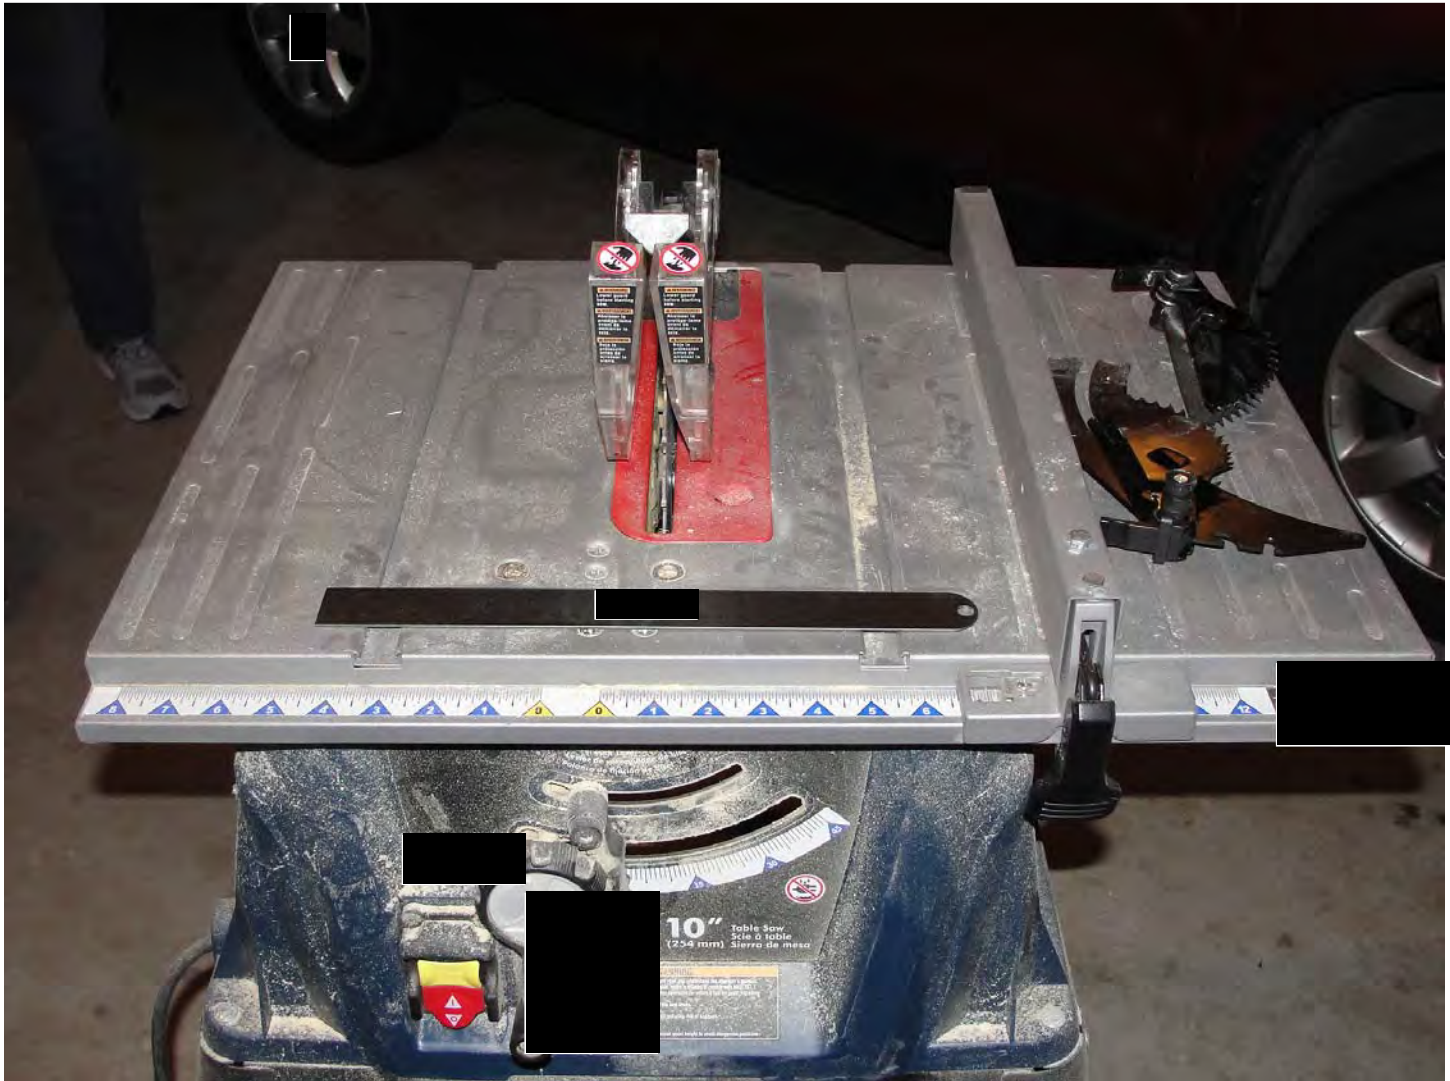
Photo 2: Close-up of incident table saw with exemplar modular blade guard installed

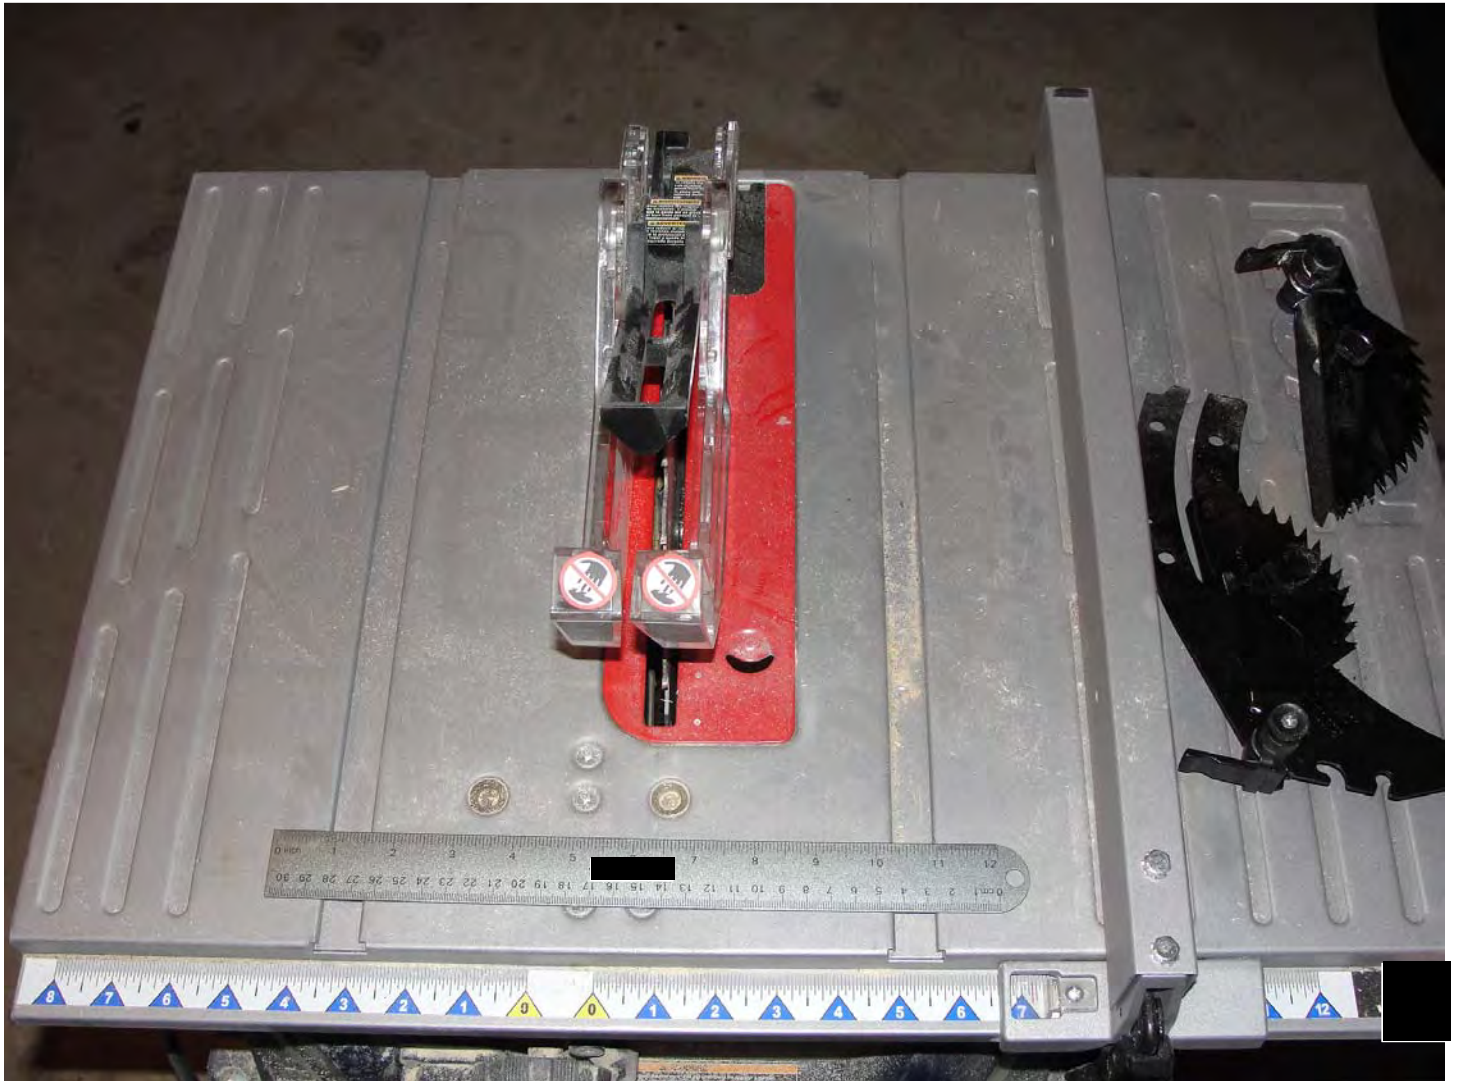
Photo 3: Close-up of exemplar modular blade guard installed on incident table saw

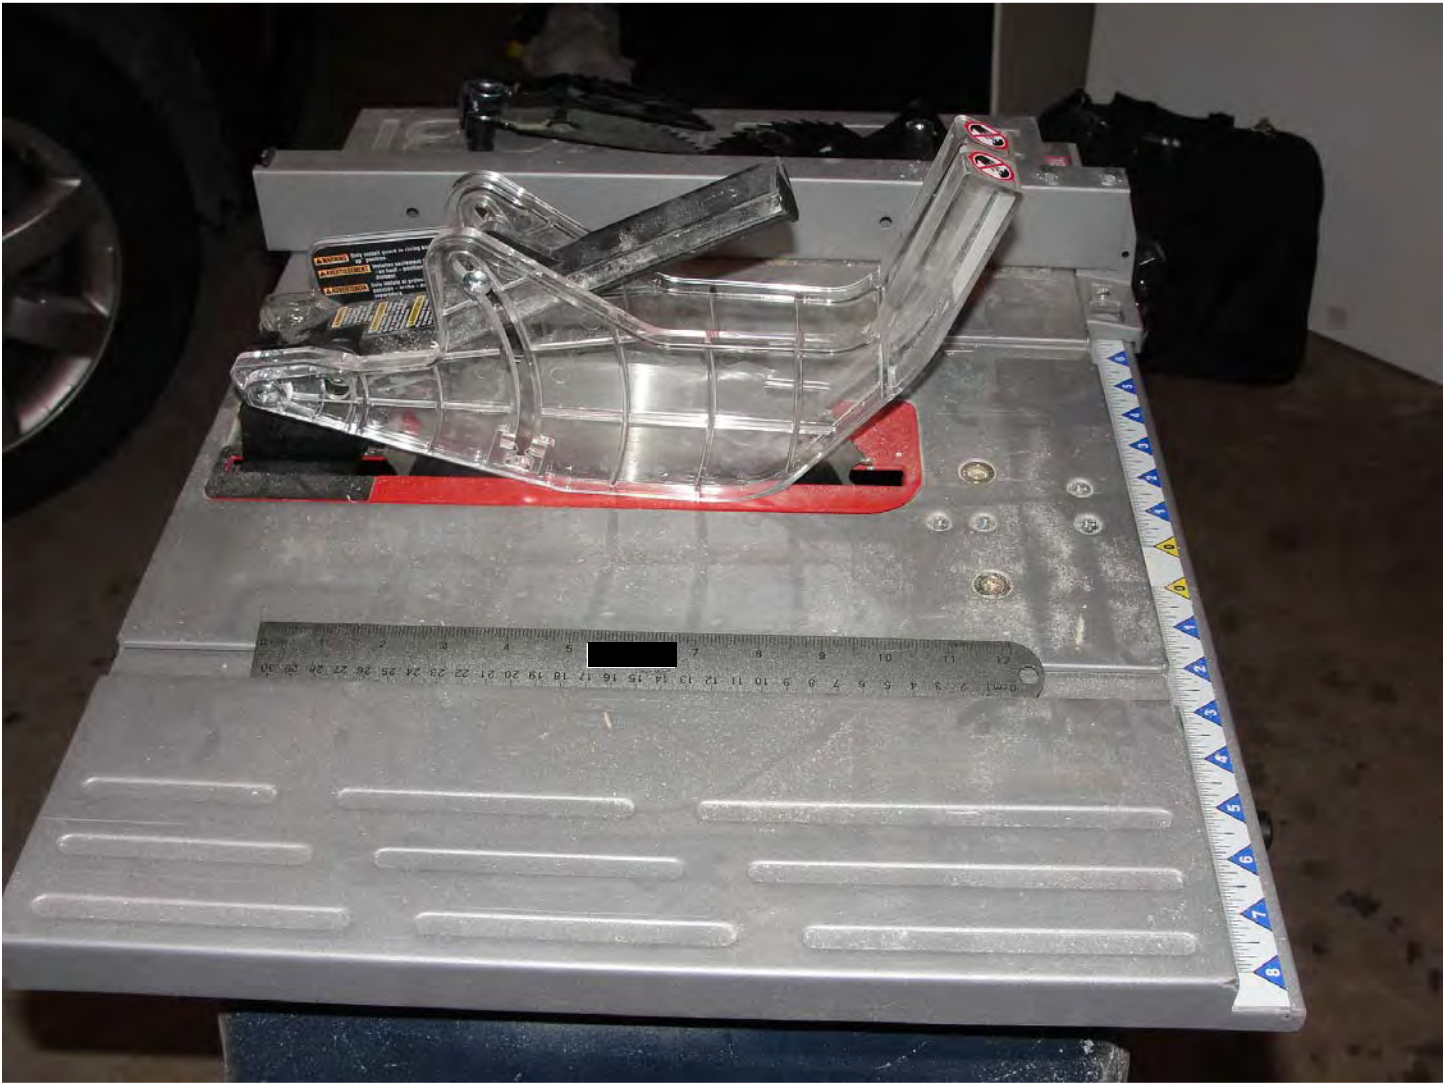
Photo 4: Side view of blade guard

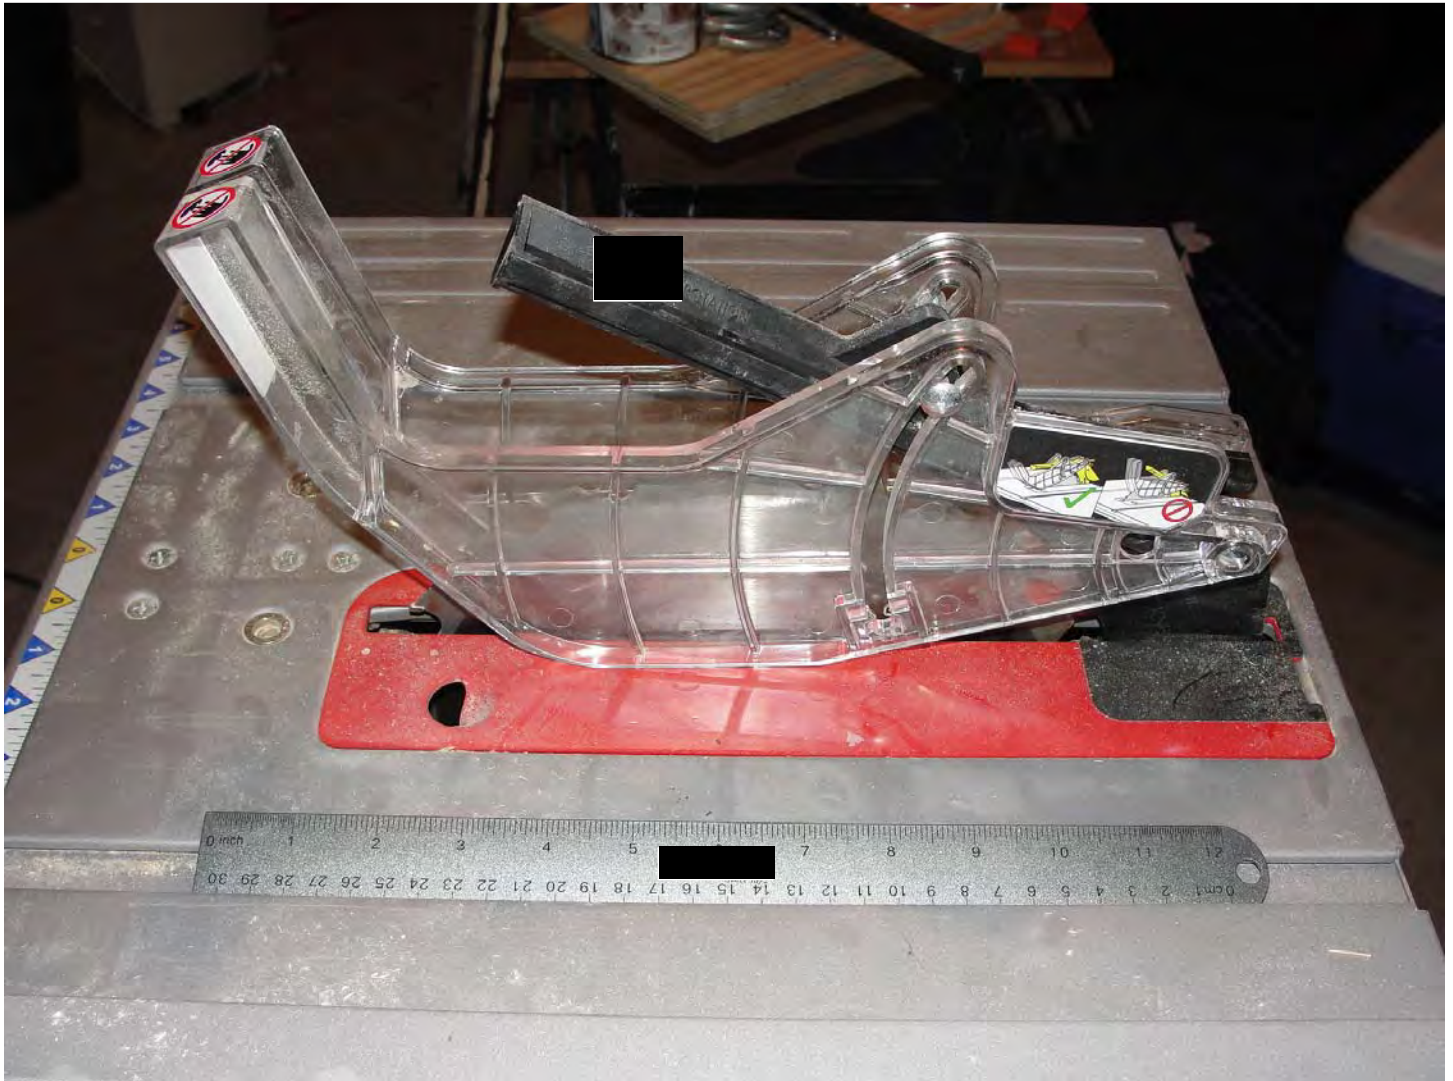
Photo 5: Side view of blade guard
