U.S. CONSUMER PRODUCT SAFETY COMMISSION  
4330 EAST WEST HIGHWAY  
BETHESDA, MD 20814

March 24, 2015

131022HCC1048

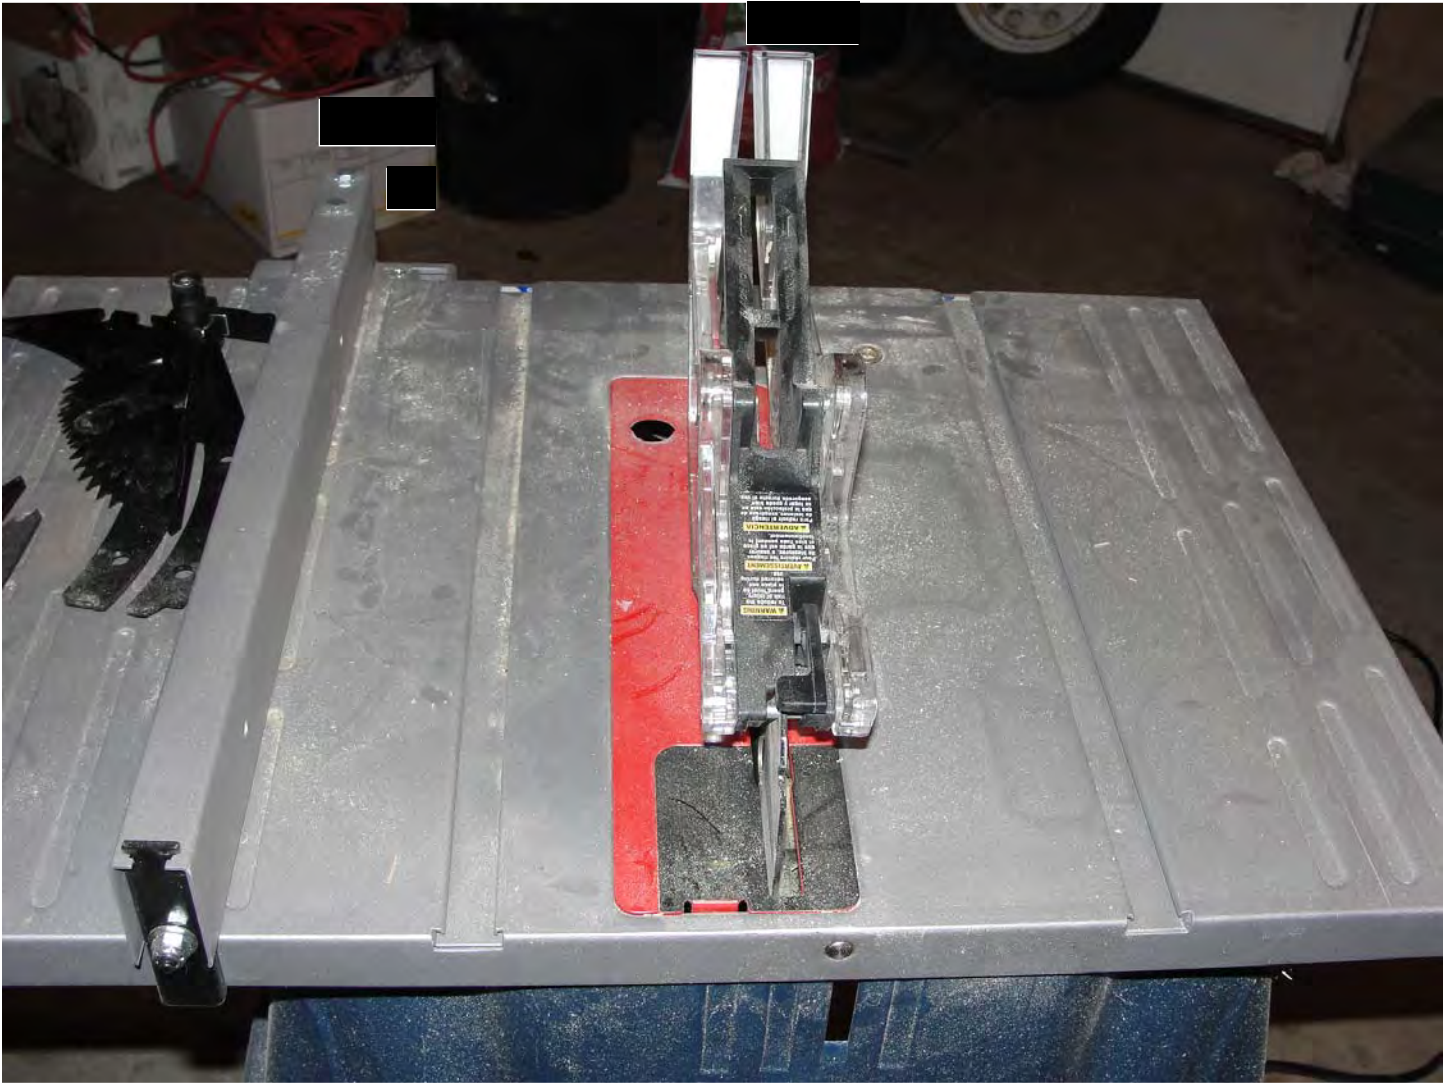
Photo 6: Back view of blade guard

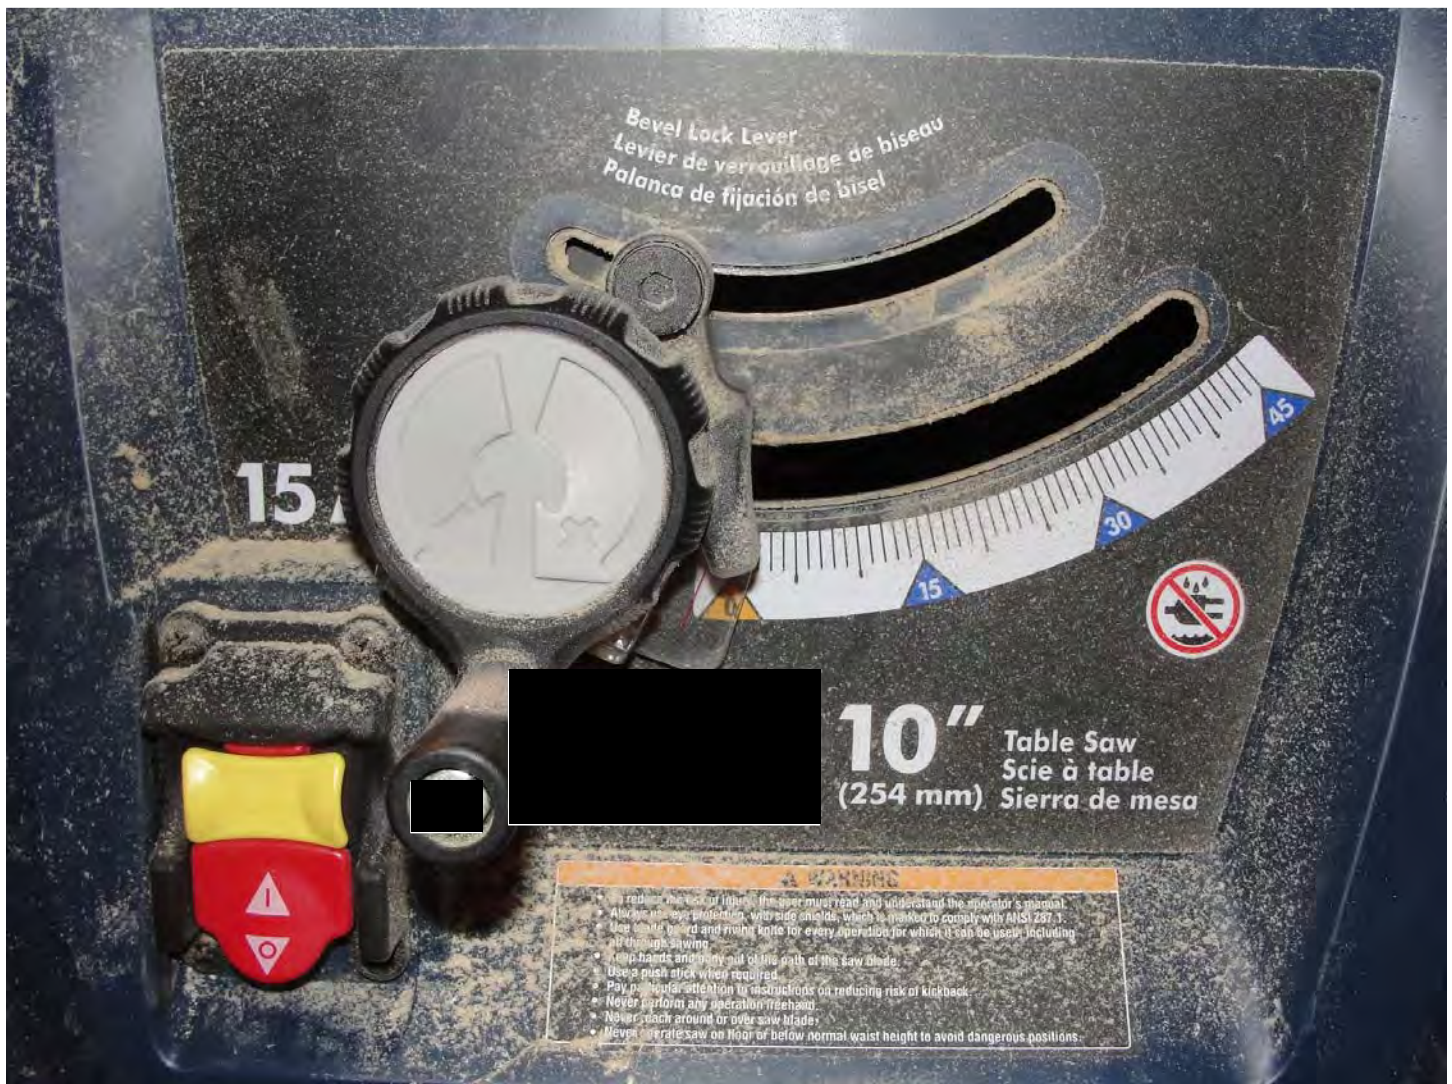
Photo 7: Close-up of front of incident unit table saw

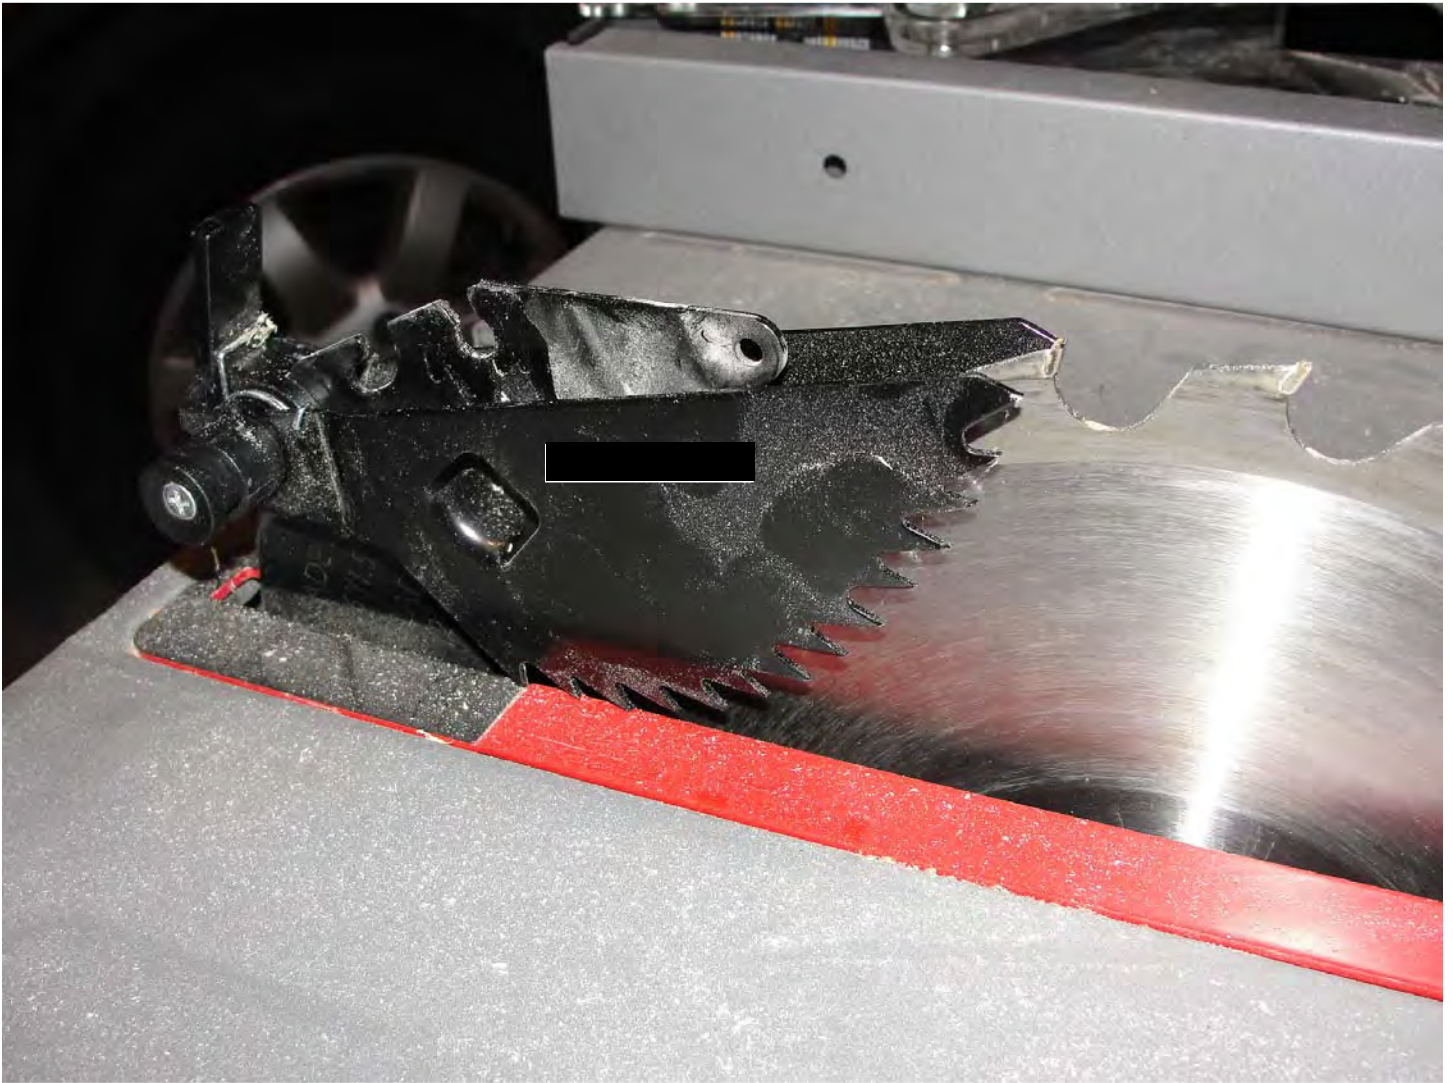
Photo 9: Anti-kickback pawls installed by consumer

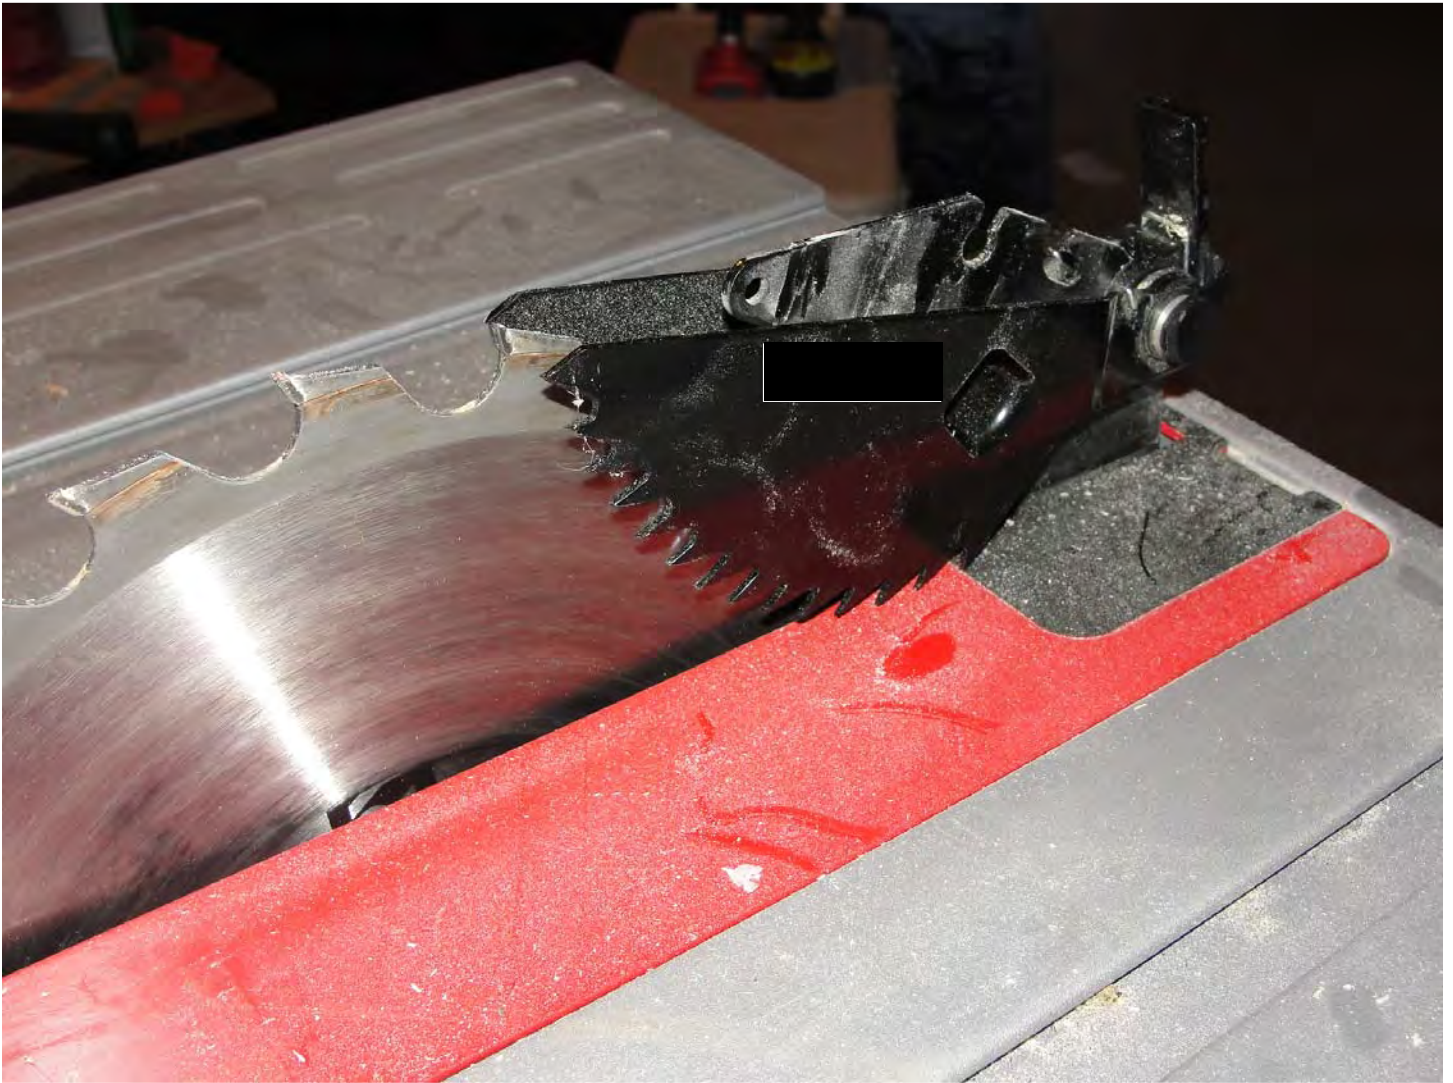
Photo 10: Anti-kickback pawls installed by consumer

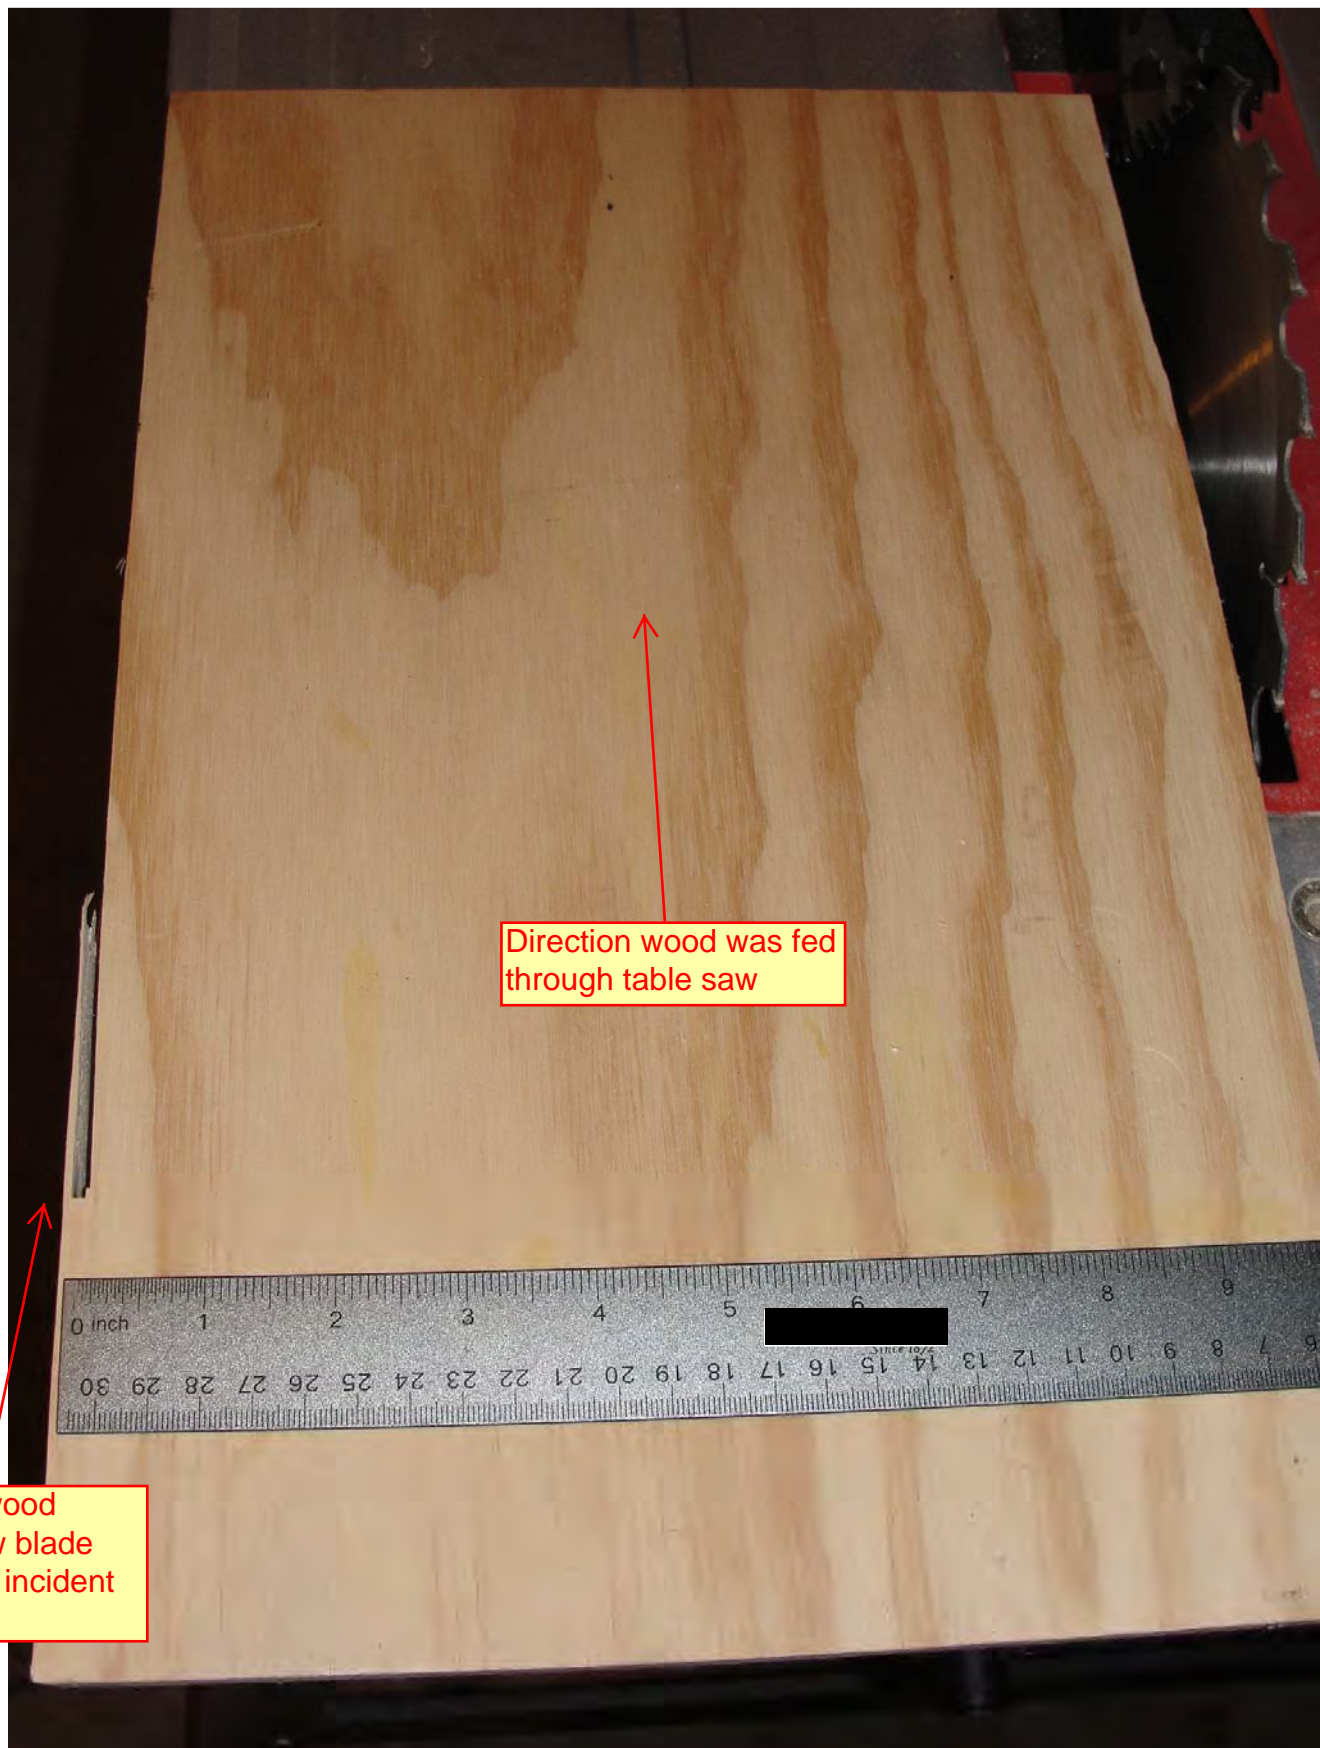
Photo 11: Piece of wood cut by consumer at time of incident

Direction wood was fed  
through table saw

Point on wood  
where saw blade  
was when incident  
occurred

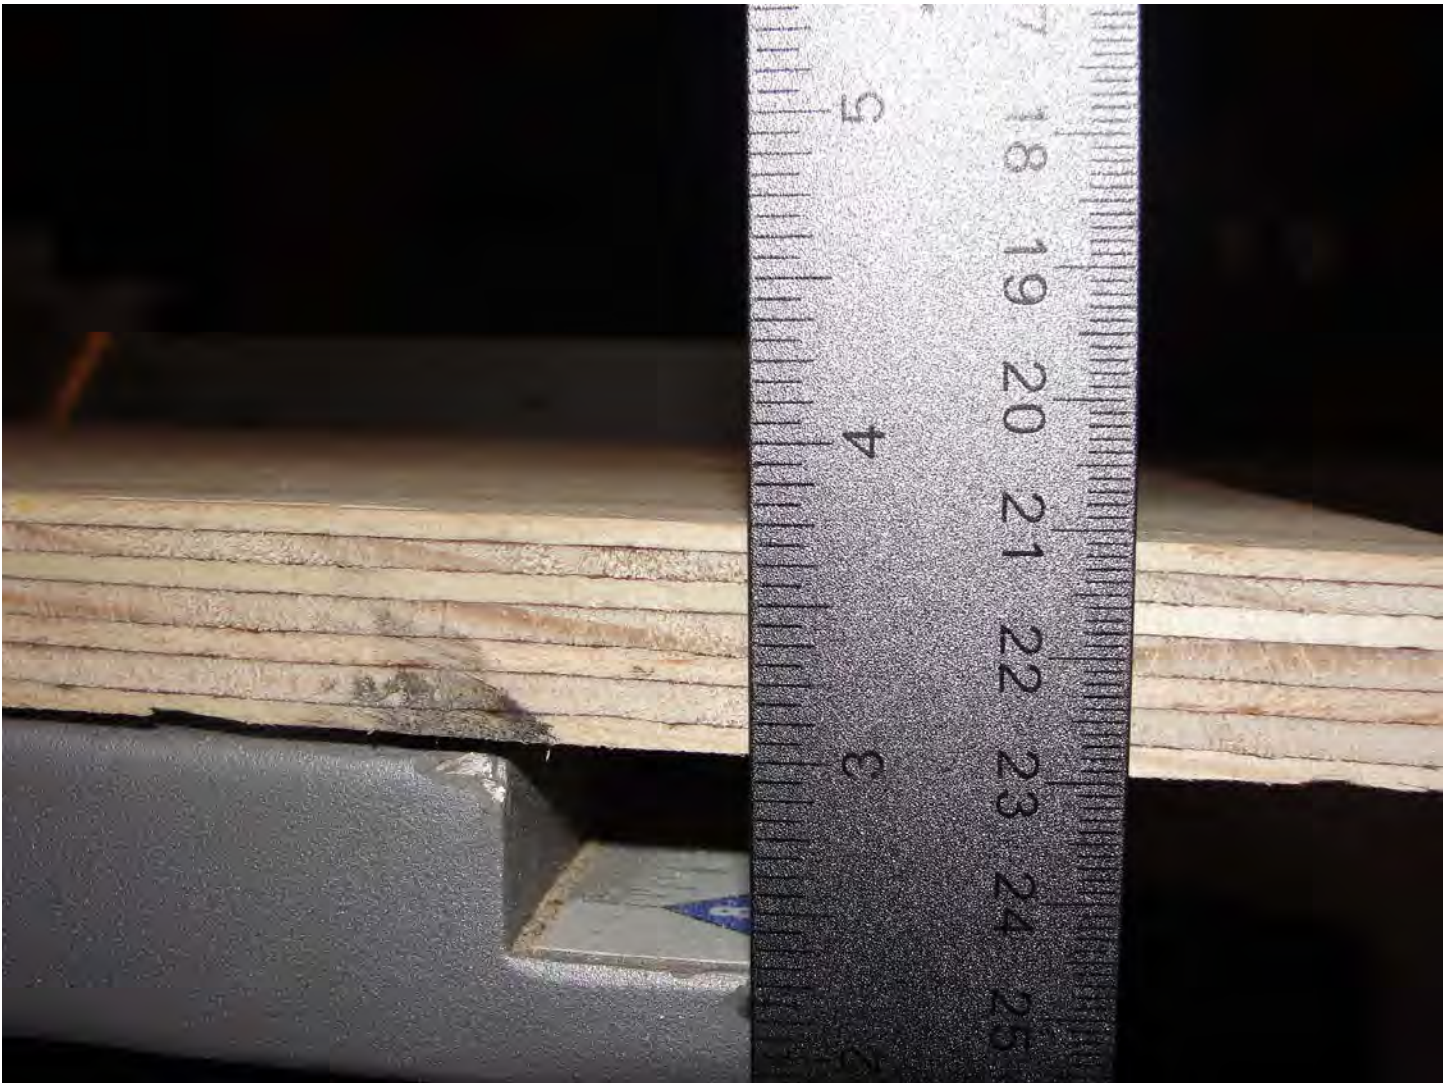
Photo 12: Piece of wood cut by consumer at time of incident

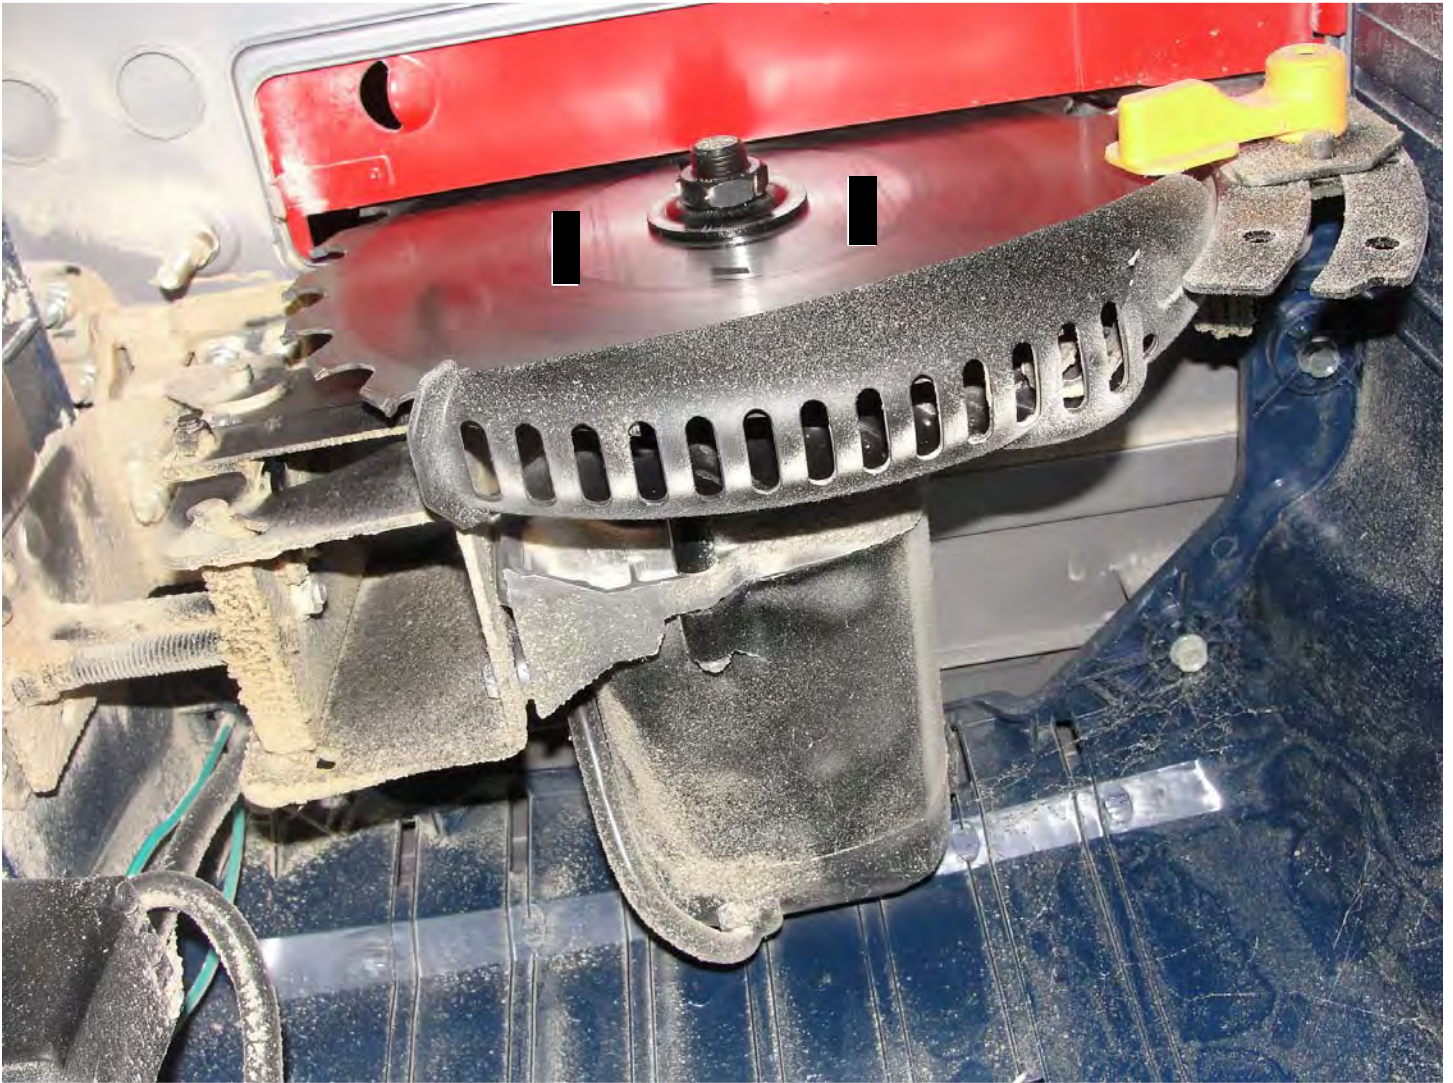
Photo 13: Underside of incident table saw

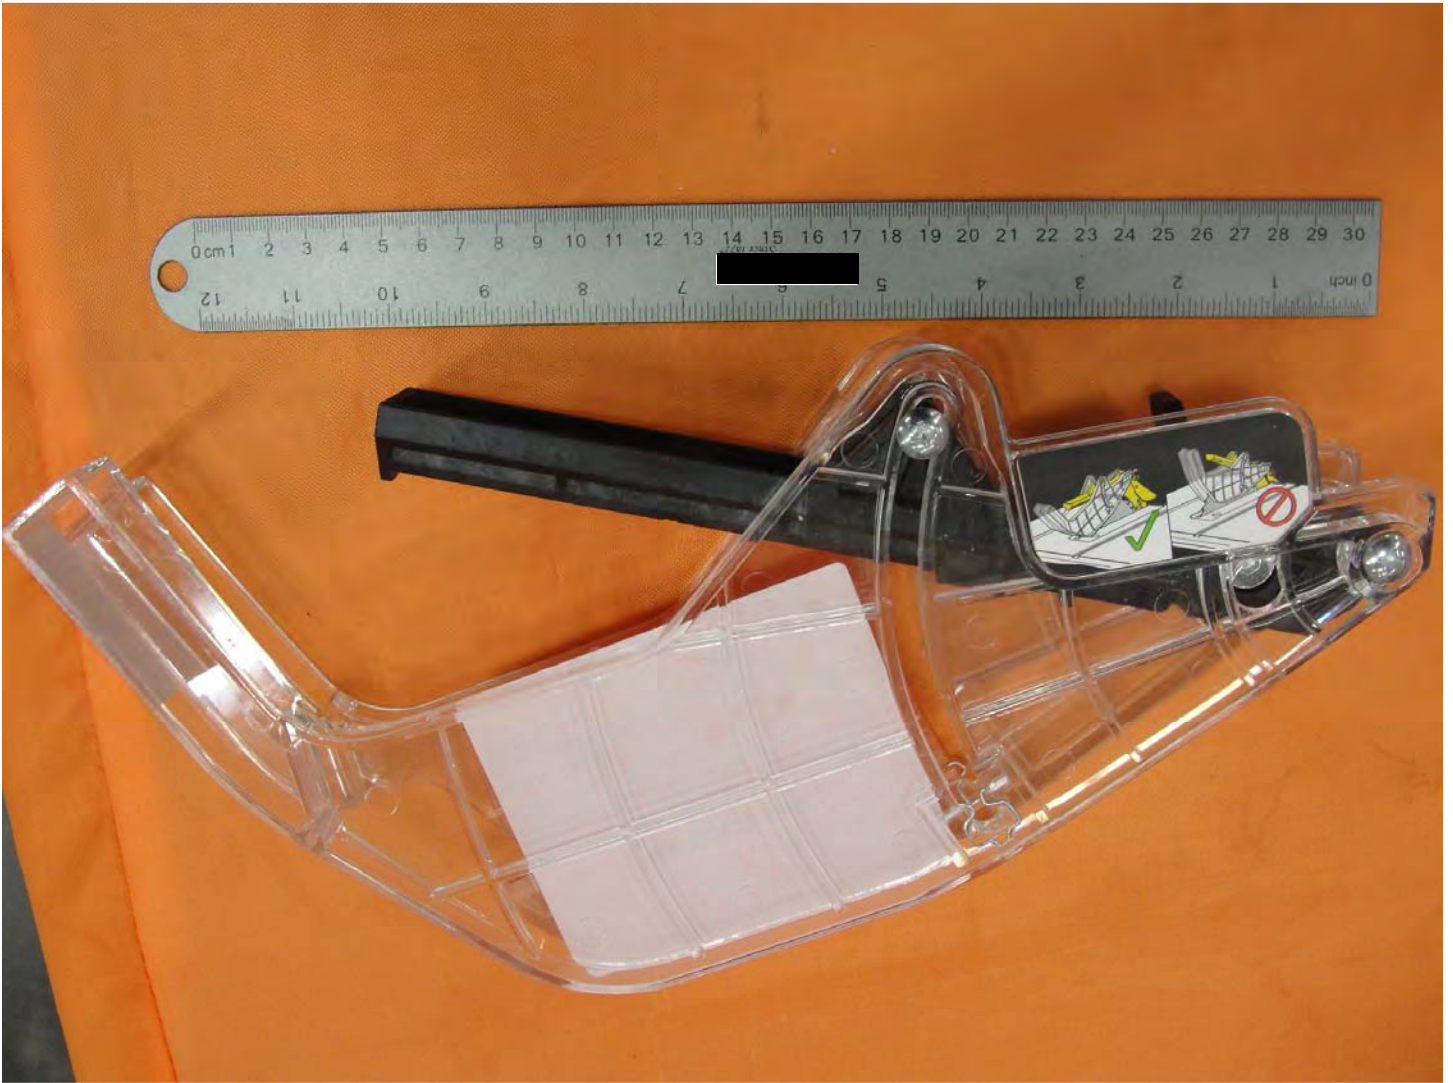
Photo 18: Overview of incident unit modular blade guard

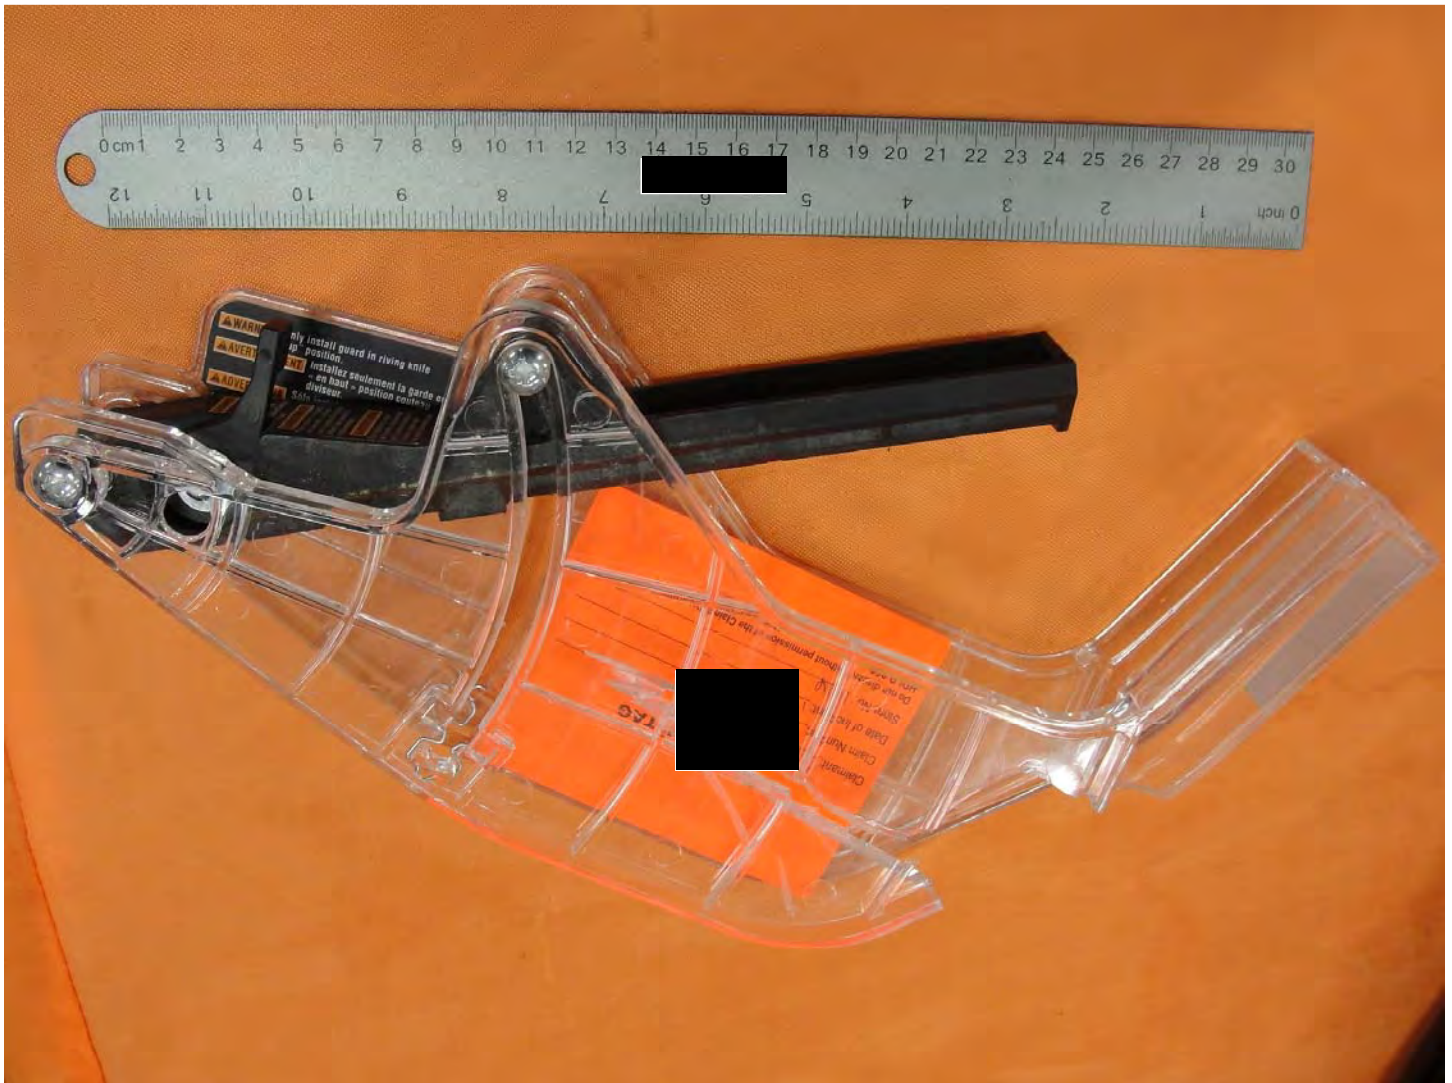
Photo 19: Overview of incident unit modular blade guard

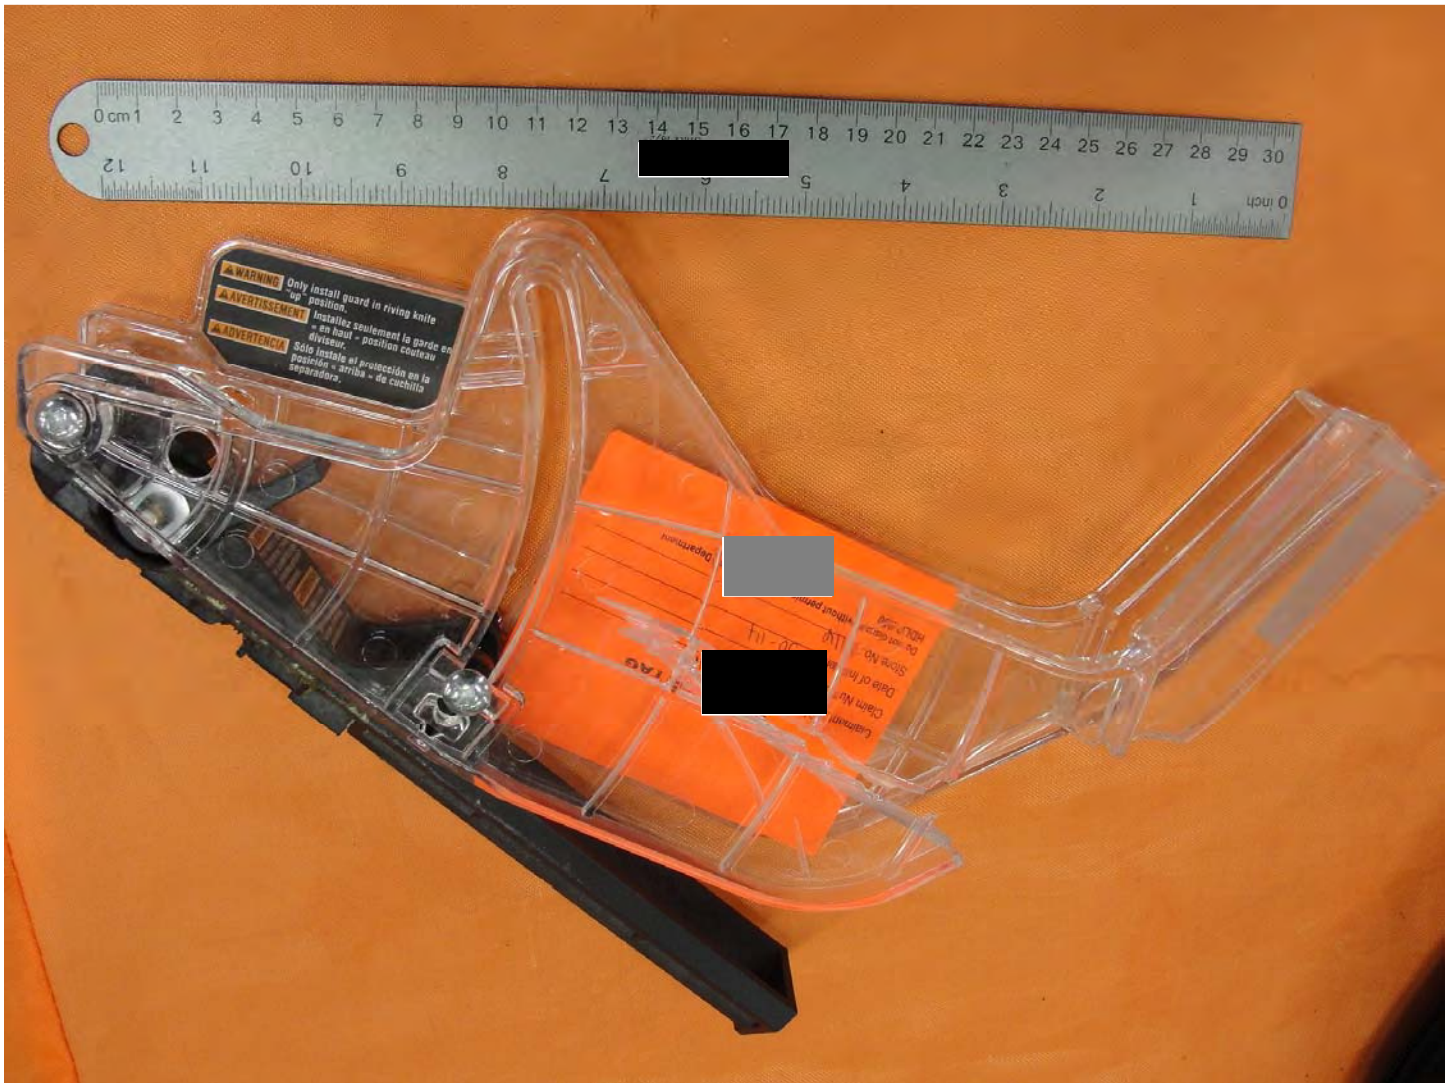
Photo 20: Overview of incident unit modular blade guard

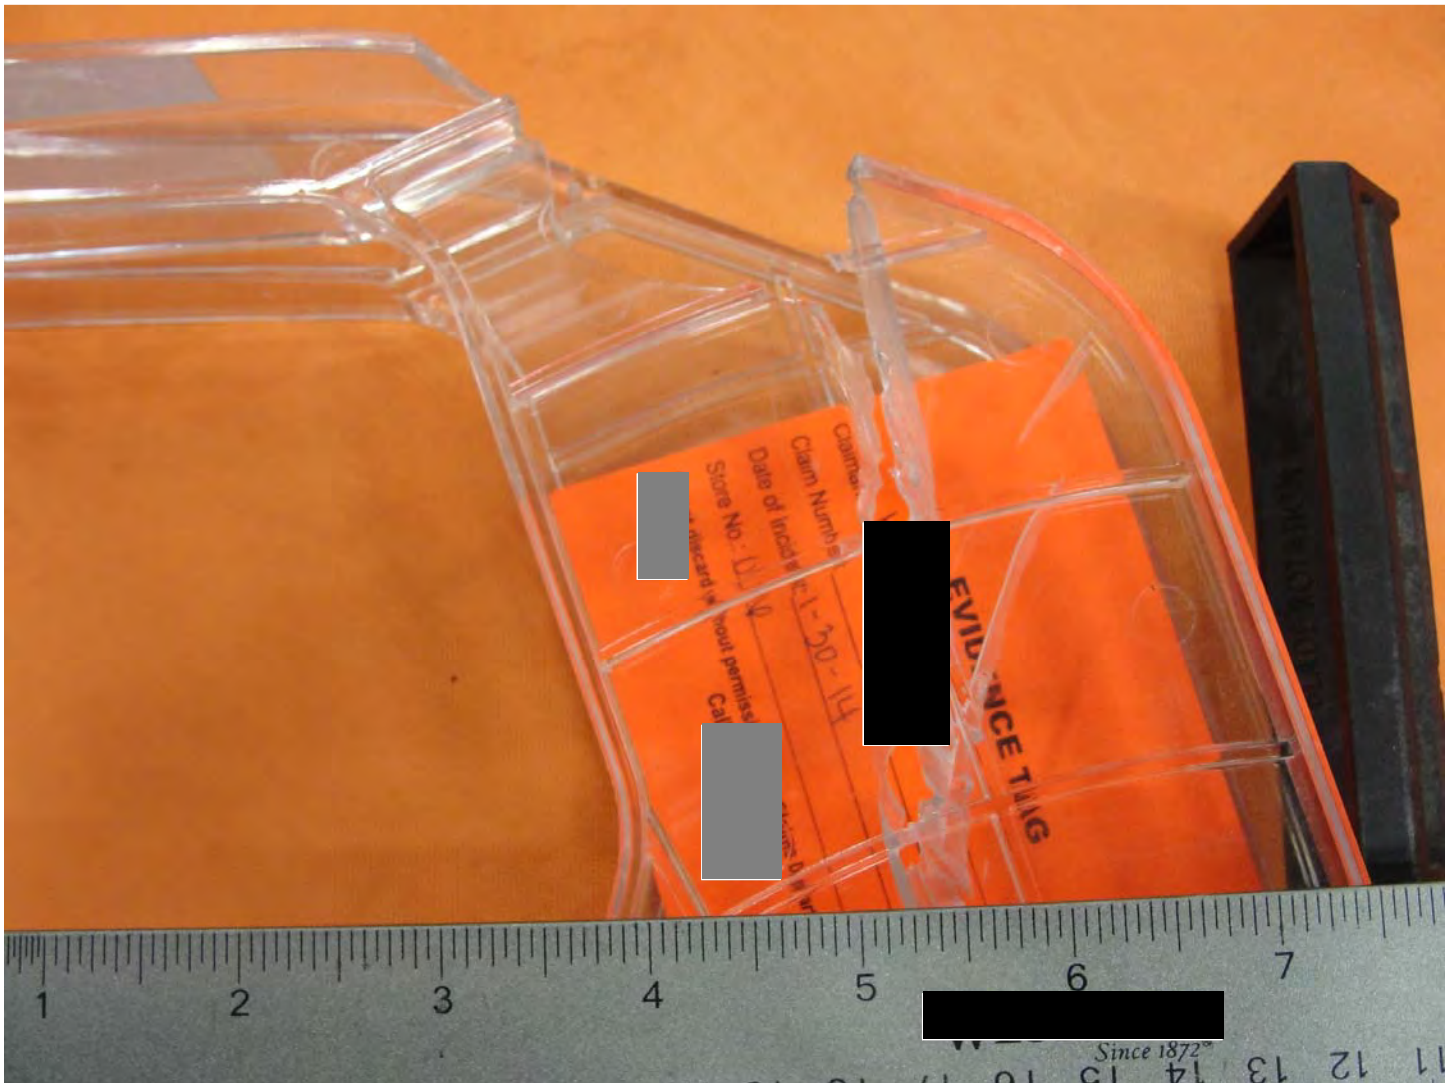
Photo 21: Close-up of damage done to incident modular blade guard as a result of incident

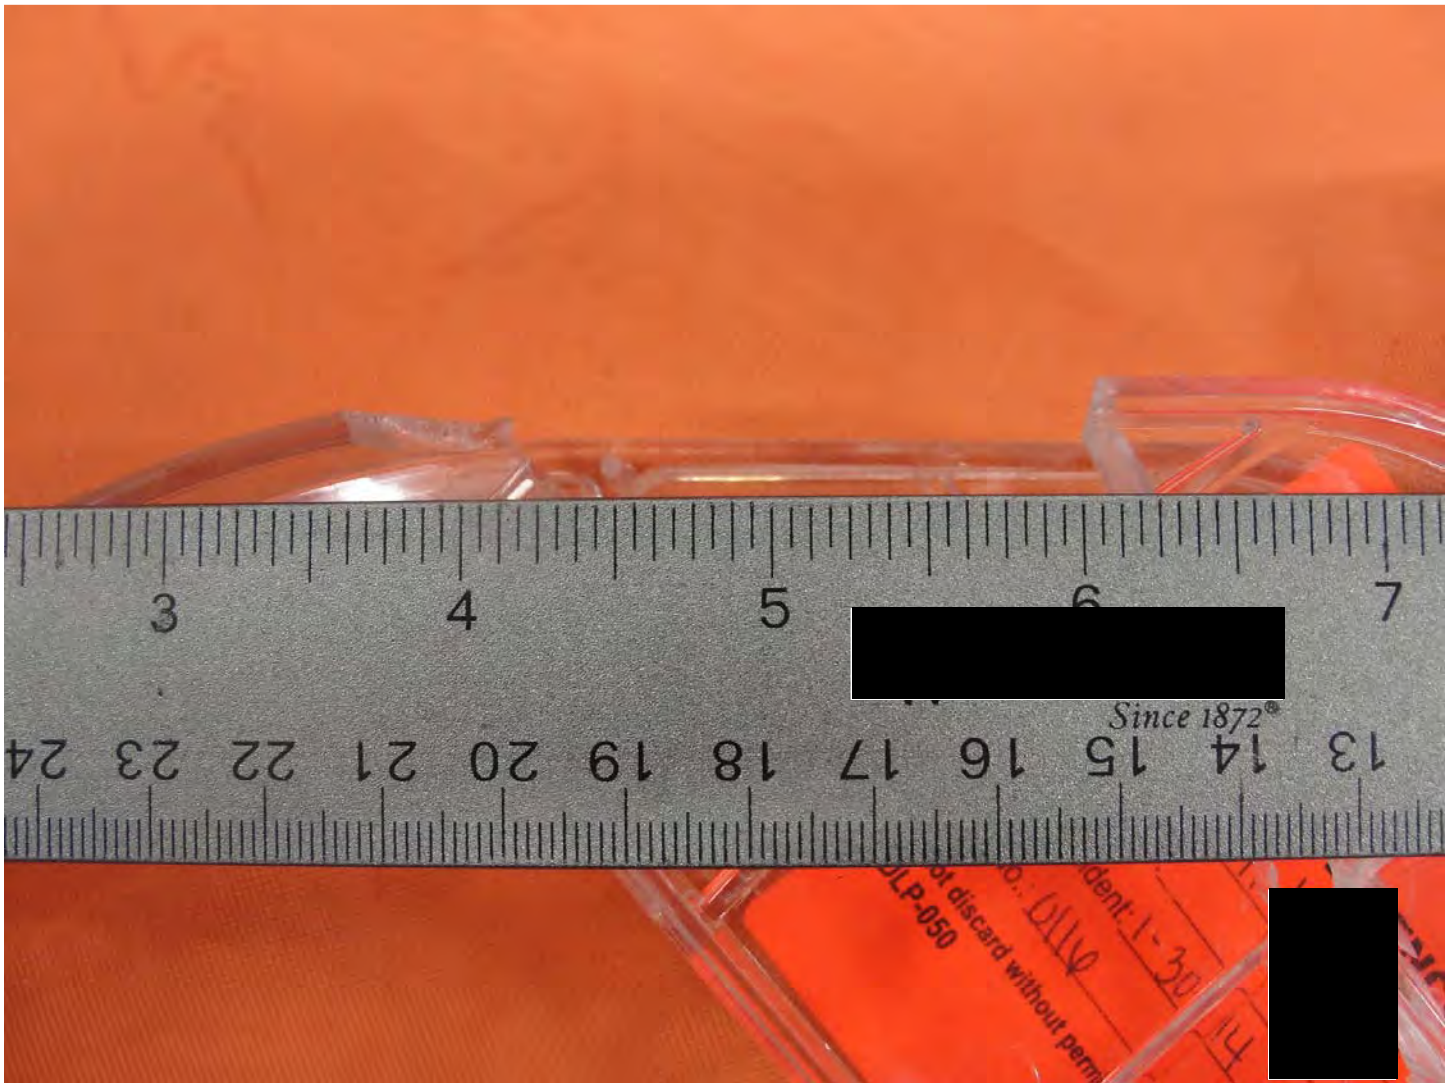
Photo 22: Close-up of damage done to incident modular blade guard as a result of incident

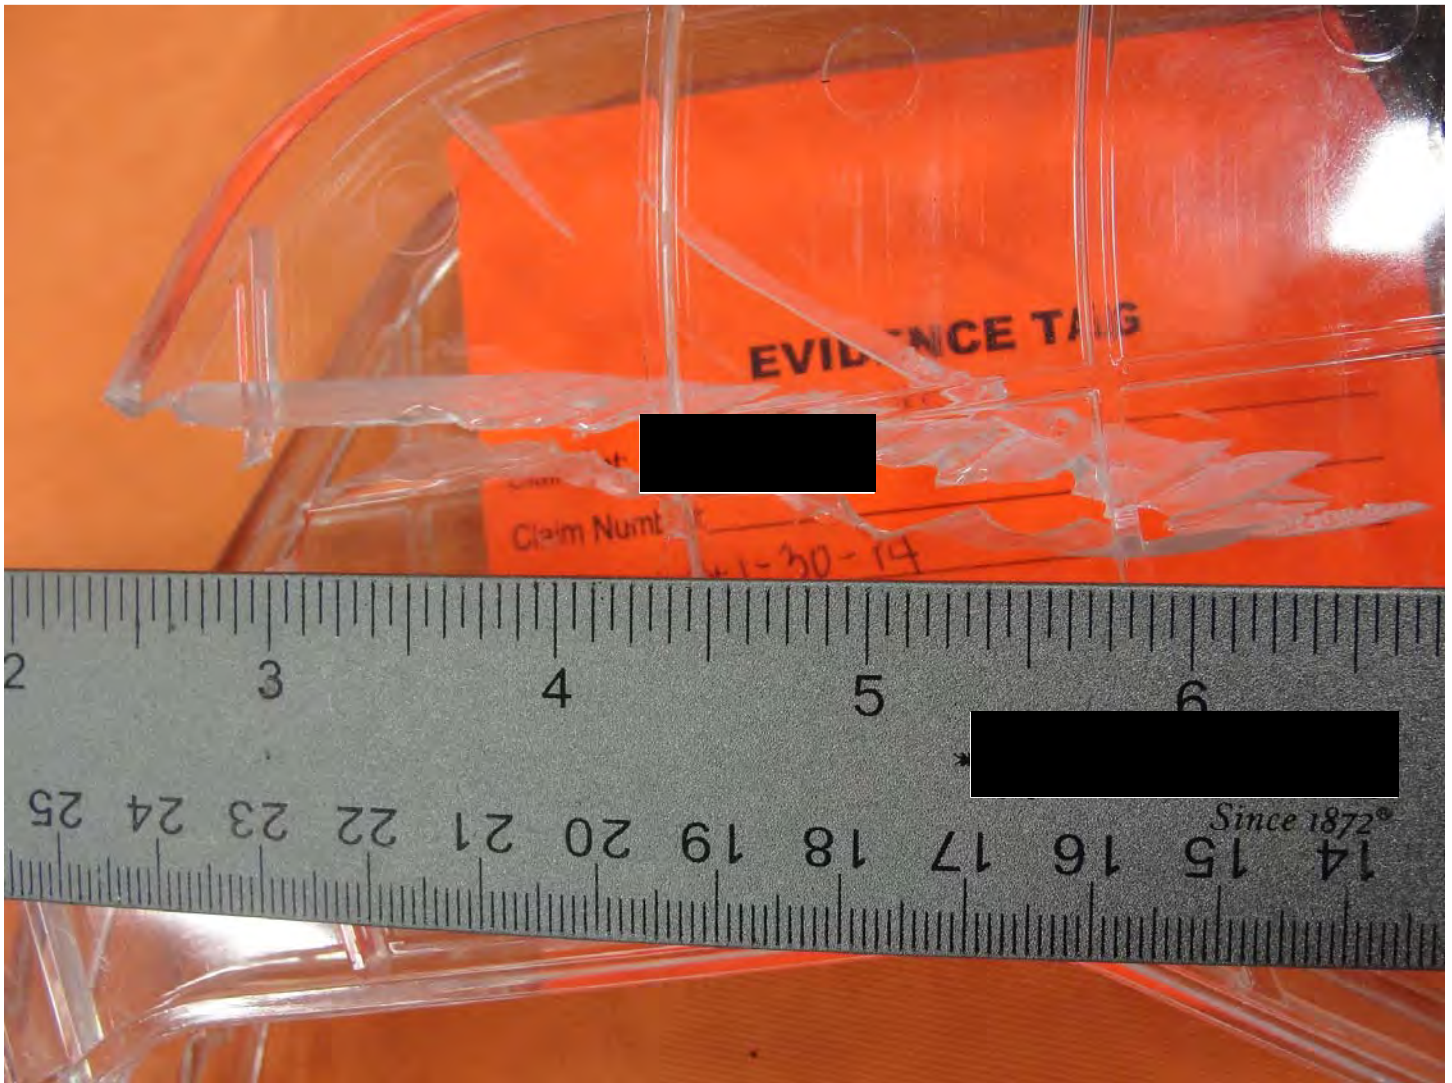
Photo 23: Close-up of damage done to incident modular blade guard as a result of incident
