U.S. CONSUMER PRODUCT SAFETY COMMISSION  
4330 EAST WEST HIGHWAY  
BETHESDA, MD 20814

March 24, 2015

131022HCC1048

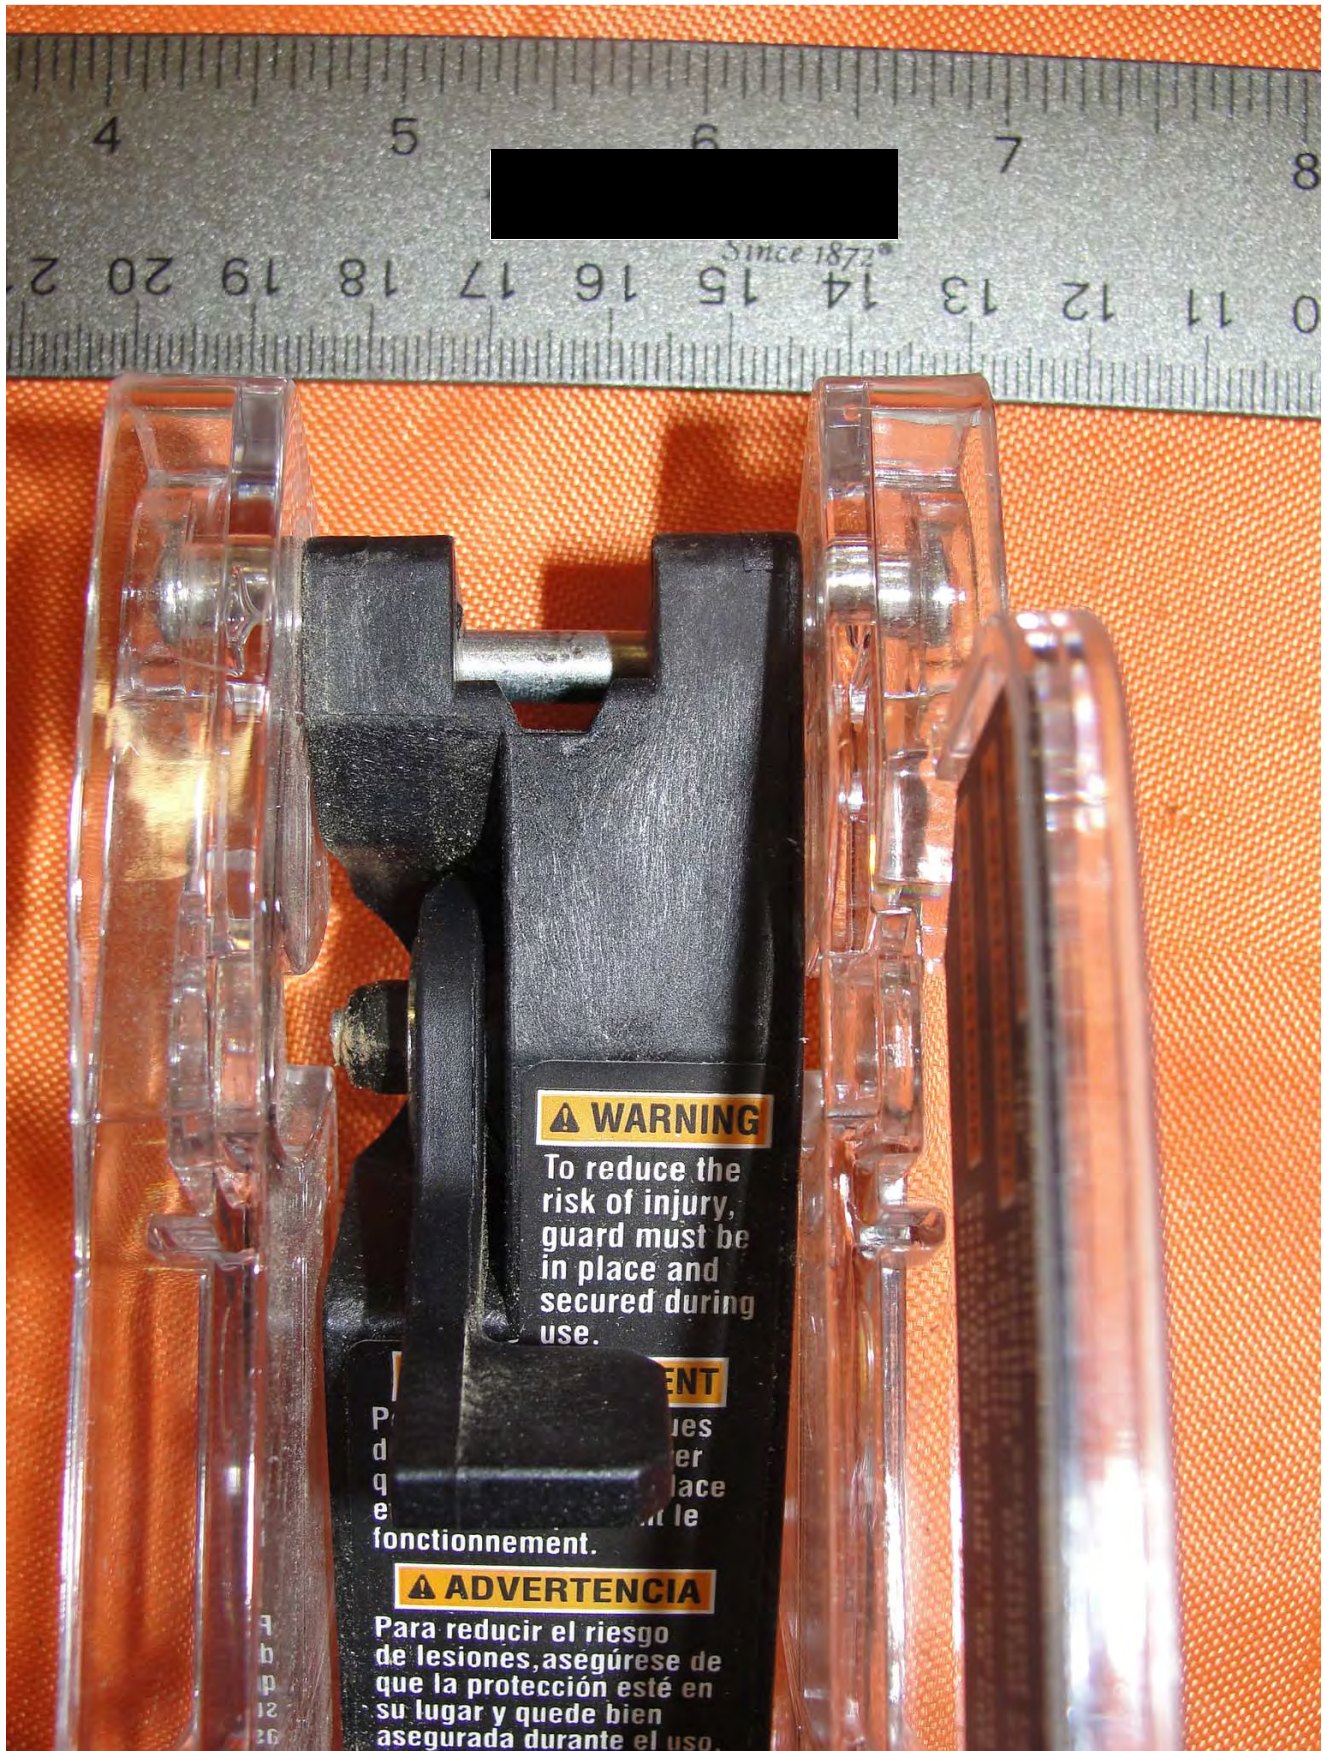
Photo 24: Close-up of modular blade guard where it attaches to table saw

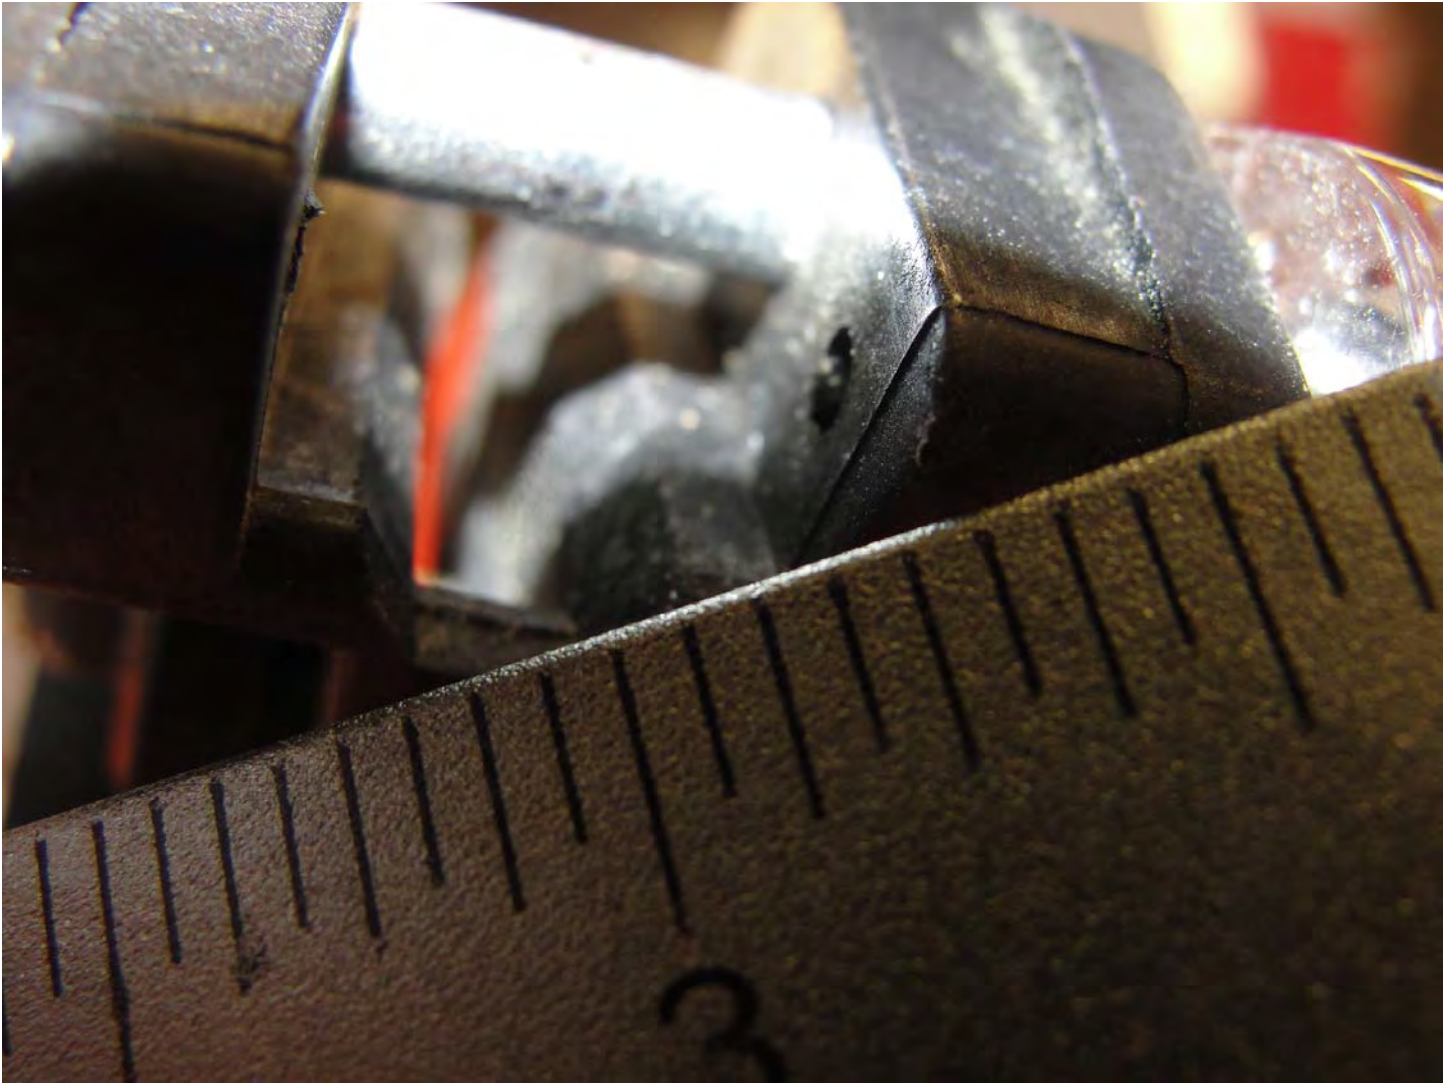
Photo 25: Close-up of modular blade guard where it attaches to table saw

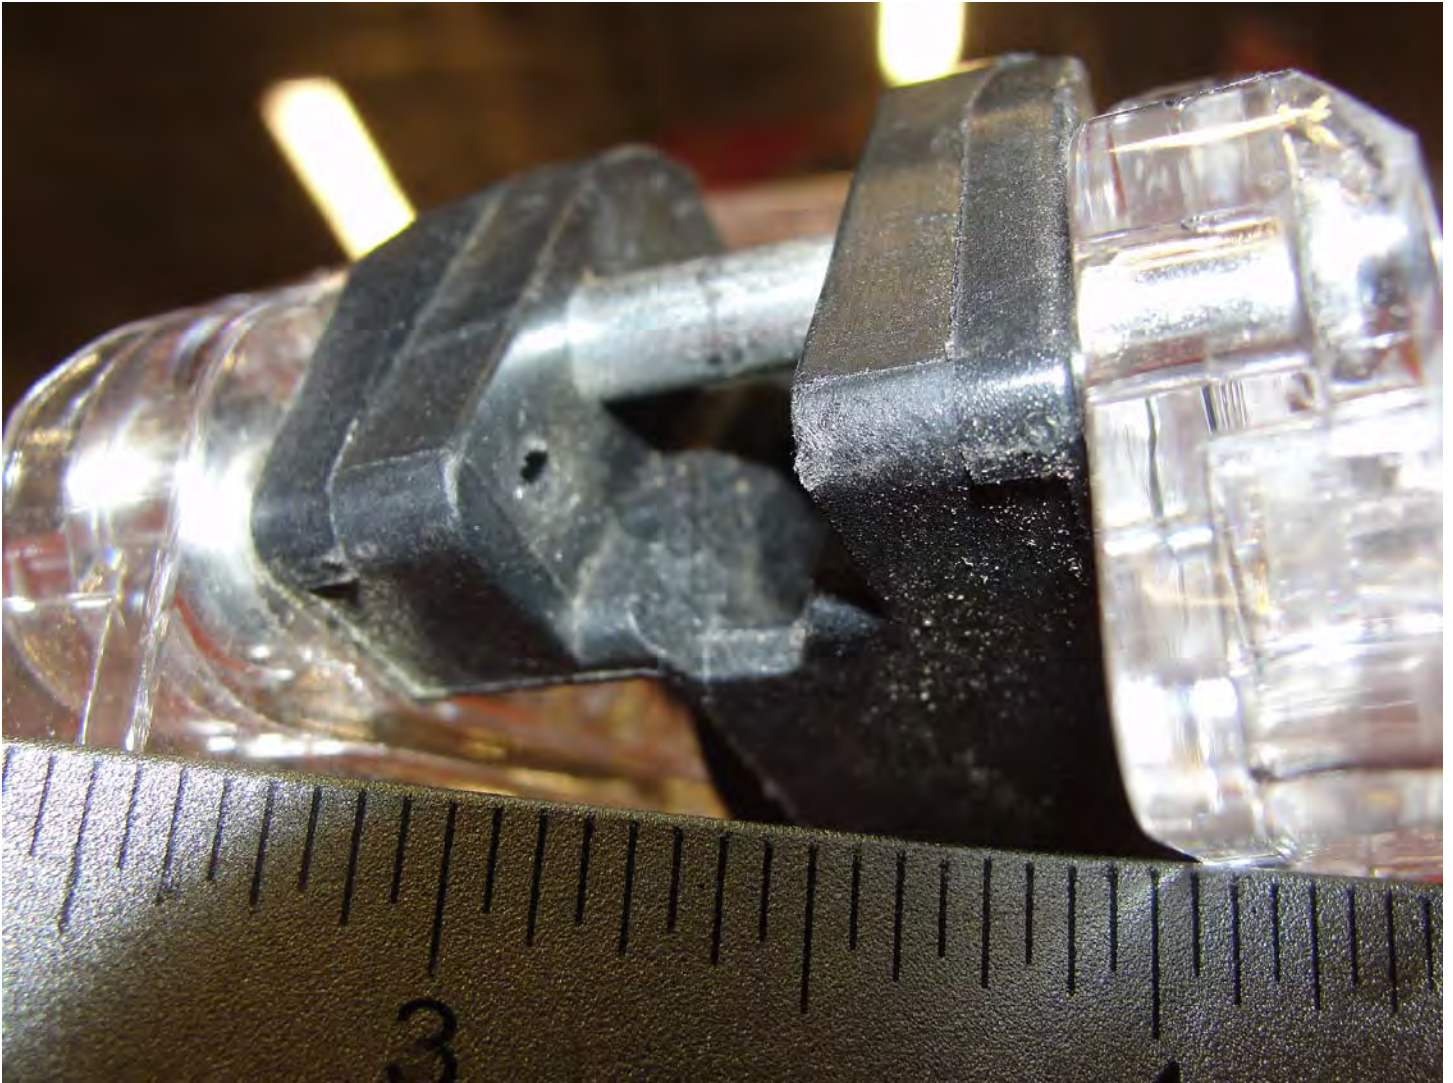
Photo 26: Close-up of modular blade guard where it attaches to table saw

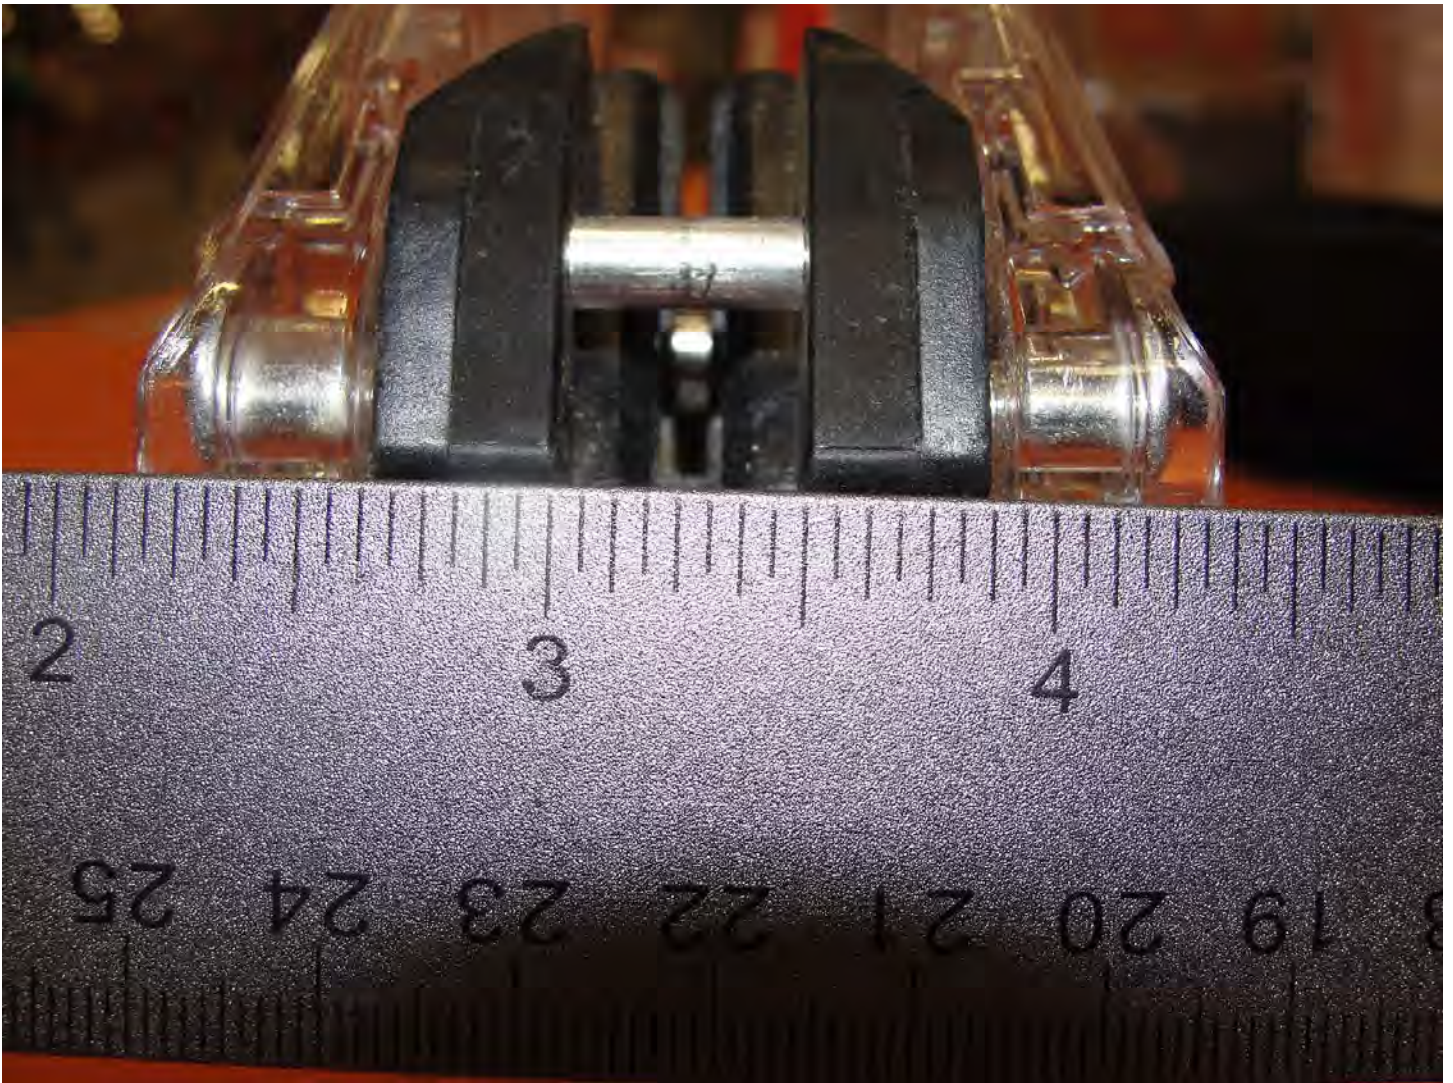
Photo 27: Close-up of modular blade guard where it attaches to table saw

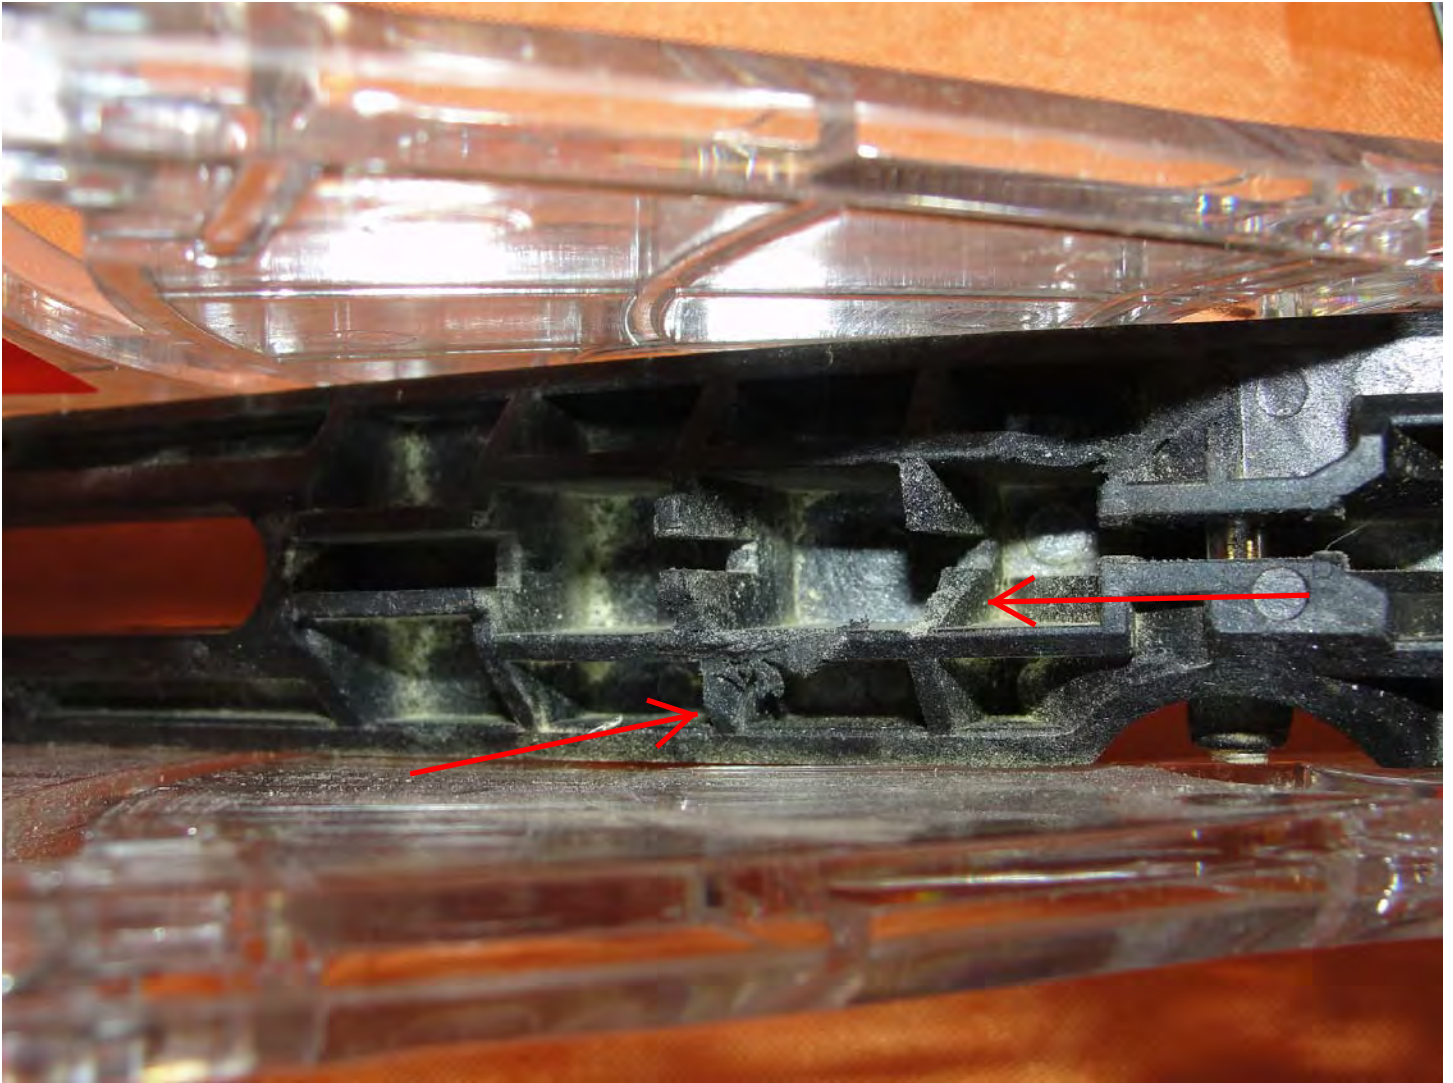
Photo 28: Underside of blade guard showing damage done as a result of the incident

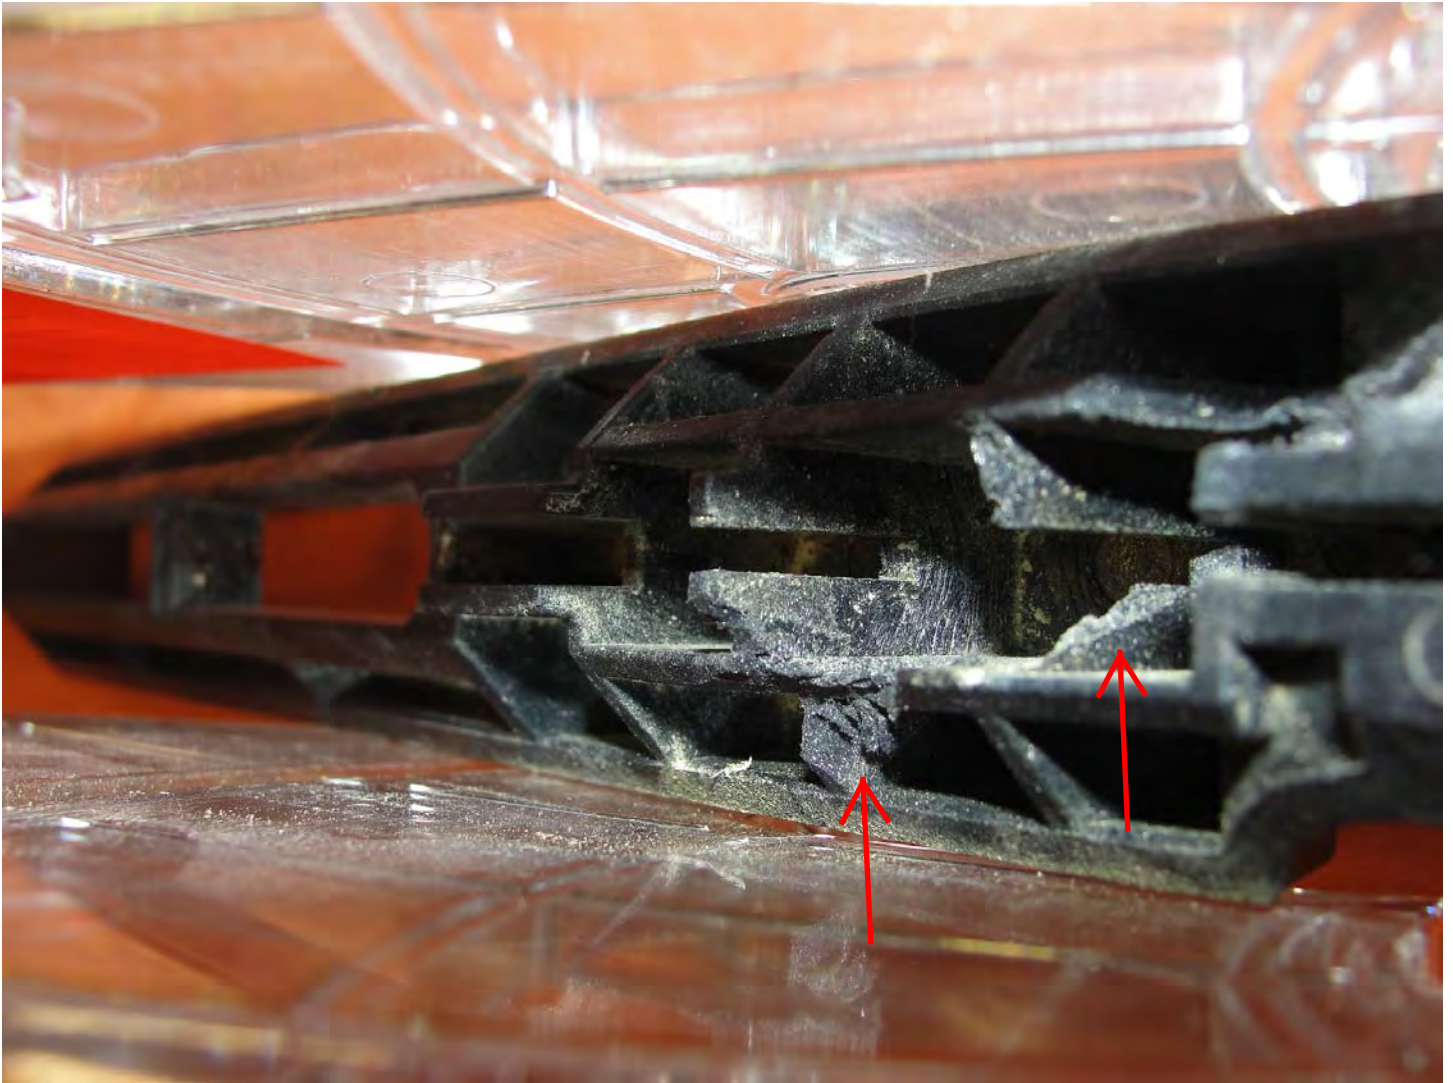
Photo 29: Underside of blade guard showing damage done as a result of the incident
