080709 FL02

Home Inspection/Questionnair Form

Client: CPSC

Project#: 16512

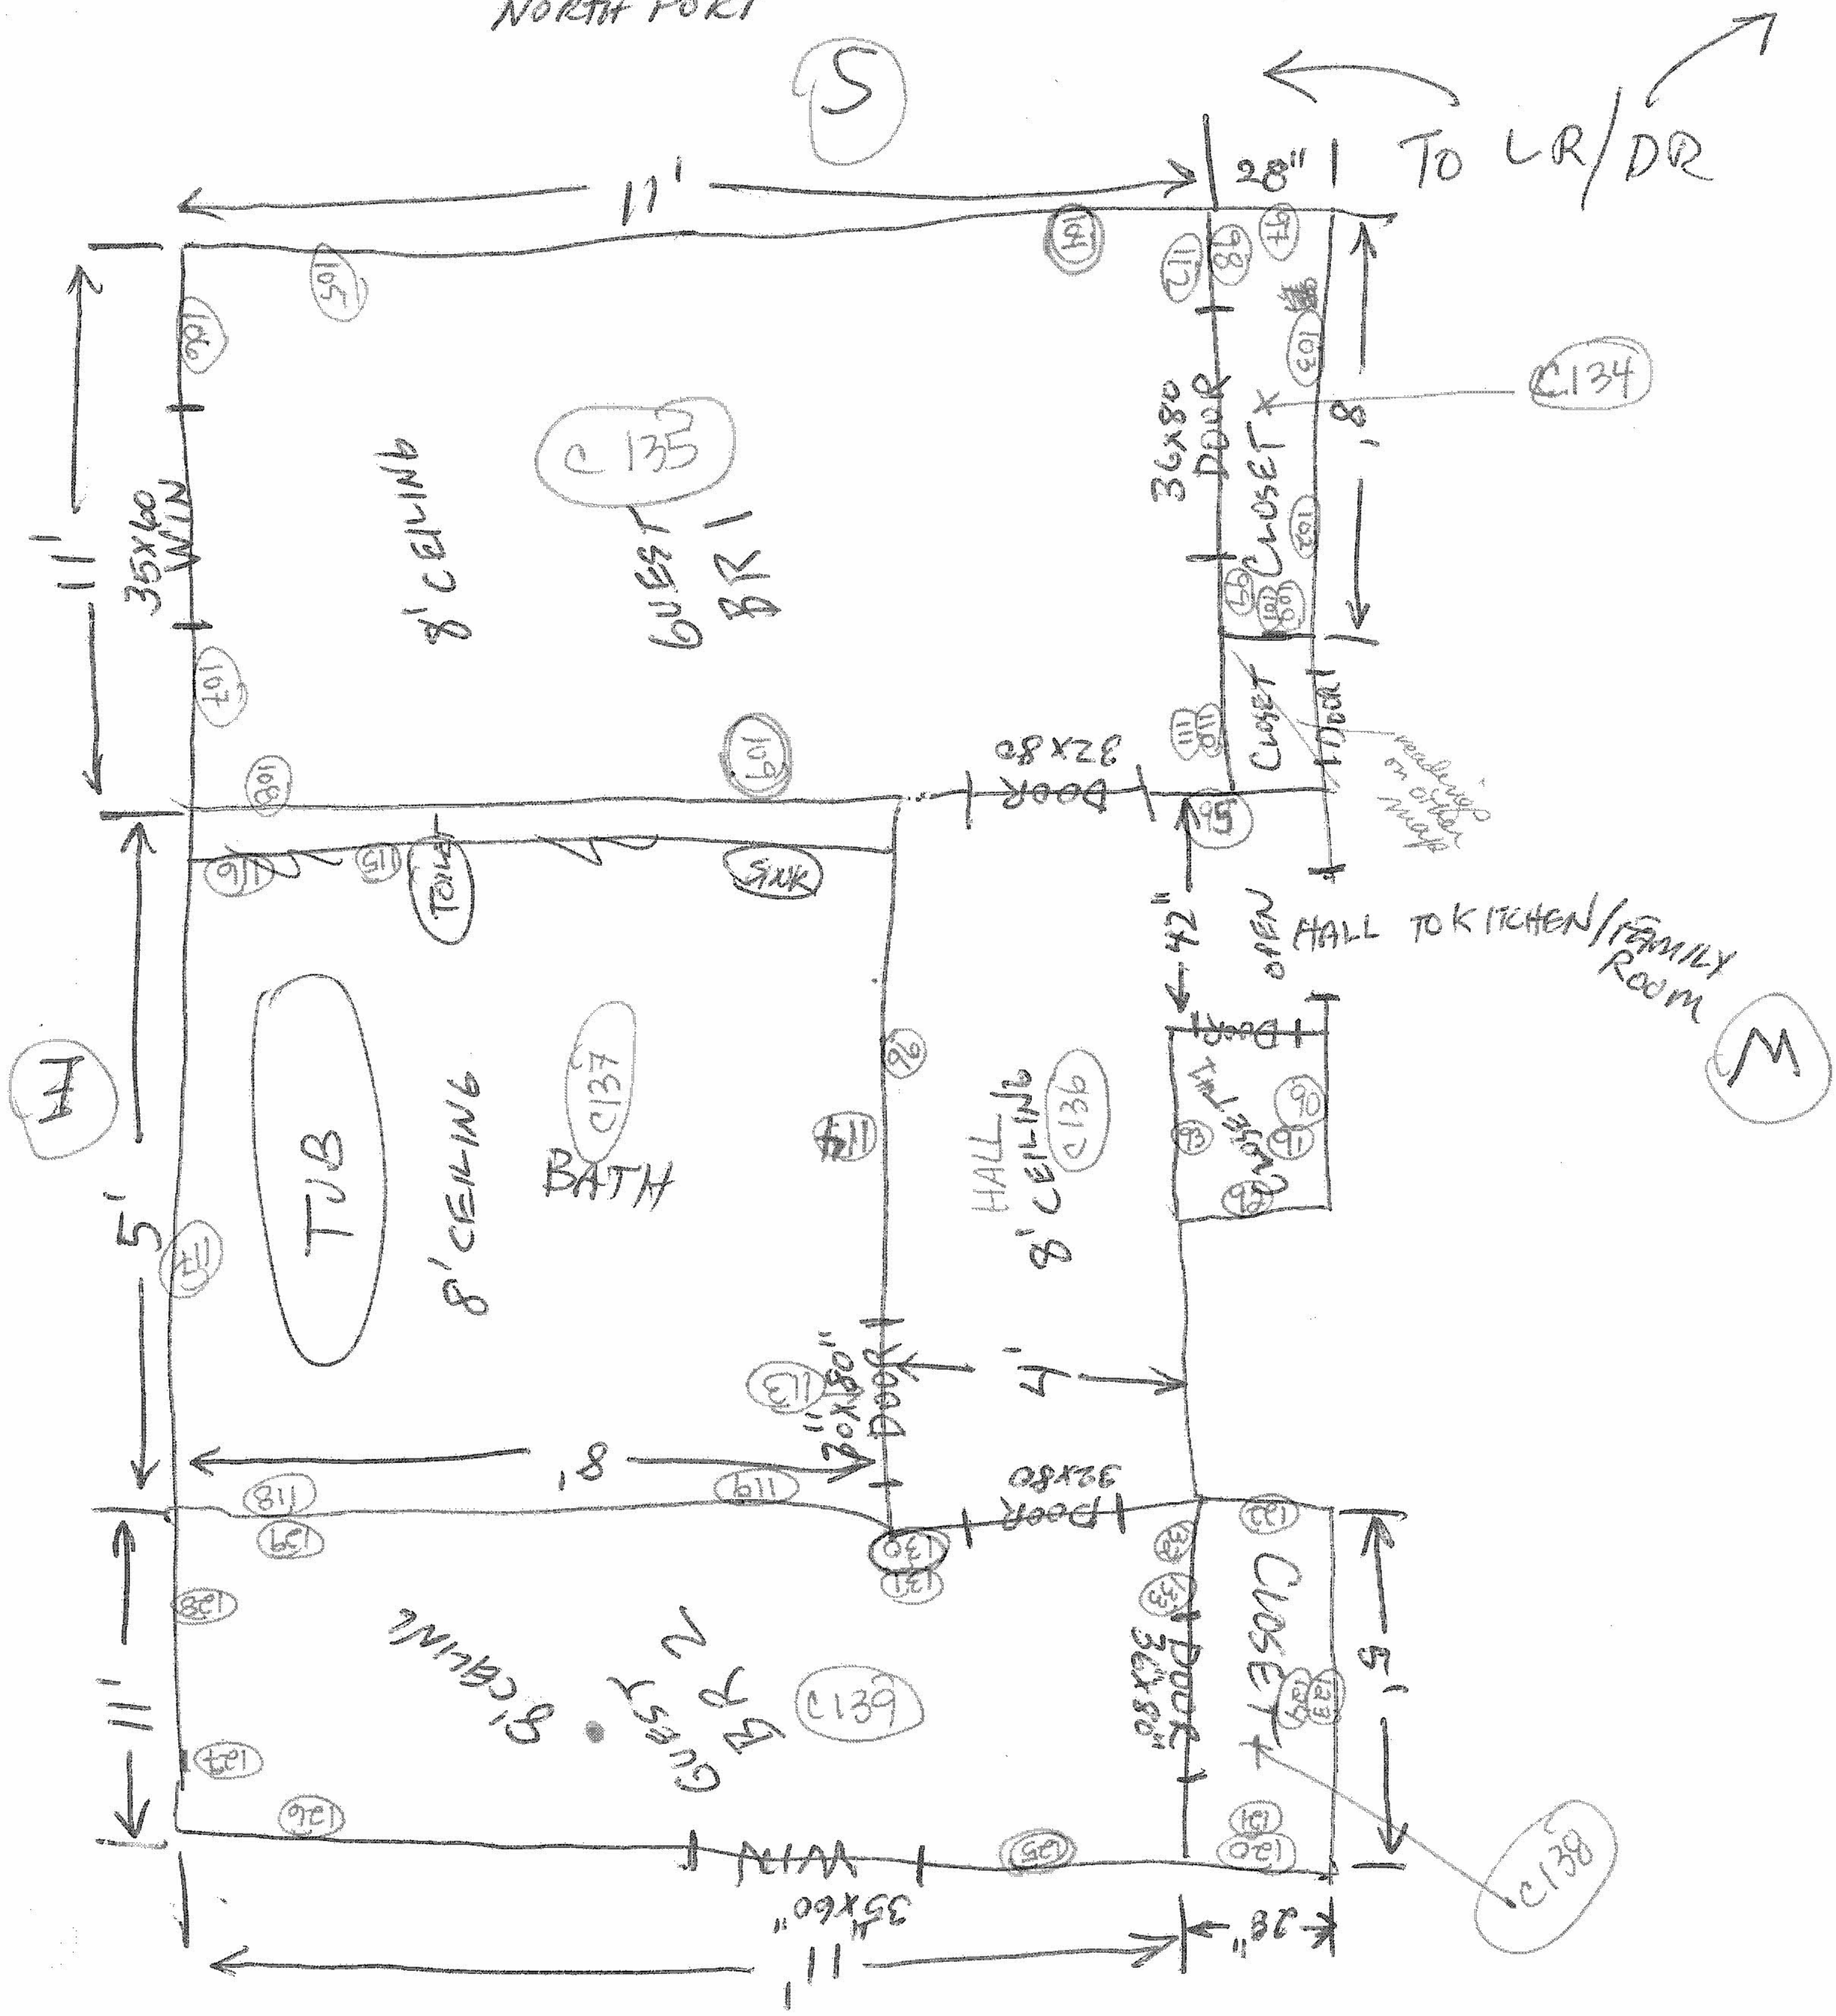
• = loc of GUEST room sampling
