**CPSC Staff Report on  
Metallurgical Investigations into Corrosion Damage  
in  
Homes Constructed with Problem Drywall**

Rohit Khanna, Fire Protection Engineer

Office of Hazard Identification and Reduction  
U.S. Consumer Product Safety Commission

September 2011

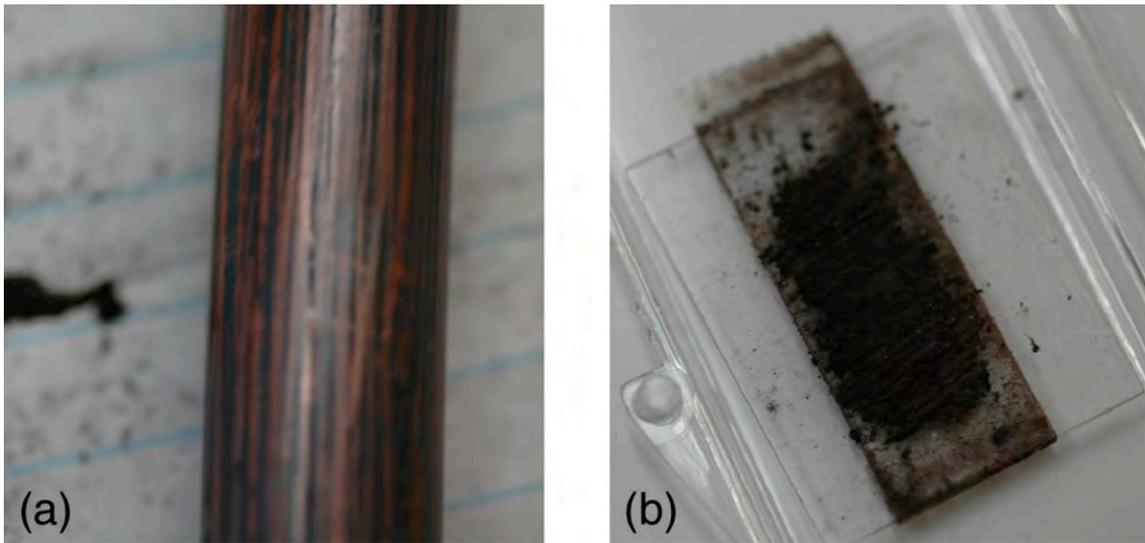
Figure 5 – Photographs of the scraped copper natural gas supply line (a) and the slide holding the sample for X-ray diffraction (b).

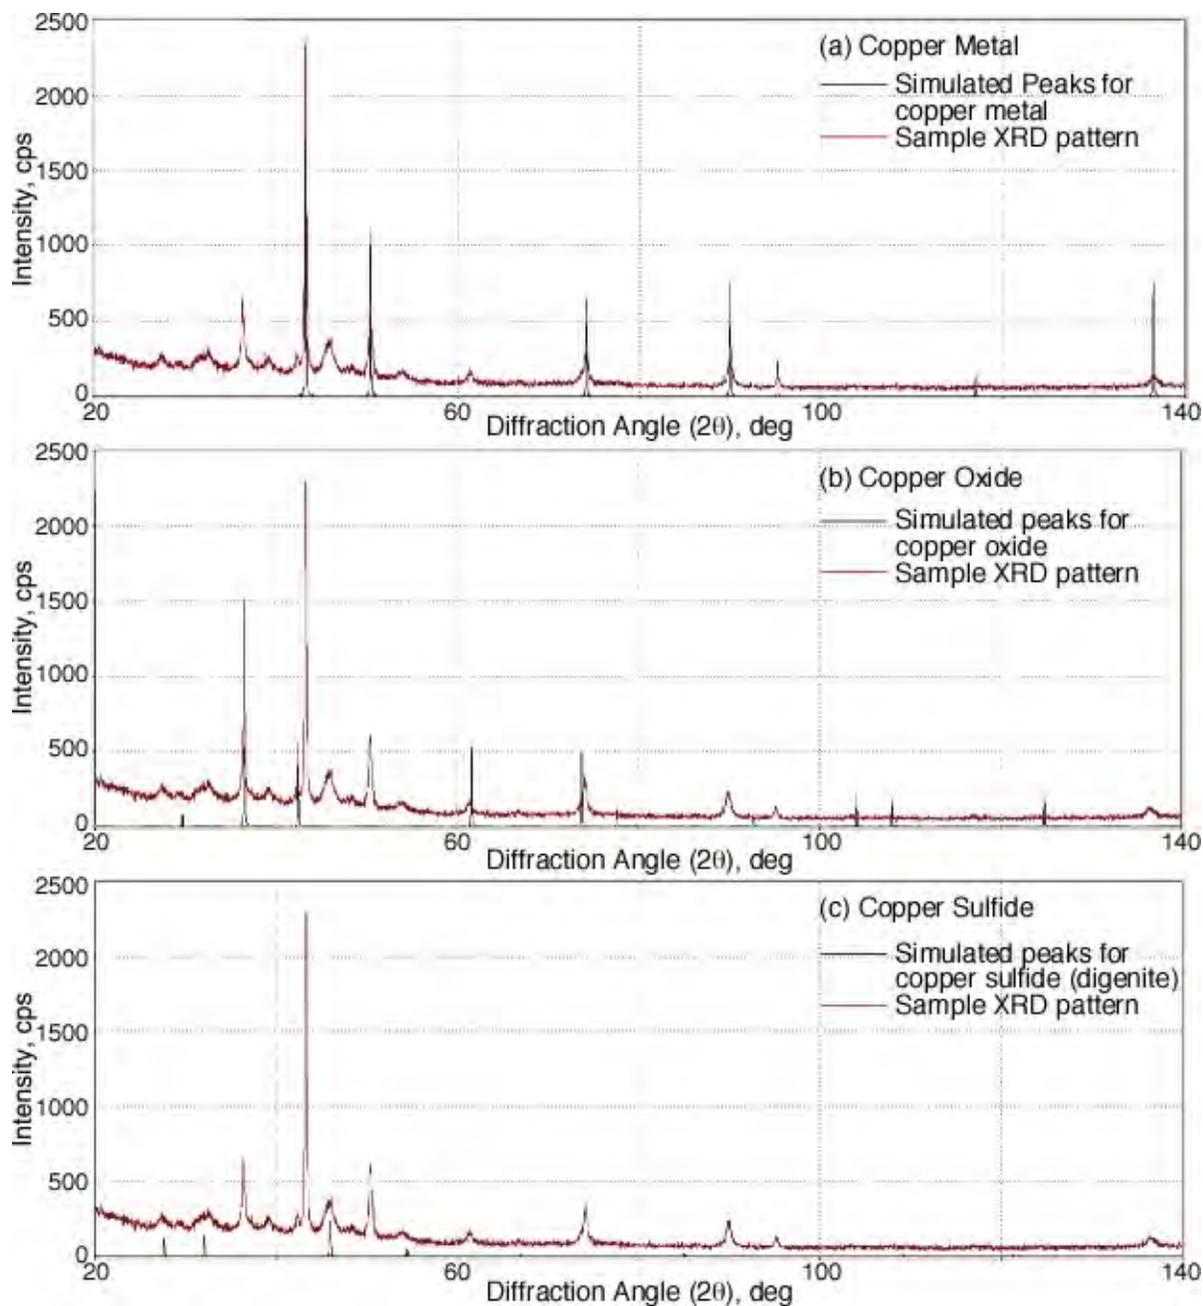
Figure 6 shows the results of these measurements in red along with the peak locations in black for copper metal (Figure 6a), copper (I) oxide (Figure 6b) and copper (I) sulfide (Figure 6c) as listed in the International Crystal Structure Database (ICSD) for the phase of copper sulfide known as digenite ( $Cu_{1.80}S$  or  $Cu_9S_5$ ). This figure shows that peaks corresponding to all three of these phases are present in the sample of scrapings from the surface of the copper natural gas supply line. Given that the sample was collected by scraping the surface of copper metal with a sharp razor blade, the peaks for copper and copper oxide were expected because copper is a soft metal compared to the steel of the razor blade, and it will normally form copper oxide when exposed to air. The third phase, copper sulfide ( $Cu_2S$ ), is not a typical atmospheric corrosion product because the concentration of the reduced sulfur species, such as  $H_2S$ , required to form this product, is usually very low under normal indoor atmospheric conditions.<sup>1, 3-5</sup> Figure 7 is a summary of the XRD results showing that all but two small peaks, indicated by question marks, are accounted for by these three phases.

Figure 6 – Measured X-ray powder diffraction patterns for the sample of corrosion products scraped off a Cu natural gas supply line in red compared with simulated patterns for specific structures in black (simulated peaks do not contain background noise): (a) Cu metal, (b) copper (I) oxide (ICSD #38233), and (c) the copper (I) sulfide phase digenite ( $\text{Cu}_9\text{S}_5$ ) (ICSD #95395).

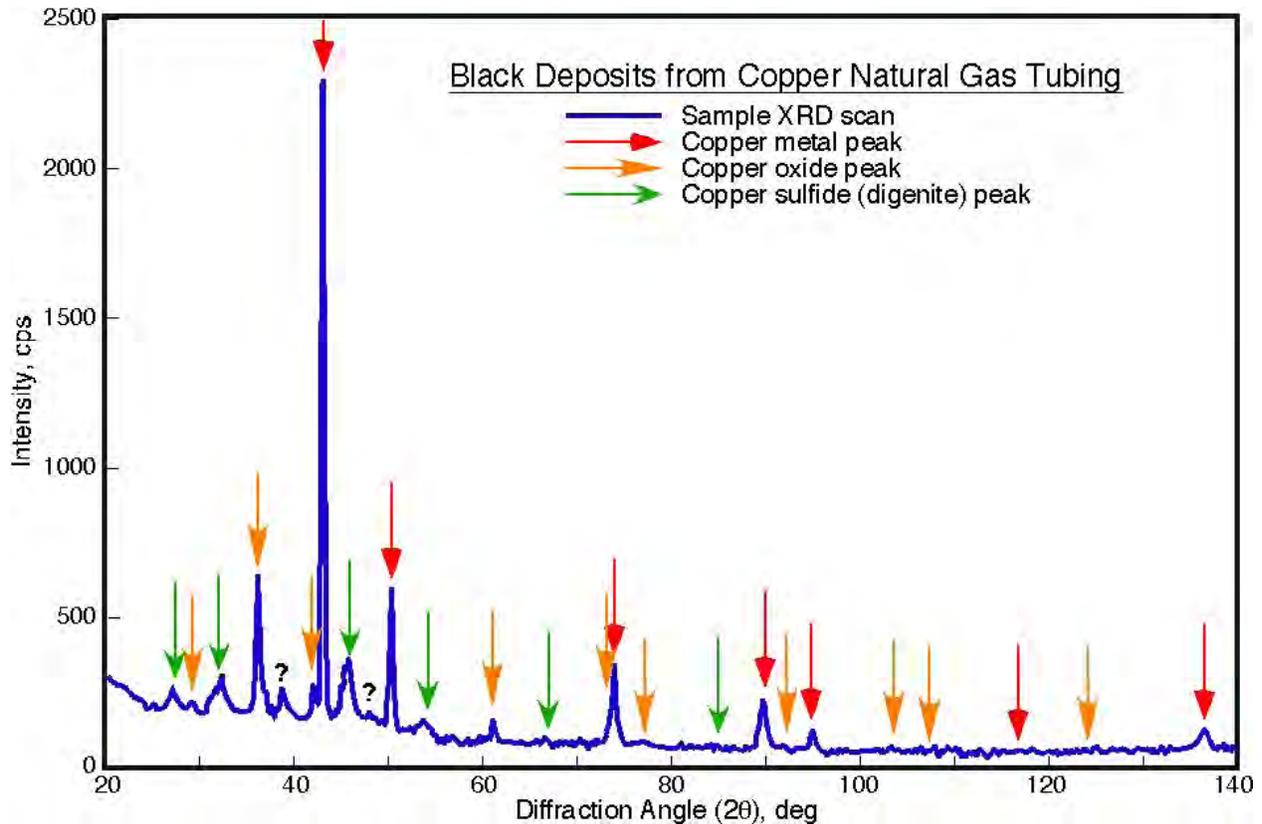
Figure 7 – Summary of peaks found in the corrosion product sample and their identification for showing that only two small peaks were unidentified by the three phases.

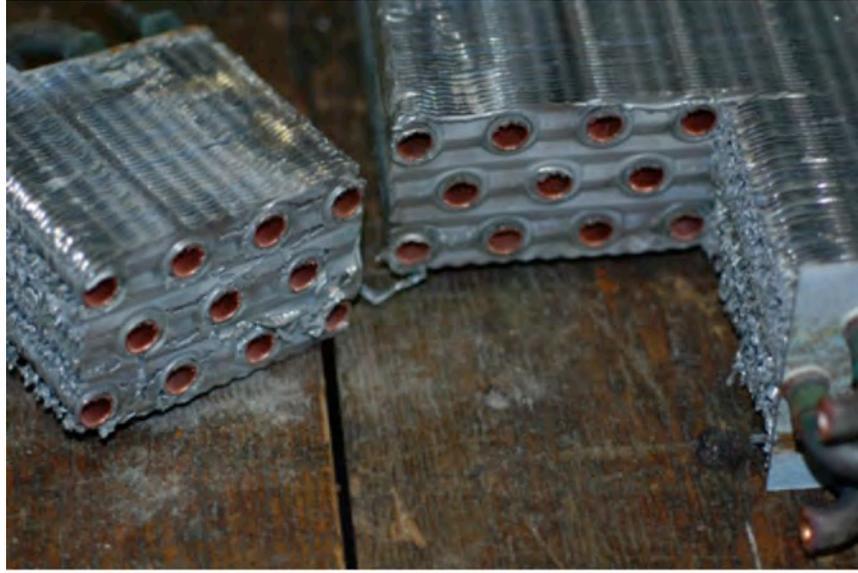
To evaluate the possibility of corrosion damage occurring between the aluminum heat transfer fins and the copper tubing inside them, the heat exchanger unit was sliced with a band saw, as shown in Figure 8, to expose these internal surfaces for examination of the copper. No evidence of localized attack was found, and visual inspection did not detect a black corrosion product layer between the aluminum fins and the copper tubes of the evaporator coil.

Figure 8 – Air conditioner evaporator coil after slicing to allow for examination for corrosion damage between the aluminum sheets and the copper tubing.

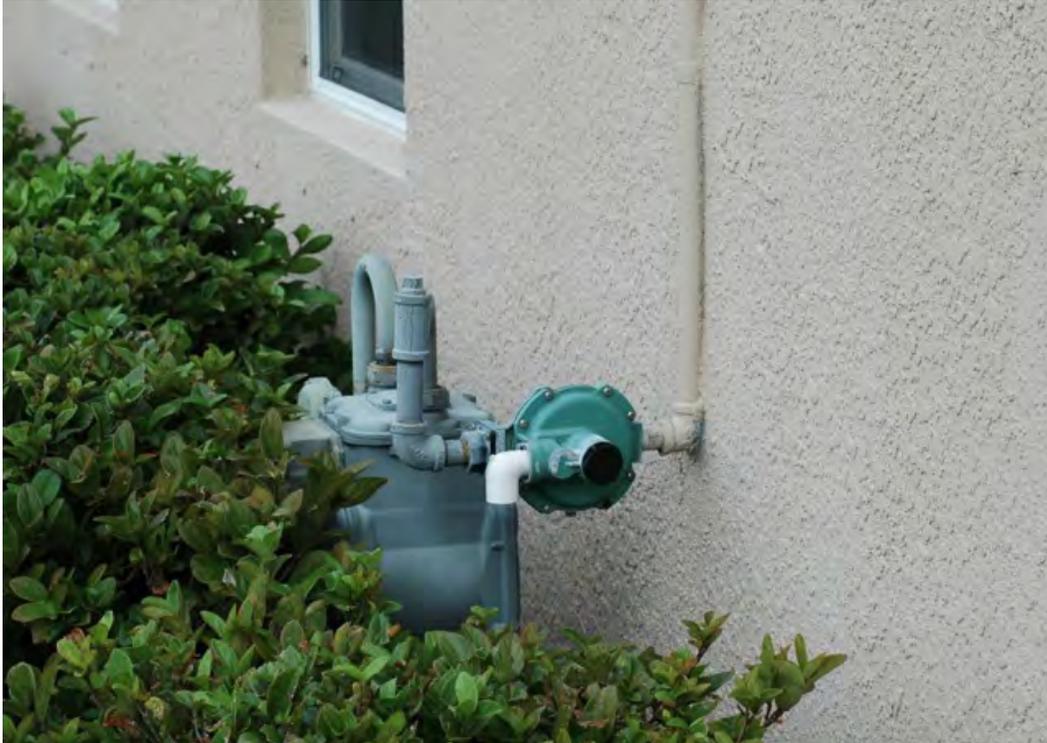
Because the emphasis was on safety-related systems, the natural gas supply systems and appliances were examined first. Figure 10 shows the natural gas meter and inlet on the outside of one of the homes. No evidence of any corrosion damage beyond that normally expected for exposure to the outdoor atmosphere in Florida can be seen in Figure 10. Figure 11 shows the stainless steel flex tube used to connect the water heater to the gas distribution pipe. The Figure shows very little evidence of corrosion, while the outside of the brass fitting on the end is covered with a dark corrosion product. The brass visible on the inside of this fitting indicates the original color of this fitting. Figure 12 shows one of the wall electrical receptacles. As is typical in homes made with problem drywall, the bare copper ground wire is covered with a thin uniform black film of corrosion products that is so uniform that it almost appears as if the wire were painted black or is covered with a thin layer of electrical insulation. Figure 13 shows the HVAC evaporator coil in a garage after removal of the side cover, and Figure 14 shows the corrosion damage in the attic unit from the same home. Both units show considerable discoloration of the copper tubes, indicative of the reaction of copper with a reduced sulfur species similar to that shown in Figures 6 and 7.

Figure 10 – Gas meter on the outside of a problem drywall home.

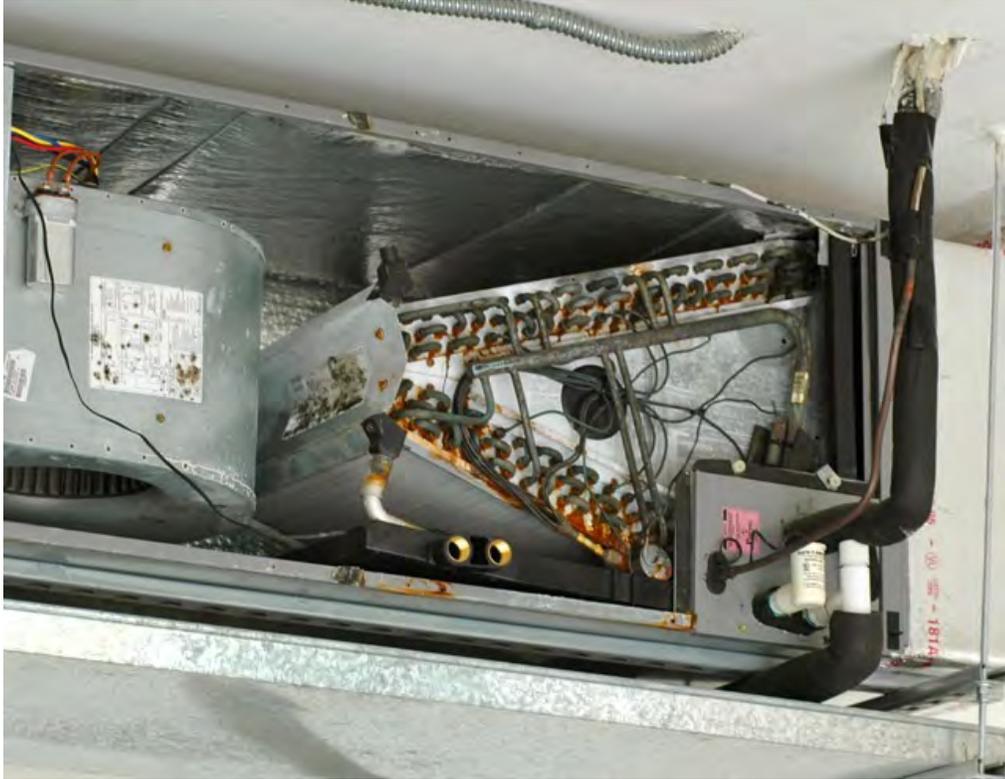
The homebuilder told NIST staff that both homes had experienced trouble repeatedly with the HVAC systems, which HVAC service providers attributed to loss of coolant pressure due to corrosion of the evaporator coil (A-coil). It was also reported that total replacement of the evaporator coil frequently was employed as a remedy and that both of the homes examined had their evaporator coils replaced at least once. However, these reports and the operational history of these units could not be documented, and the actual working status of the systems at the time of the NIST inspection could not be determined unequivocally. The evaporator coil shown in Figure 13, suspected to have failed in service, was tagged and shipped to NIST for laboratory examination. At NIST, the coil was pressurized and leak-tested, as shown in Figure 15. No evidence of leaking was detected, and no loss of pressure was observed. Therefore, it is concluded that either: (i) this unit was not leaking in service, or (ii) the leak was not in the evaporator coil but in a connection or section of the pressure boundary not included in this sample. Therefore, no further examinations were conducted on this unit.

Figure 13 – HVAC unit in the garage of a problem drywall home.

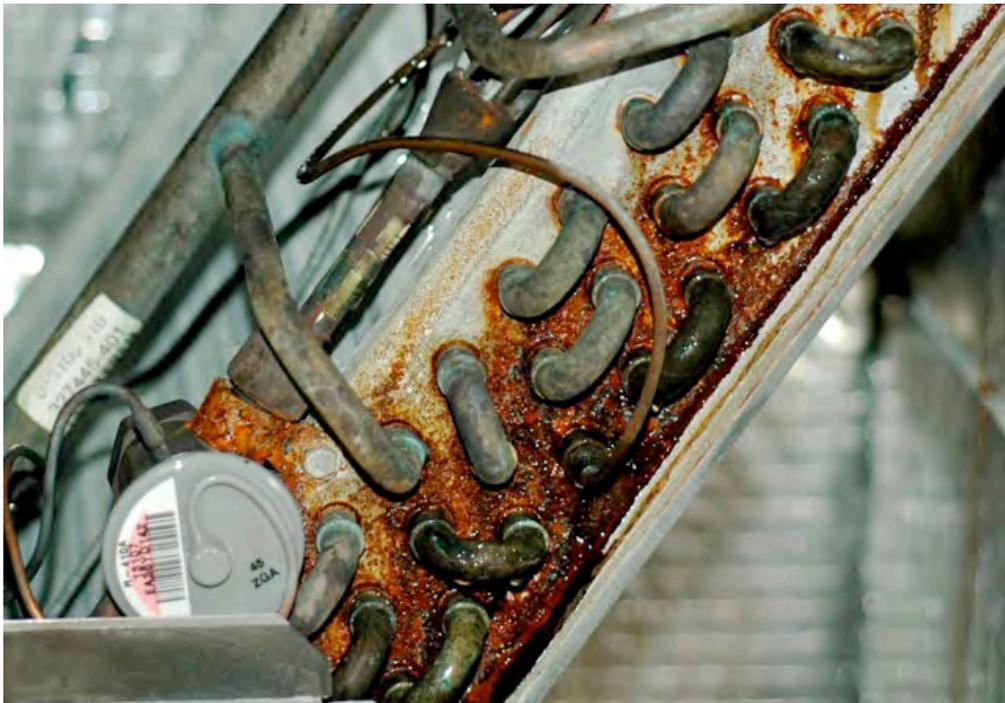
Figure 14 – HVAC unit in the attic of a home with problem drywall.

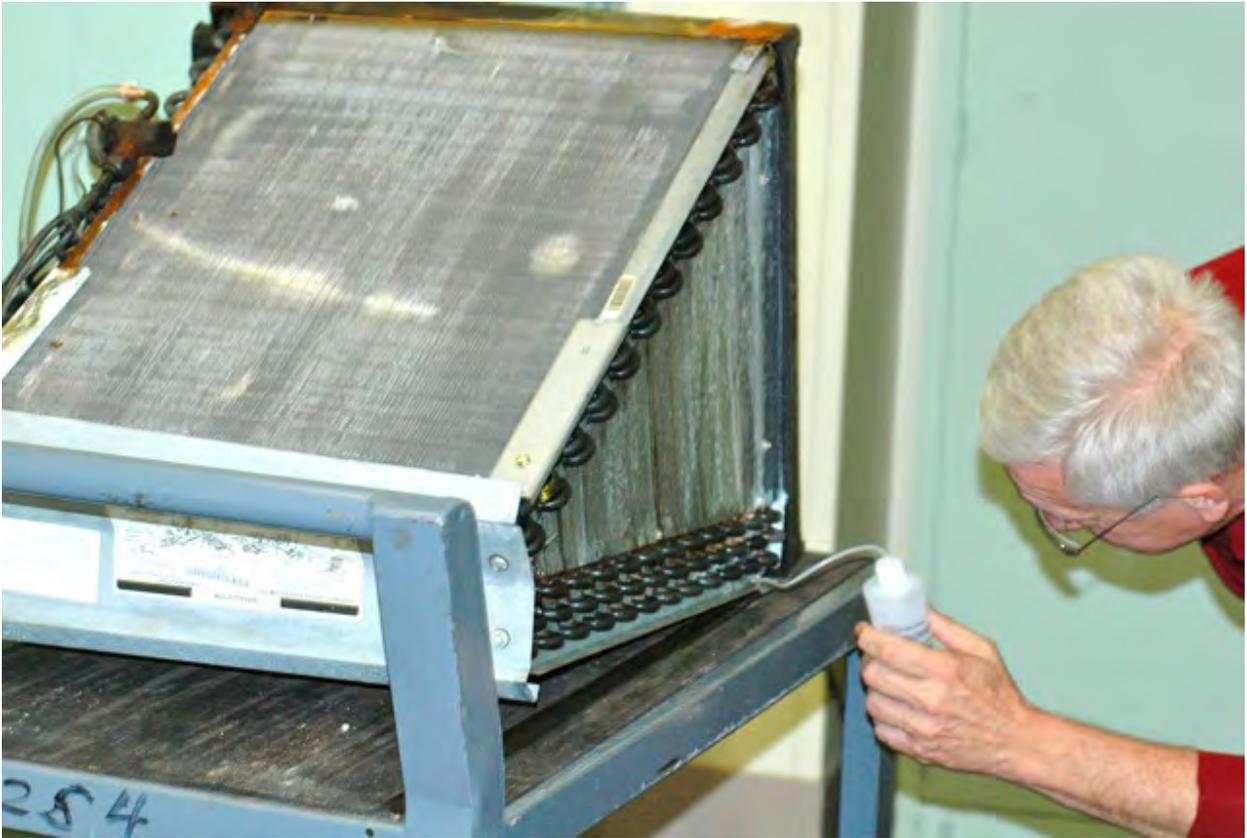
Figure 15 – The garage HVAC unit shown in Figure 13 undergoing leak testing in the metallurgy laboratory at NIST.

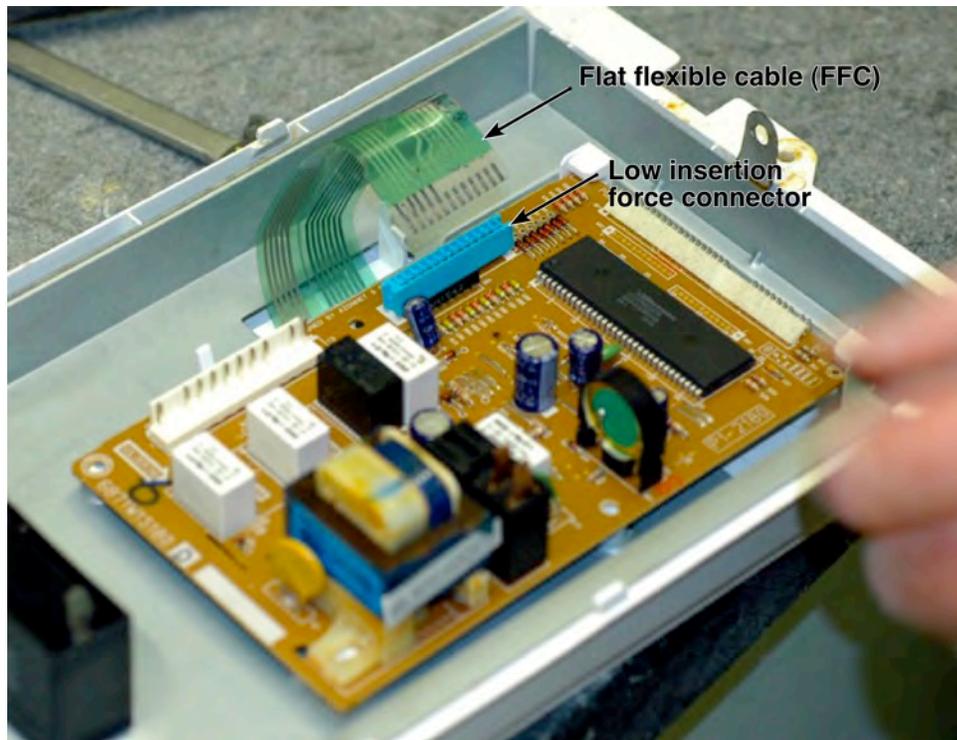
Figure 16 – Removal of the control module of the microwave oven.

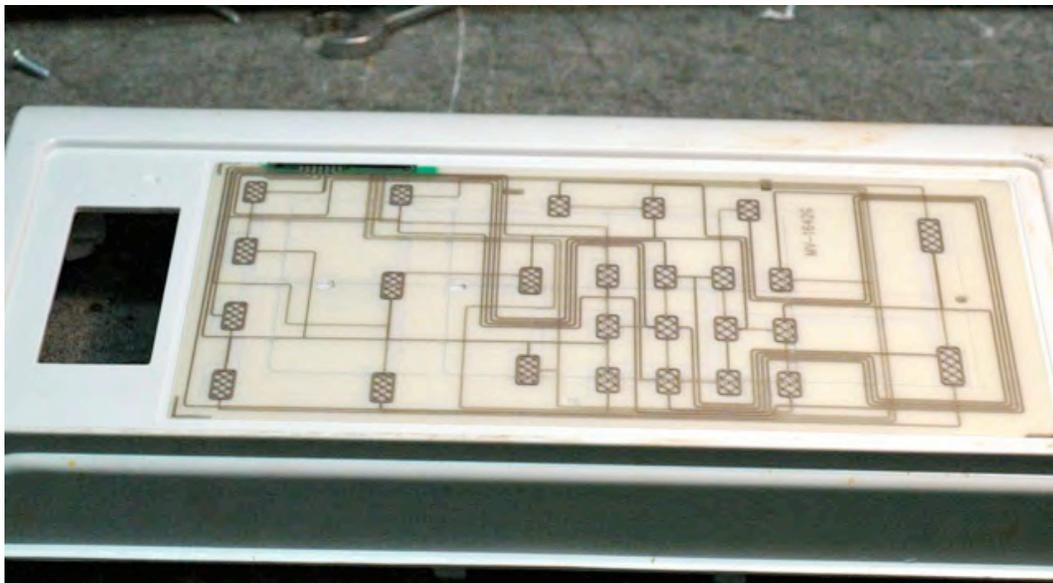
Figure 17 – Pushbutton controls with cover removed.

After arrival at NIST, the microwave oven was plugged into an electrical outlet, and it went through its self-checks in a perfectly normal fashion. However, when NIST staff attempted to operate the microwave oven, it failed to respond to any user pushbutton commands. The team concluded that the power supply and related power systems were functioning normally and that the failure was in the low-voltage control circuits or the user pushbuttons. Because pushbuttons rely on making surface contact between metallic conductors, and because corrosion products are usually poor conductors of electricity, corrosion of the pushbutton contacts was the first failure mode hypothesis. As a result, the flat, front panel display and pushbuttons were removed (Figure 16) and examined (Figure 17). There was no immediately obvious evidence of corrosion damage to the buttons that was sufficient to cause these systems to fail, as shown in Figure 17. However, corrosion was found on the silver contacts of the flat flexible cable (FFC) contacts that are inserted into the low-insertion force connector between the flat panel pushbuttons and the microwave oven.

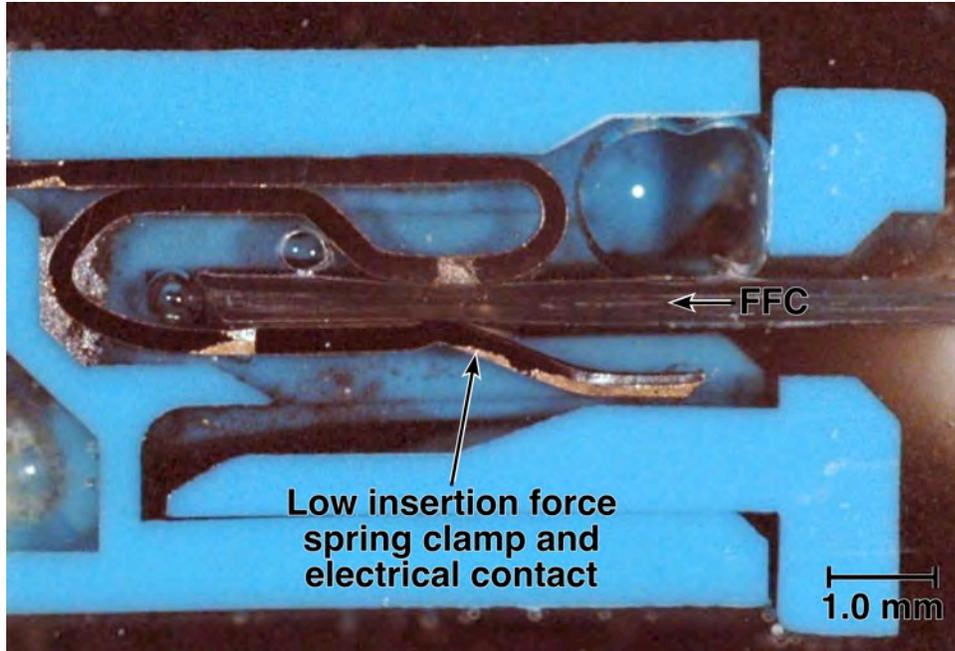
Figure 20 – Flat, flexible cable plug in low-insertion force connector mounted in clear epoxy, cross sectioned, and polished for microscopic examination.

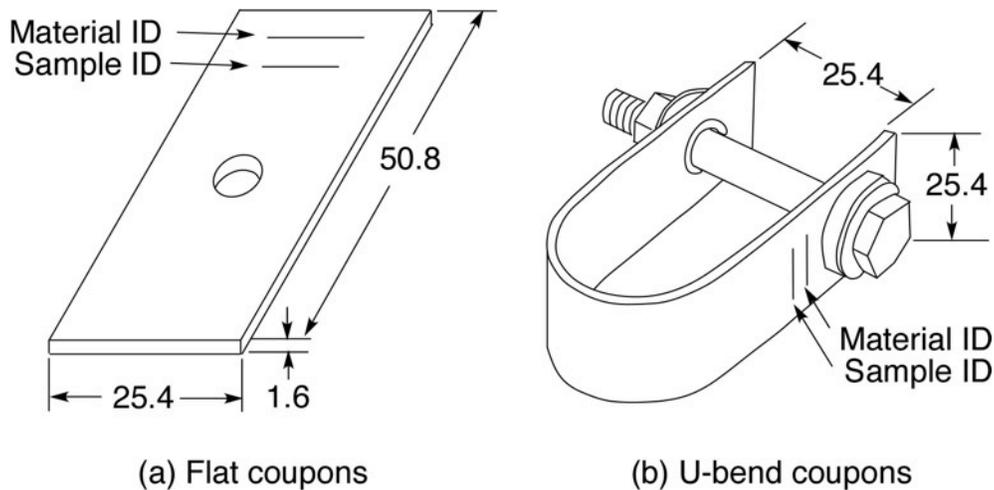
Figure 22 – Corrosion coupons designs selected for the accelerated corrosion tests.

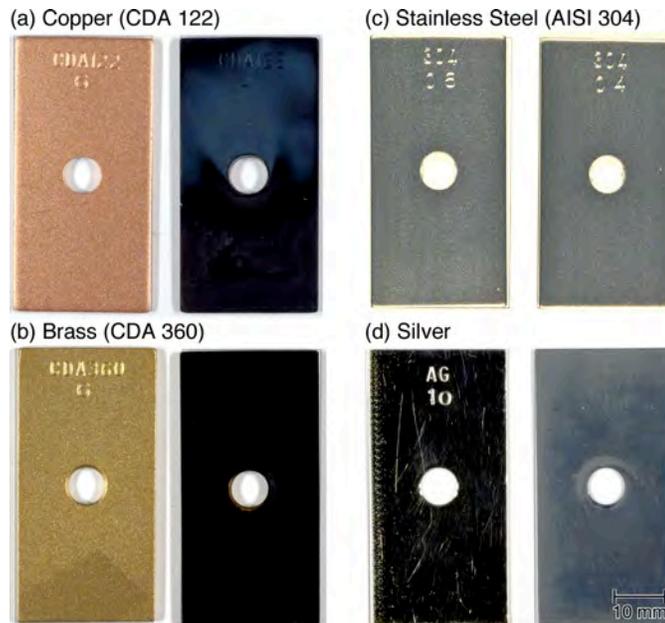
(2) Optical Examination Results. Figure 23 shows photographs of the five flat coupon samples of each alloy after exposure to the accelerated test environment at SNL. Figure 24 shows a photograph of a representative sample of each alloy, after exposure, next to a sample that was not exposed to the accelerated test environment. By comparing these photographs, it can be seen that the alloys that contain copper formed very dark deposits that appear to be thick due to the dark opaque color of these deposits. The silver samples are also significantly altered

Figure 24 – Unexposed samples (left side) compared to samples of the same alloy after 60 days of exposure to the accelerated testing environment at SNL (right side). The unexposed silver sample appears dark because its mirror-like surface is highly reflective.

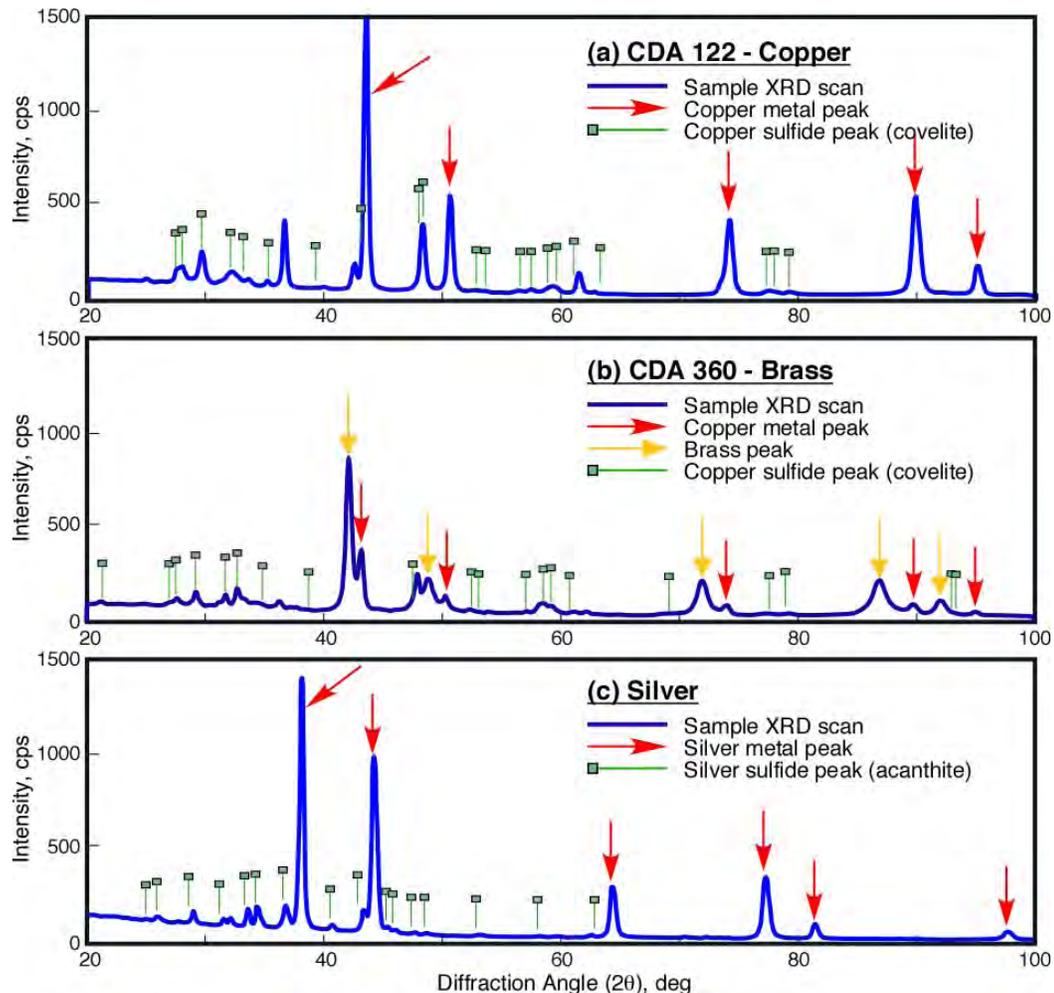
(3) X-ray Diffraction Results. The corrosion product scales on the accelerated test coupons were analyzed by X-ray diffraction for comparison to the scales found on samples removed from homes with problem drywall. This also enabled the use of corrosion product stoichiometry in the analysis of the coupon mass change measurements. A commercial diffractometer with a Cu K-alpha radiation source and a gas-filled 2D area detector at a 15 cm sample-to-detector distance with a field of view of 35 degrees was used. The X-ray beam spot size was 0.5 mm x 1.5 mm in lateral dimensions. Three consecutive scans were performed over the 2-theta range from 20 degrees to 100 degrees. Table II shows the results of this analysis, and Figure 25 shows powder diffraction scans, one each obtained from a sample of copper (CDA122), brass (CDA360) and silver. It should be noted that the X-ray diffraction results show that the accelerated testing environment with its greater concentrations of reactants, including H<sub>2</sub>S, altered the corrosion product on the surface of copper and brass from the digenite phase (Cu<sub>9</sub>S<sub>5</sub>) found on samples removed from homes with problem wallboard to the covellite phase (CuS). The deposit on the silver sample was found by X-ray diffraction to be acanthite (Ag<sub>2</sub>S). A similar analysis was not performed on samples from problem drywall homes, but silver has only one sulfide phase that is stable at ambient temperatures.

Figure 25 – X-ray powder diffraction scans from samples of three alloys after exposure to the accelerated testing atmosphere for 60 days. Table II summarizes the findings.

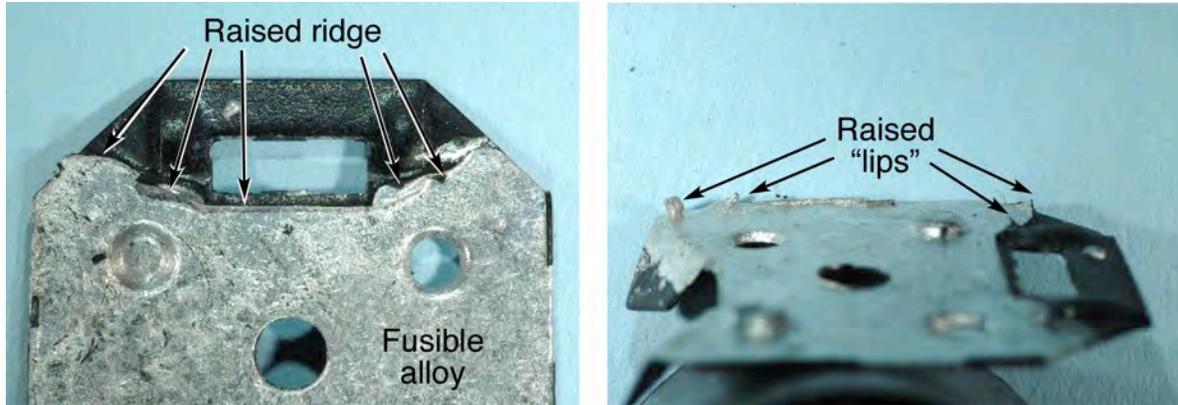
Figure 33 – Two macro photographs of the plate from a fusible link plate from a sprinkler that activated in the plunge test at NIST. The remains of the fusible alloy are the silver-colored substances in the fusion region of the plate, and the remains of the black coating can be seen to form a lip on the edge of the fusion zone.

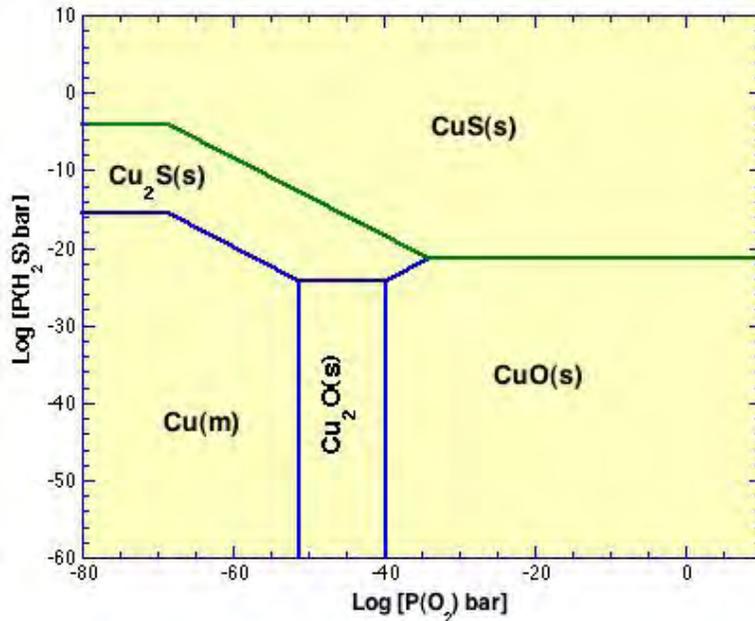
Figure 34 is a diagram of the stable phases of oxygen and hydrogen sulfide, at different partial pressures, on the surface of copper (concentration or activities). This diagram was created from the assembled list of postulated chemical reactions in Appendix A. The free energy change was calculated using the data of Wagman et al.,<sup>17</sup> and the equilibrium line determined for the reaction with respect to variable oxygen and hydrogen sulfide partial pressures. For these calculations, it was assumed that the total gas pressure was 1 barr (approximately atmospheric pressure) and the relative humidity was assumed constant at 31.6 percent (where  $\text{Log}_{10}[\text{H}_2\text{O}] = -0.5$ ). By examining this figure, it can be seen that copper sulfide and copper oxide are stable-to-very low concentrations of these gasses in an atmosphere. The relative position of the  $\text{Cu}_2\text{S}$  and the  $\text{CuS}$  phase fields in this diagram indicates that increasing the hydrogen sulfide concentration (as measured by partial pressure in the diagram), causes the stoichiometry of the stable phase to shift to a lower Cu/S ratio. Wagman et al.<sup>17</sup> provide thermodynamic data for only two of the copper sulfide phase that can form. Fourteen different phases have been identified in the Copper-sulfide system,<sup>18-20</sup> but the composition of these lie between these two extremes. Copper sulfides are non-stoichiometric compounds that will exchange ions with the atmosphere to equilibrate at intermediate concentrations of hydrogen sulfide. Therefore, it is not too surprising that a different phase of copper sulfide was found on the laboratory samples, as compared to that found in the homes with problem drywall. The greater concentration of hydrogen sulfide used in this environment to accelerate the test just moved the stoichiometry of the corrosion product to one of the lower Cu/S ratio sulfides.

Figure 34 – Diagram of the stable phases on copper metal as a function of the oxygen and hydrogen sulfide partial pressures (concentrations). This diagram assumes that the activity of water vapor in this atmosphere is constant at 31.6 percent relative humidity.
