SUBJECT: Advance Notice of Proposed Rulemaking Regarding Off-Highway Vehicles

Off-Highway Vehicle (OHV) Fire and Debris-Penetration Hazards; Advance Notice of Proposed Rulemaking; Request for Comments and Information

Off-Highway Vehicle (OHV) Fire and Debris Penetration Hazards

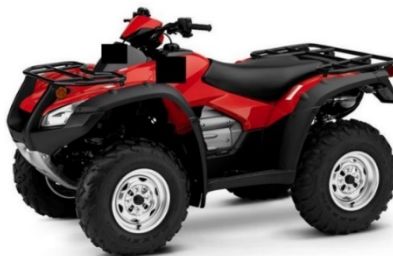
Figure 1: Example of an ATV

An all-terrain vehicle (ATV) is a motorized vehicle with three or four broad, low-pressure tires (less than 10 pounds per square inch), a seat designed to be straddled by the operator, handlebars for steering, and designed for off-highway use. Since the 1980s, the CPSC has addressed ATV safety through various activities, including rulemaking, recalls, consumer education, media outreach, and litigation. These efforts focused on stability and handling issues related to ATV overturn and collisions. Figure 1 shows an example of an ATV.

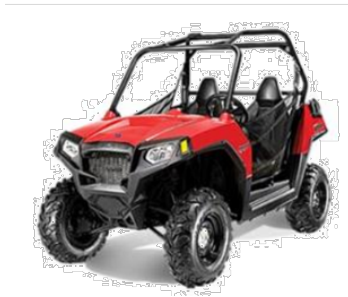
Figure 2: Example of an ROV

An ROV is a motorized vehicle having four or more low-pressure tires designed for off-highway use and intended by the manufacturer primarily for recreational use by one or more persons. Other characteristics of an ROV include: a steering wheel for steering control, foot controls for throttle and braking, bench or bucket seats, rollover protective structure (ROPS), restraint system, and a maximum speed greater than 30 miles per hour (mph). ROVs are intended to be used on terrain similar to ATVs. ROVs are distinguished from ATVs by the presence of a steering wheel, instead of a handle bar for steering; bench or bucket seats for the driver and passenger(s), instead of straddle seating; foot controls for throttle and braking, instead of levers located on the handle bar; and ROPS and restraint systems that are not present on ATVs. CPSC staff has worked on

stability, handling, and occupant protection issues related to ROVs since 2009.³ Figure 2 shows an example of an ROV.

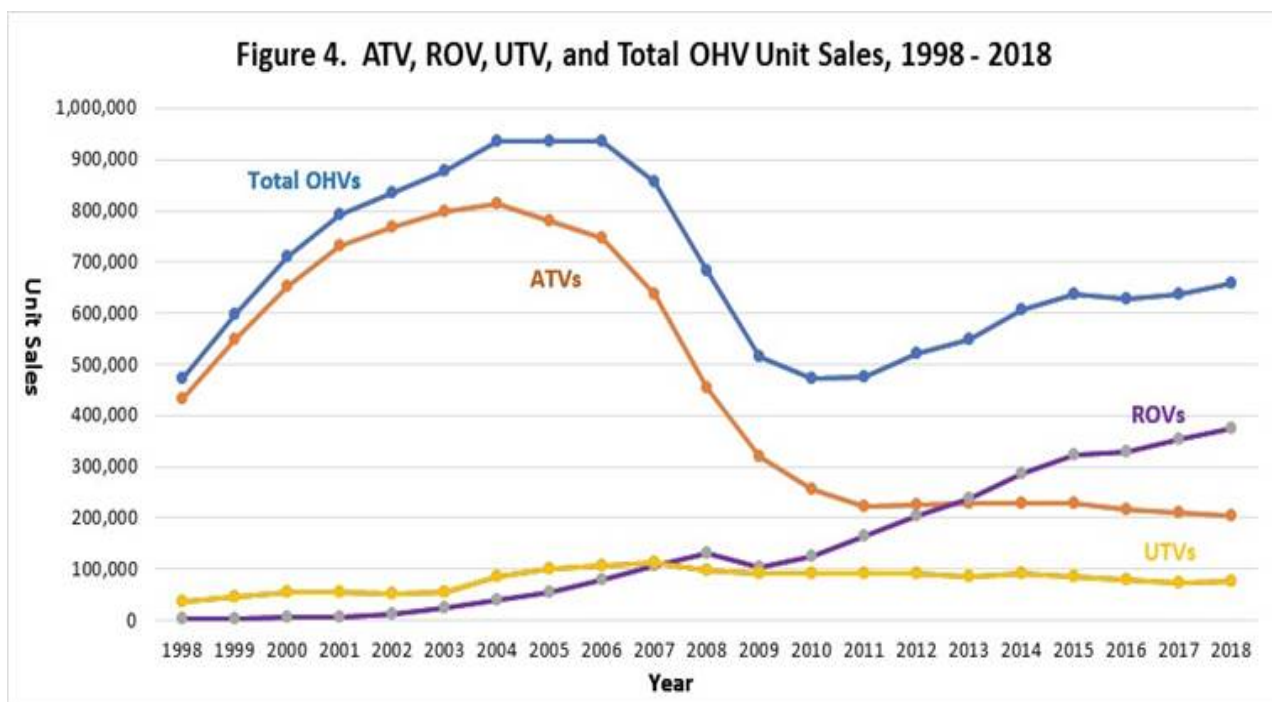
Total U.S. OHV unit sales peaked in 2004, at approximately 937,000. OHV sales then declined, to approximately 475,000 by 2011, before beginning a partial recovery. Figure 4 illustrates ATV, ROV, UTV, and total OHV unit sales from 1998 through 2018. The Commission identified as many as 52 manufacturers and 68 distributors/brands of OHVs supplying an estimated 657,000 OHVs to the U.S. market in 2018, with sales revenue exceeding \$7.87 billion. The Commission estimates U.S. manufacturers accounted for approximately 75 percent of 2018 U.S. OHV sales; SVIA, ROHVA, and OPEI members accounted for approximately 93 percent of 2018 U.S. OHV sales.

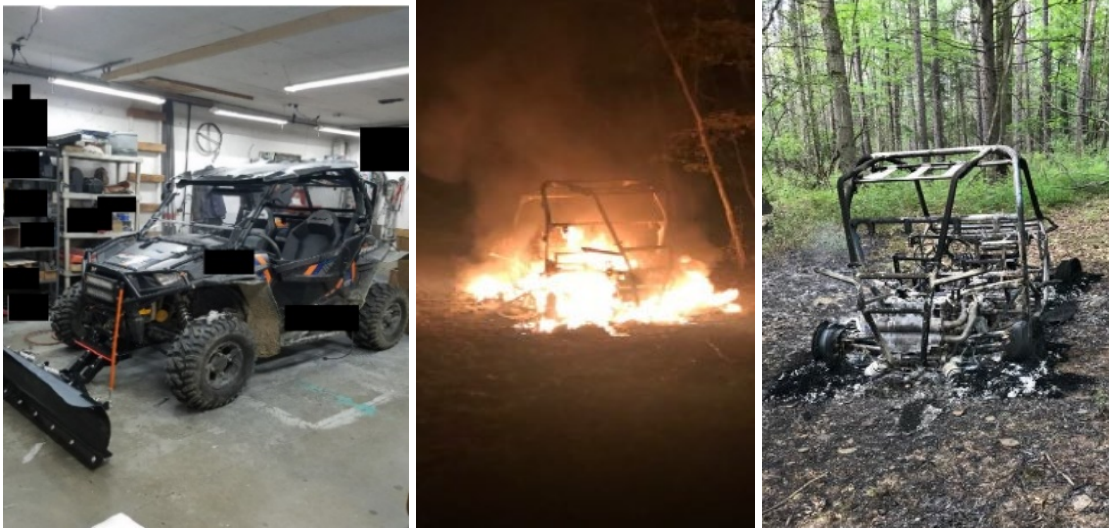
Of the 37 IDIs that had unknown fire causations, 20 involved total-OHV losses. A total loss fire refers to an OHV that has been completely consumed by the fire, leaving only a metal frame and other non-combustible metal parts. A total loss can occur when a smaller fire spreads into a fuel-fed fire, so that the entire vehicle becomes engulfed in flames. This often makes it difficult to determine the origin of the fire. The smaller fire can originate from various sources, such as an overheating exhaust that burns a plastic body panel, a fuel leak fire, or a fire from an electrical short, where a portion of a plastic body panel may catch fire, then that fire can spread to the entire vehicle because the majority of the OHV body panels are generally made of flammable plastics. Total loss incidents, as shown in Figure 5, represent the most severe fire hazard of an OHV.

Figure 5: ROV Prior to the Fire Incident (Left), ROV on Fire (Middle), and ROV Post-Total Loss Fire (Right)

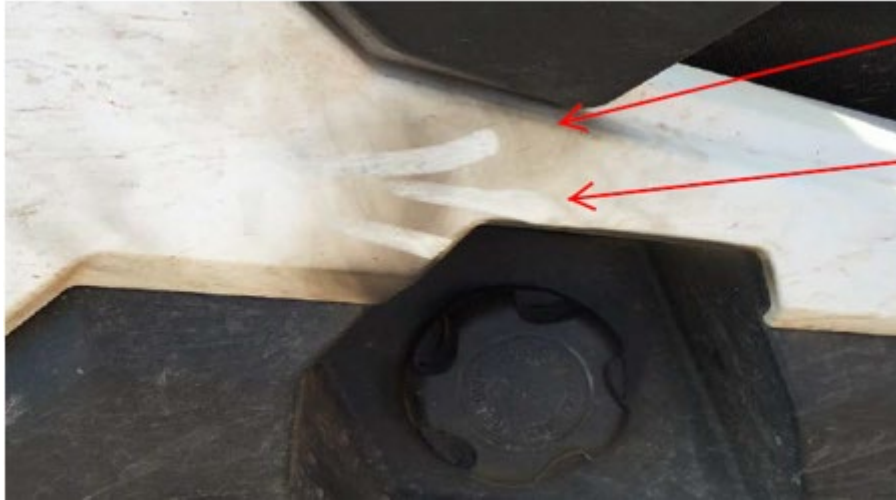
system can result in boiling gasoline, which can expel abruptly when opening the fuel cap, potentially splashing hot gasoline onto consumers. Figure 6 shows an example from an IDI of an over-pressurization scenario with an ROV. Unbeknownst to the consumer, opening the fuel cap released pressurized gasoline and a brief fire resulted. Black soot can be seen surrounding the fuel cap.

Figure 6 – Soot on the Frame of the ROV (Red Arrows) Resulted from Flames that Shot Out from the Fuel Tank When the Consumer Opened the Gas Cap

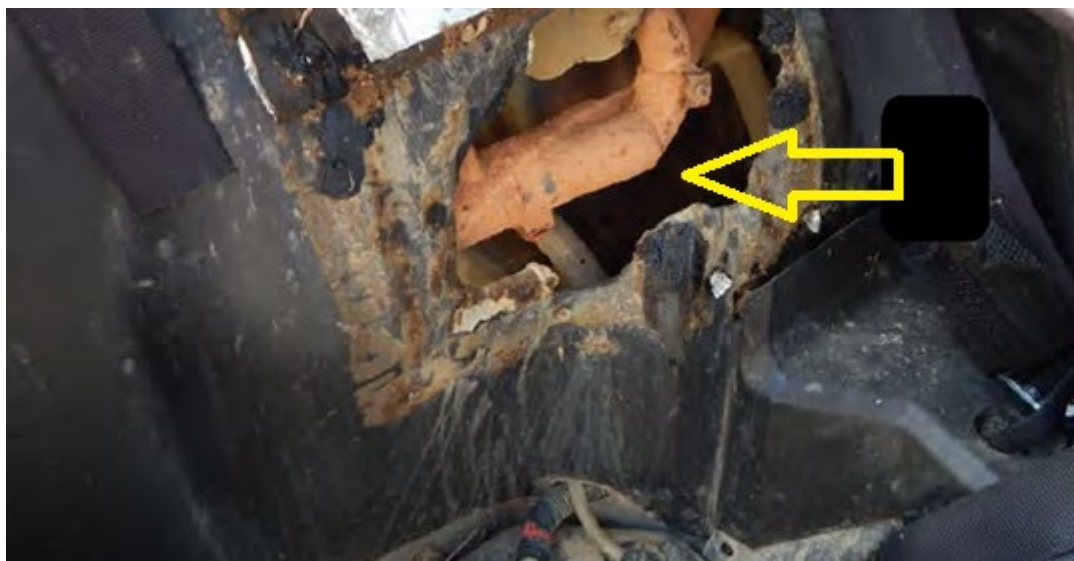
Excessive exhaust heat near flammable plastics can cause melting and subsequently fires, if the exhaust systems do not manage the exhaust heat sufficiently, via heat shielding and/or adequate ventilation. It is not uncommon for modern ROV exhaust surface temperatures to exceed 800°F. Insufficient heat shielding between the exhaust pipes and plastic paneling can cause the plastic to melt. Figure 8 illustrates a fire that ignited when melted plastic paneling dripped onto the exhaust pipe and burned a hole through the panel.

Figure 8 – Example of Fire Damage Caused by Excessive Exhaust Heat

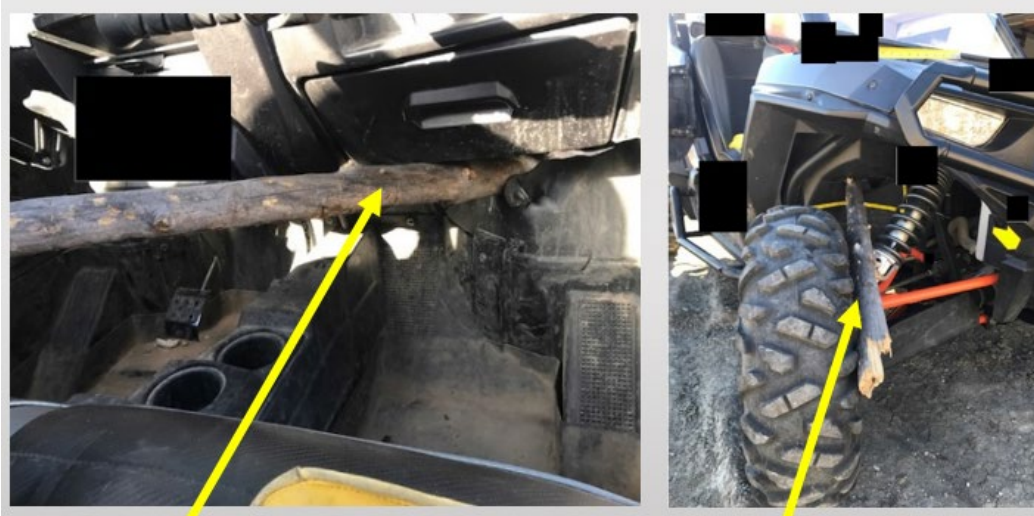
Debris-penetration hazards are unique to ROVs and UTVs because the wheel-well areas on these vehicles are generally larger and more open, compared to ATVs. The larger space exposes more floorboard and wheel-well surface to branches that can and do penetrate into the occupant compartment. Debris penetration through the floorboard or wheel well can impale the occupants of the vehicle and has caused severe injuries and deaths. An example of debris penetration is shown in Figure 9. CPSC staff did not find any ATV-related debris-penetration incidents in the injury/death data searches or debris-penetration recalls.

Figure 9: Example of Tree Branch (Yellow Arrows) Penetrating ROV floorboard; Left Photograph Shows View from the Cabin (Passenger Seat); Right Photograph Shows Front View of ROV

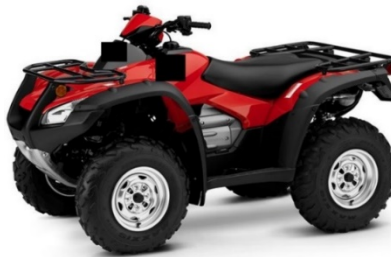
An ATV is a motorized vehicle with three or four broad, low-pressure tires (less than 10 pounds per square inch), a seat designed to be straddled by the operator, handlebars for steering, and designed for off-highway use. Since the 1980s, the CPSC has addressed ATV safety through

Figure 1: Example of an ATV

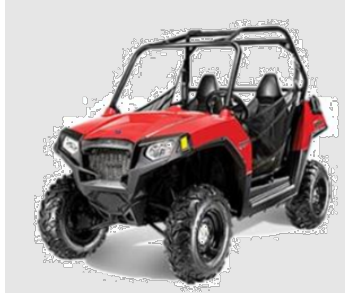
Figure 2: Example of an ROV

The Recreational Off-Highway Vehicle Association (ROHVA) developed ANSI/ROHVA 1 *American National Standard for Recreational Off-Highway Vehicles* for recreation-oriented ROVs, and the Outdoor Power Equipment Institute (OPEI) developed ANSI/OPEI B71.9 *American National Standard for Multipurpose Off-Highway Utility Vehicles* for utility-oriented ROVs and includes requirements for vehicles that exceed 30 mph (and thus meet CPSC's definition of "ROVs").

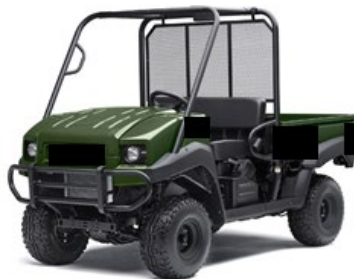
Figure 3: Example of a UTV

A UTV is a motorized vehicle having four or more low-pressure tires designed for off-highway use with the same characteristics (bench seating, steering wheel, foot controls, ROPS, and seat belts) as ROVs, but are intended for utility use, have larger cargo beds to accommodate hauling-type tasks, and they generally have maximum speeds between 25 and 30 mph.

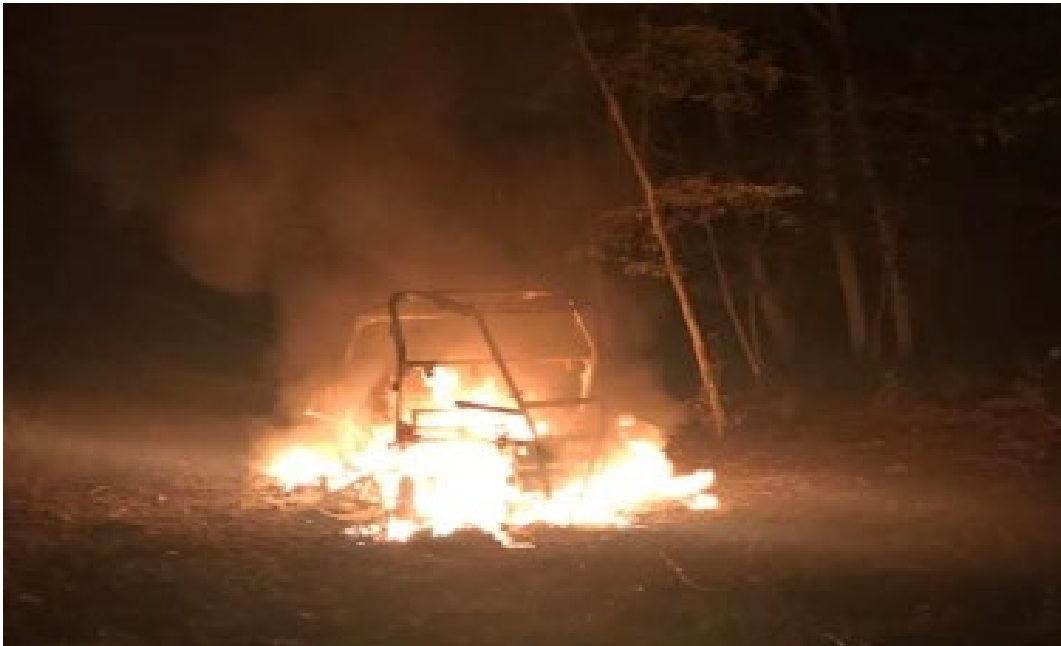
Fires and fire hazards (*e.g.*, fuel leaks) are caused by many different sources, including breach in the fuel system, electrical component failure, exhaust overheating, and debris (grass/dry vegetation) ignition when contacting exhaust systems. Figure 4 illustrates an ROV fire where flames have engulfed the entire vehicle prior to a total loss.

Figure 4: Example of ROV on Fire Prior to a Total Loss

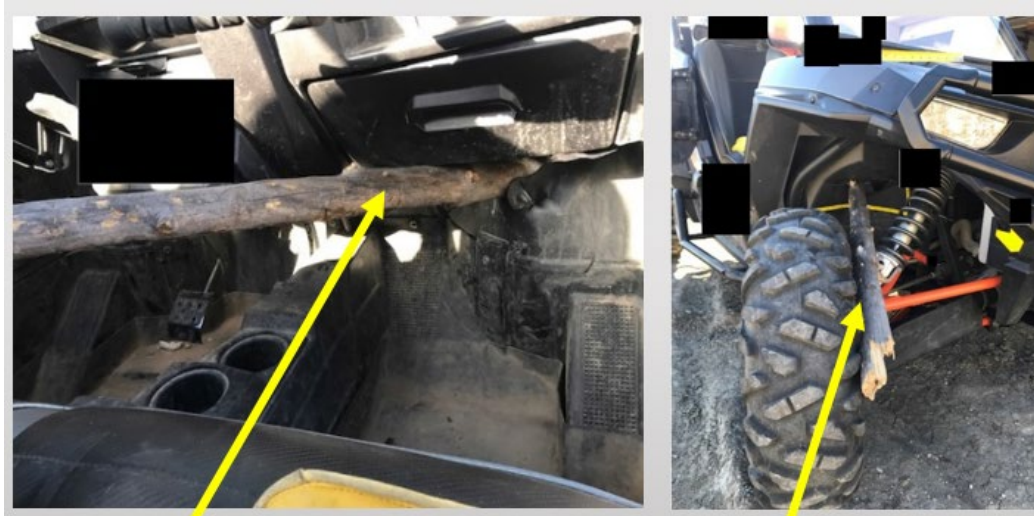
Debris penetration hazards are unique to ROVs and UTVs. These hazards involve foreign objects, usually tree branches that puncture through the floorboard, which can impale the occupants. An example of debris penetration is shown in Figure 5. Debris impalements have caused deaths and serious injuries. CPSC staff did not find any ATV debris penetration incidents in the injury/death data searches or any ATV debris penetration recalls. ROVs and UTVs generally have larger open wheel well areas when compared to ATVs, which presents a higher probability and opportunity for debris penetration to occur on ROVs and UTVs.

Figure 5: Example of Tree Branch (Yellow Arrows) Penetrating ROV Floorboard; Left Photograph Shows View from the Cabin (Passenger Seat); Right Photograph Shows Front View of ROV

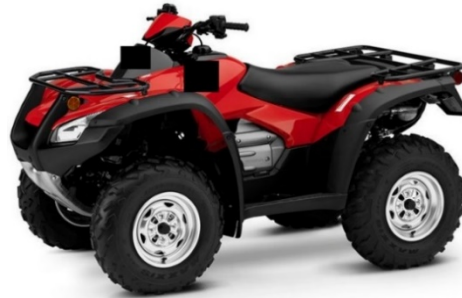
Figure 1: Example of an ATV

An ATV is a motorized vehicle with three or four broad, low-pressure tires (less than 10 pounds per square inch), a seat designed to be straddled by the operator, handlebars for steering, and it is designed for off-highway use. Since the 1980s, the CPSC has addressed ATV safety through various activities, including rulemaking, recalls, consumer education, media outreach, and litigation. These efforts focused on stability and handling issues related to ATV overturn and collisions, and with the Consumer Product Safety Improvement Act of 2008, the voluntary standard for ATVs, ANSI/SVIA-1, has been incorporated by reference in 16 CFR 1420.3(a) since November 2008.

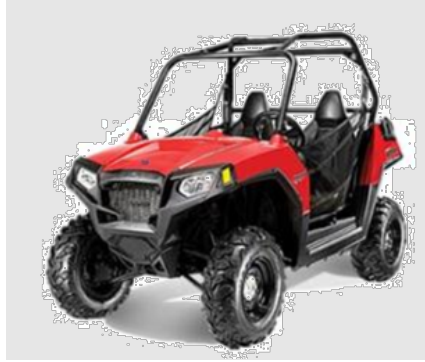
An ROV is a motorized vehicle having four or more low-pressure tires designed for off-highway use and intended by the manufacturer primarily for recreational use by one or more persons. Other characteristics of an ROV include: a steering wheel for steering control, foot controls for throttle and braking, bench or bucket seats, rollover protective structure (ROPS), restraint system, and a maximum speed greater than 30 miles per hour (mph). ROVs are intended to be used on terrain to what ATVs are used on, but they are distinguished from ATVs by the presence of a steering wheel instead of a handle bar for steering, bench or bucket seats for the driver and passenger(s) instead of straddle seating, foot controls for throttle and braking instead of levers located on the handle bar, and ROPS and restraint systems that are not present on ATVs. CPSC staff has worked on stability, handling, and occupant protection issues related to ROVs since 2009.¹

Figure 2: Example of an ROV

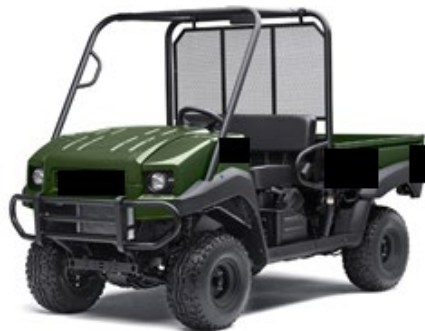
Figure 3: Example of a UTV

A UTV is a motorized vehicle having four or more low-pressure tires designed for off-highway use with the same characteristics (bench seating, steering wheel, foot controls, ROPS and seat belts) as ROVs, but are intended for utility use, have larger cargo beds to accommodate hauling type tasks, and generally have maximum speeds between 25 and 30 mph.

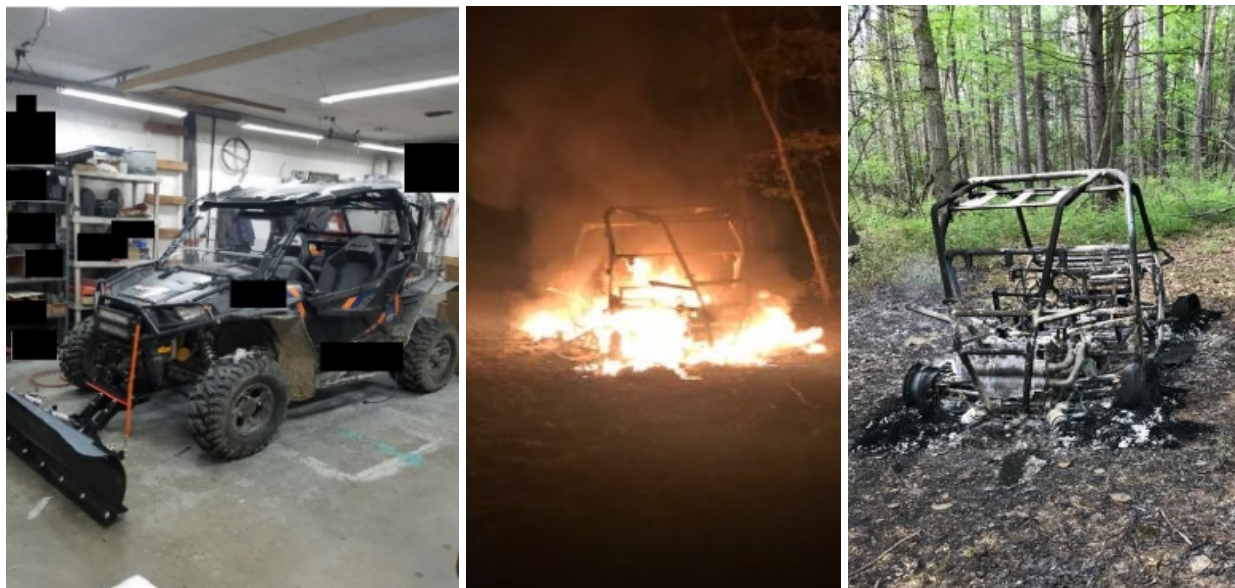
Of the 37 IDIs that had unknown fire causations, 20 involved total OHV losses. A total-loss fire refers to an OHV that has been completely consumed by the fire, leaving only a metal frame and other non-combustible metal parts. A total loss can occur when a smaller fire spreads into a fuel-fed fire, so that the entire vehicle becomes engulfed in flames. This often makes it difficult to determine the origin of the fire. The smaller fire can originate from various sources, such as an overheating exhaust that burns a plastic body panel, a fuel leak fire, or a fire from an electrical short, where a portion of a plastic body panel may catch fire, then that fire can spread to the entire vehicle because the majority of the OHV body panels are generally made of flammable plastics. Total-loss incidents represent the most severe fire hazard of an OHV. Figure 4 shows an example of an ROV total-loss fire. Photos from Figure 4 are from an IDI that had an unknown fire causation.

Figure 4: ROV Prior to the Fire Incident (Left), ROV on Fire (Middle), and ROV Post-Total Loss Fire (Right)

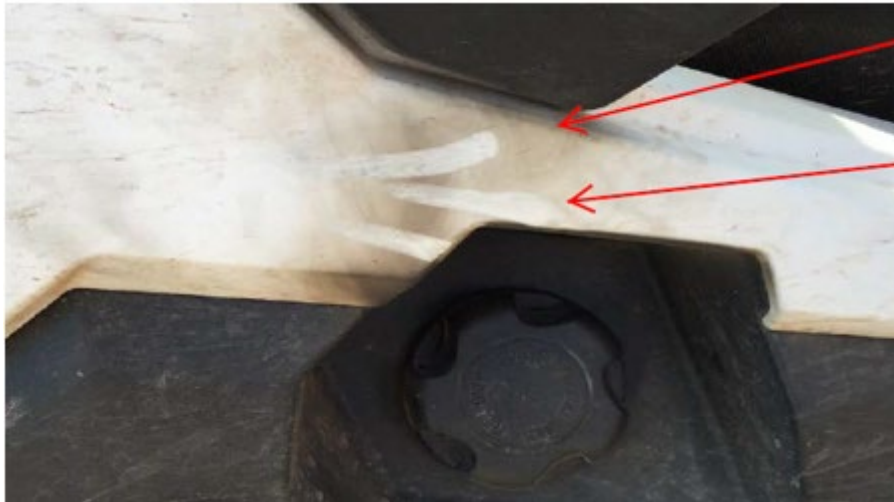
Other fuel-related fire hazards can be due to over-pressurization of the fuel system and inadequate ventilation. Inadequate ventilation and over-pressurization of the fuel system can result in boiling gasoline, which can expel abruptly when opening the fuel cap, potentially splashing hot gasoline onto consumers. Figure 5 shows an example from an IDI of an over-pressurization scenario with an ROV. Unbeknownst to the consumer, opening the fuel cap released pressurized gasoline and a brief fire resulted. Black soot can be seen surrounding the fuel cap.

Figure 5 – Soot on the Frame of the ROV (Red Arrows) Resulted from Flames that Shot Out from the Fuel Tank When the Consumer Opened the Gas Cap

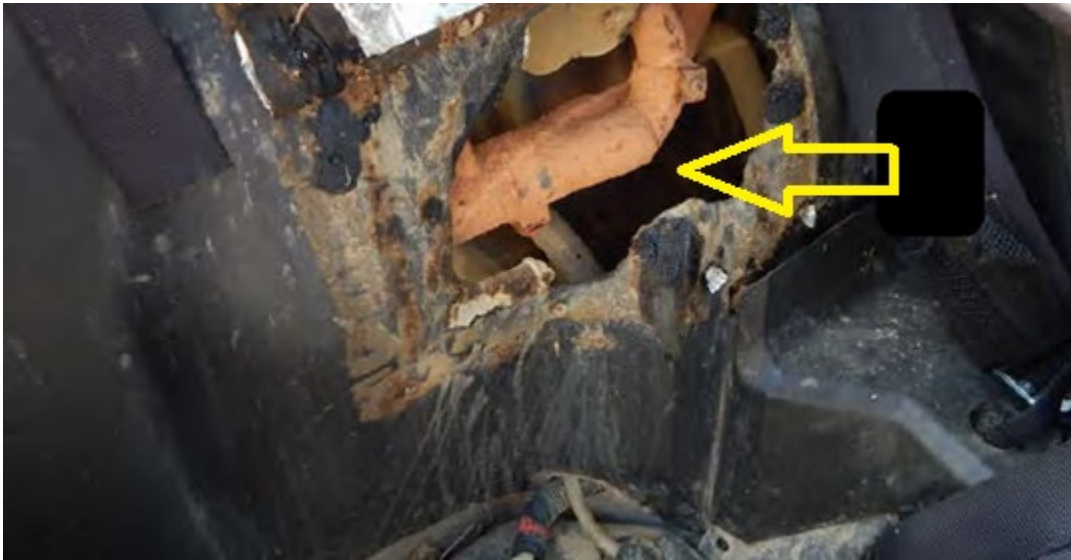
Excessive exhaust heat near flammable plastics can cause melting and subsequently fires if the exhaust systems do not manage the exhaust heat sufficiently, via heat shielding and/or adequate ventilation. It is not uncommon for modern ROV exhaust surface temperatures to exceed 800°F.

Figure 7 – Example of Fire Damage Caused by Excessive Exhaust Heat

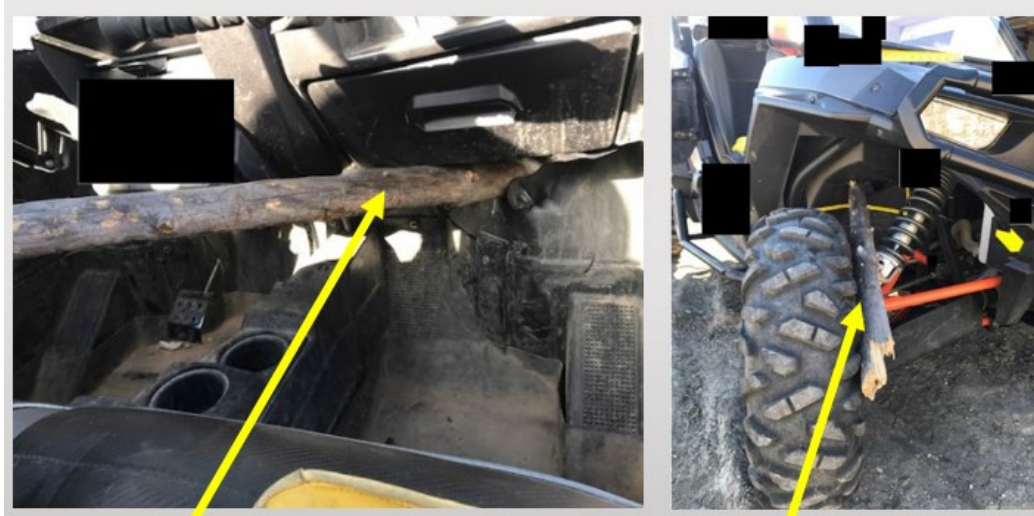
Debris penetration hazards are unique to ROVs and UTVs because the wheel well areas on these vehicles are generally larger and more open compared to ATVs. The larger space exposes more floorboard and wheel well surface to branches that can and do penetrate into the occupant compartment. Debris penetration through the floorboard or wheel well can impale the occupants of the vehicle and has caused severe injuries and deaths. An example of debris penetration is shown in Figure 6. CPSC staff did not find any ATV-related debris penetration incidents in the injury/death data searches or debris penetration recalls.

Figure 6: Example of Tree Branch (Yellow Arrows) Penetrating ROV floorboard; Left Photograph Shows View from the Cabin (Passenger Seat); Right Photograph Shows Front View of ROV

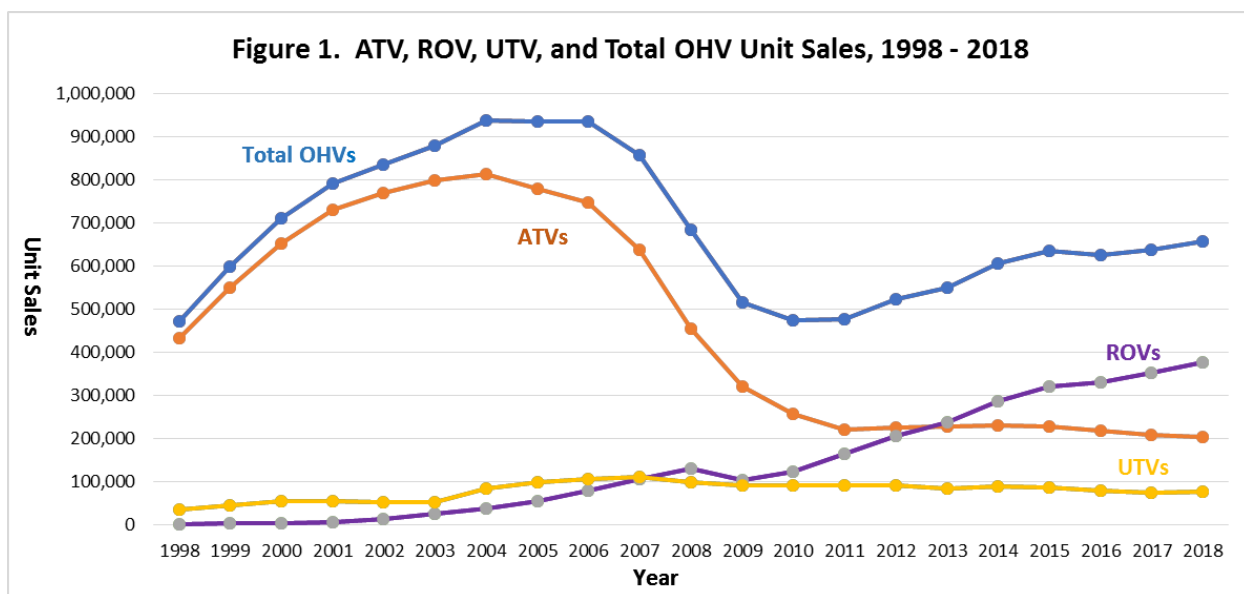
Total U.S. OHV unit sales peaked in 2004 at approximately 937,000. OHV sales then declined, to approximately 475,000 by 2011, before beginning a partial recovery. Figure 1 below illustrates ATV, ROV, UTV, and total OHV unit sales from 1998 through 2018. CPSC staff identified as many as 52 manufacturers and 68 distributors/brands of OHVs supplying an estimated 657,000 OHVs to the U.S. market in 2018, with sales revenue exceeding \$7.87 billion. CPSC staff estimates U.S. manufacturers accounted for approximately 75 percent of 2018 U.S. OHV sales; SVIA, ROHVA, and OPEI members accounted for approximately 93 percent of 2018 U.S. OHV sales.
