Home Elevator Safety Program Launches With Free Inspection, Space Guards

Homelevator-Safety.com Website, 800 Number Available to Help Homeowners Address Installation Issues with thyssenkrupp Access Corp. Elevators

thyssenkrupp Access Corp. Home Elevator Safety Program

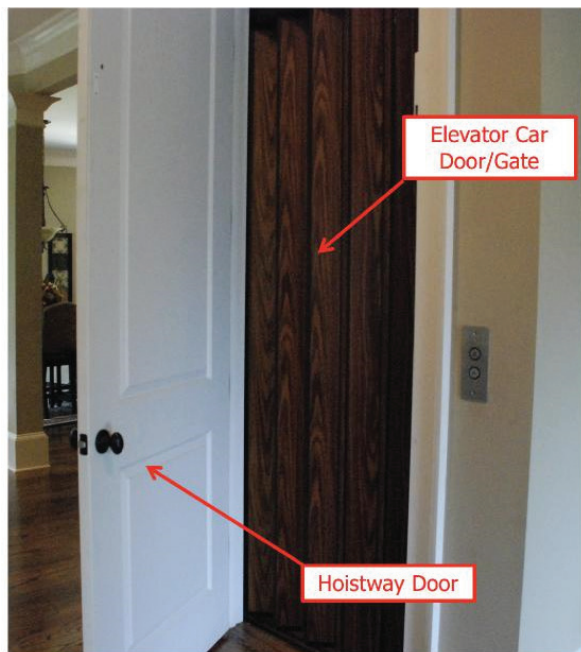
Figure 1

Elevator Car Door or Gate: The elevator car door or gate is attached to the elevator car itself, and is commonly an accordion door or a scissor gate. Some elevators have more than one entrance.

Hoistway Door: The hoistway door is the exterior door that leads from the hallway to the elevator car. There is one hoistway door on every floor serviced by the elevator.

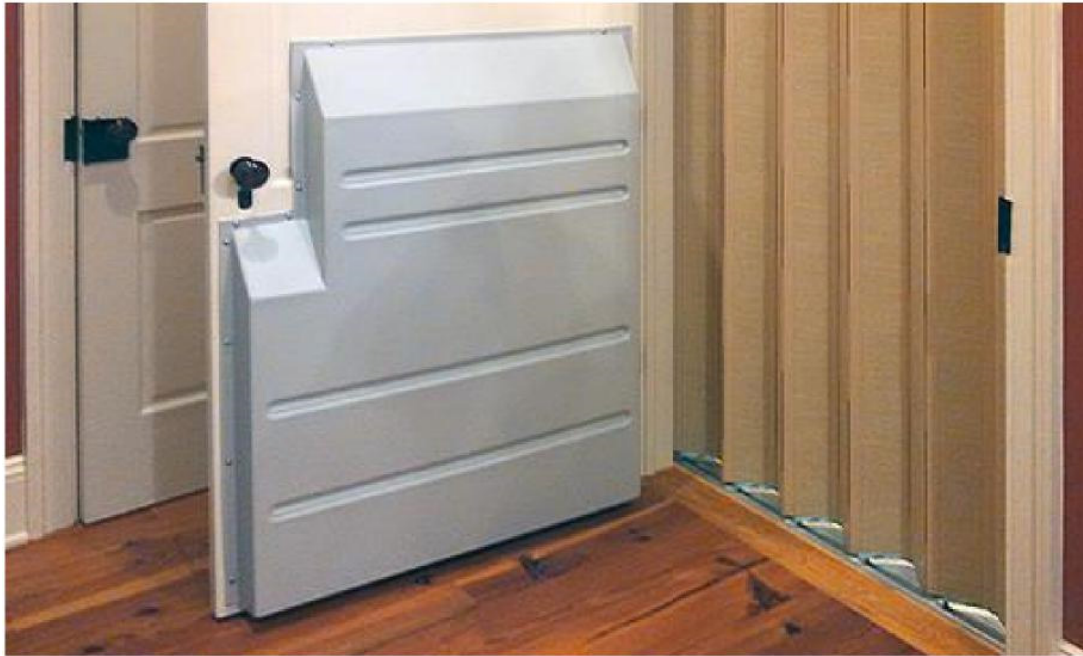
Figure 4

A properly installed space guard will not interfere with the operation of your elevator.

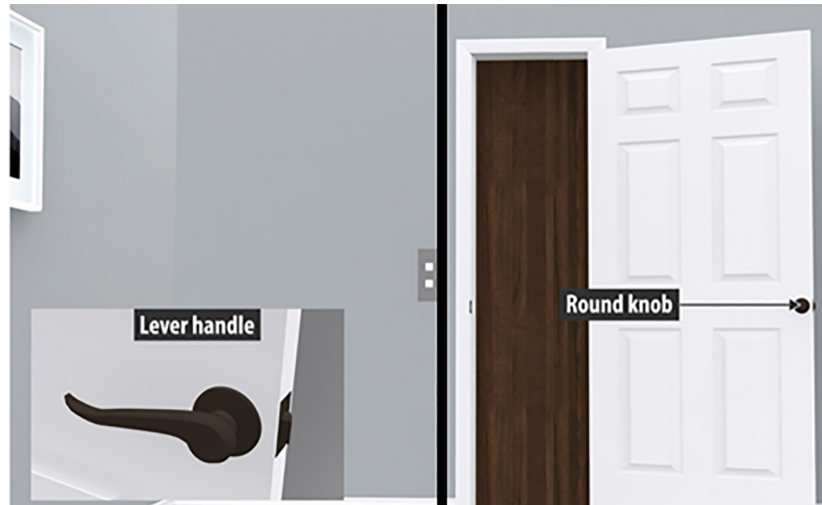
2. **DOOR KNOB TYPE:** If the door has a lever rather than a round knob, please verify that the lever is not longer than four inches. (Note: The Space Guard was designed for doors that have a round knob but may accommodate many lever-style handles. However, if the Space Guard hinders proper operation of your particular lever-style handle due to the handle's size or shape, then you might need to replace the handle with a round knob or different style handle.)

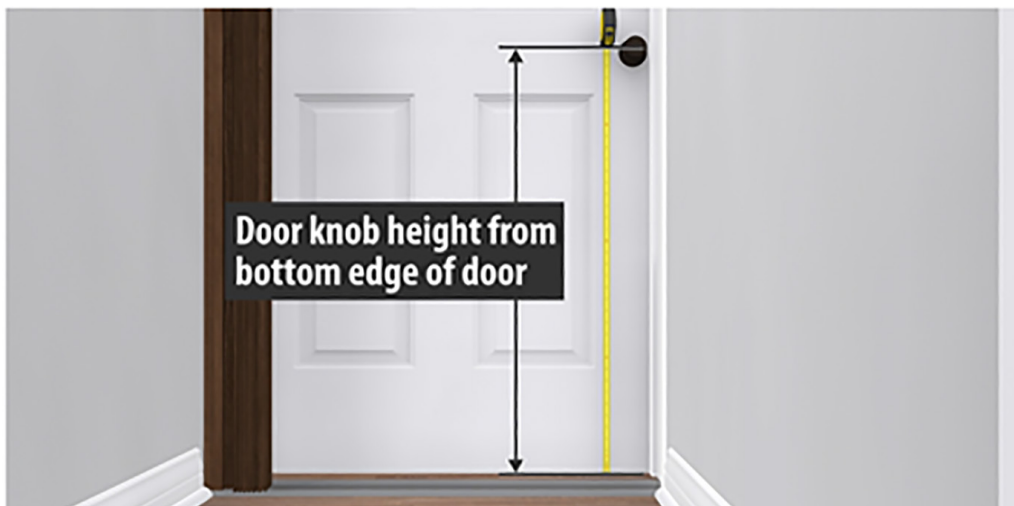
3. **DOOR KNOB HEIGHT:** At each floor with an excessive Gap Space, measure the vertical distance from the bottom edge of the door (directly beneath the door knob) to the center of the hoistway door knob (on the side of the door that faces the elevator car). (Note: Please do not make this measurement from the floor to the door knob, but only from the bottom edge of the door to the door knob.)

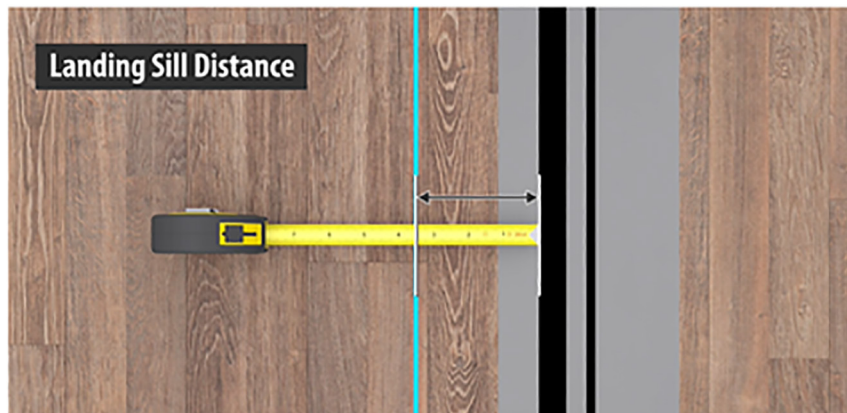
6. **HOISTWAY LANDING SILL SIZE:** Measure the distance from the inside of the hoistway door to the edge of the landing sill.

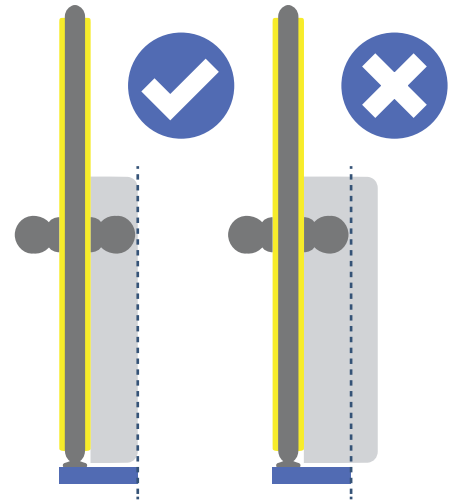
- 7** Before attaching the Space Guard, make sure it does not extend beyond the edge of the landing sill to ensure that it will not interfere with the movement of the elevator car.

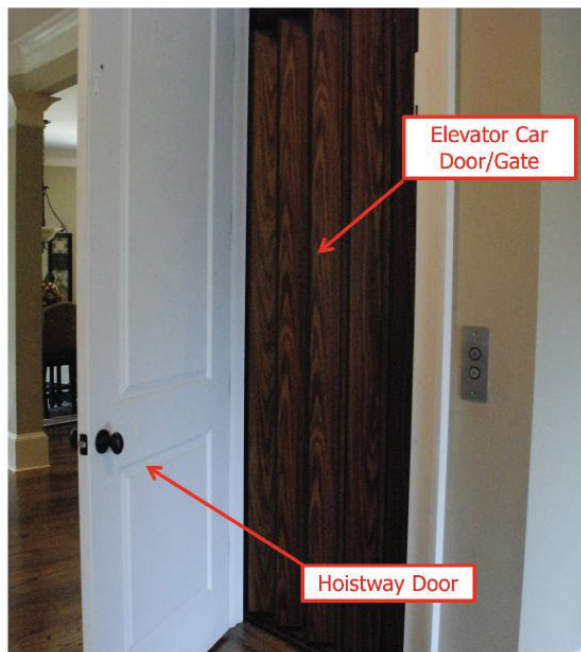
Figure 1

Elevator Car Door or Gate: The elevator car door or gate is attached to the elevator car itself, and is commonly an accordion door or a scissor gate. Some elevators have more than one entrance.

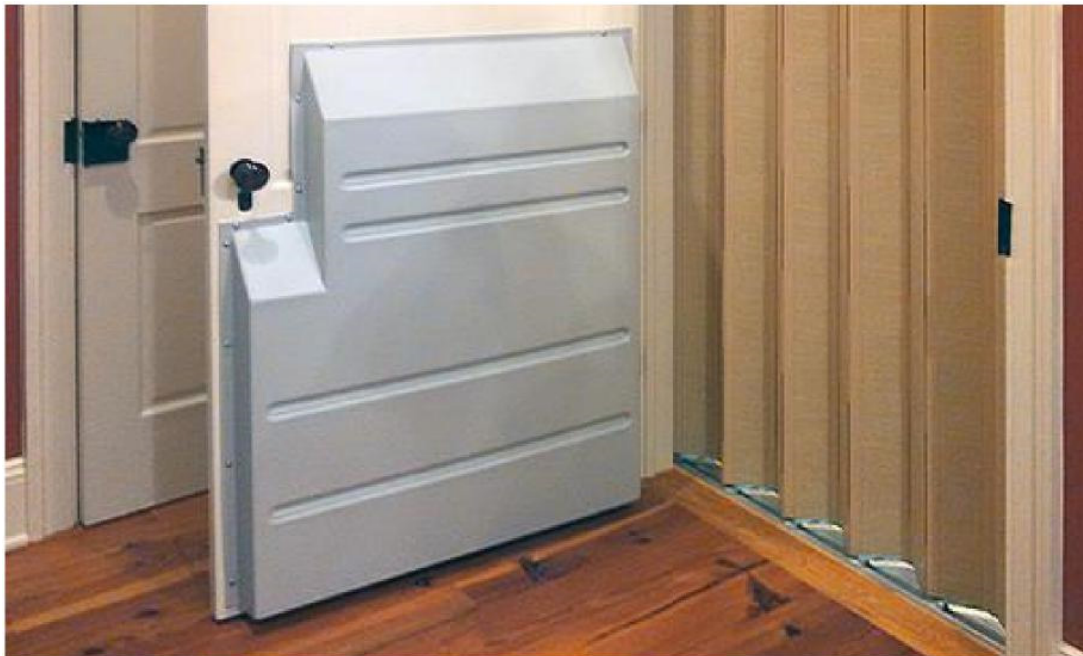
Figure 4

A properly installed space guard will not interfere with the operation of your elevator.
